Memo

To:	Joe Martella, RIDEM
From:	David Heislein and Steve Herzog, Amec Foster Wheeler
cc:	Greg Simpson, Textron
Date:	September 14, 2016
Re.	Parcel C-1 Restored Wetlands Assessment Monitoring Final Report, Mashapaug Inner Cove and Mashapaug Pond Former Gorham Manufacturing Site, Providence, Rhode Island

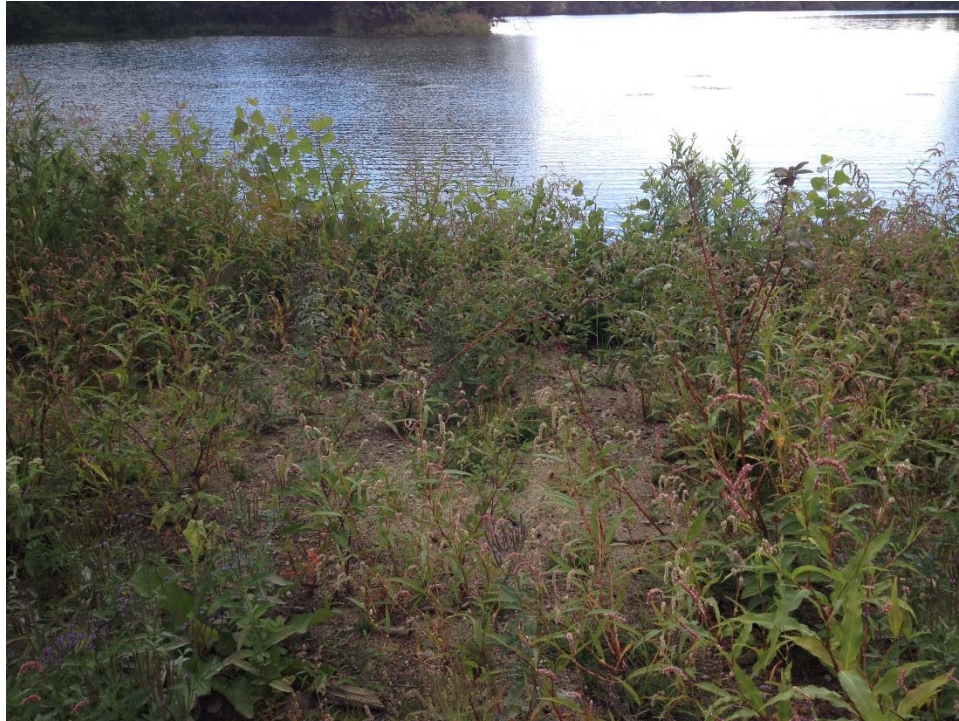
Vegetation: Since our May/June 2016 inspection of the fringe wetland, the herbaceous species have grown up from seed and become very well-established. Vegetation cover was 95–100% (Photos 1-4). Only small areas (several square feet) of the fringe wetland exhibited less than 100% coverage (Photo #5). The woody herbaceous plants were not counted due to the obvious health of the plants and tall (up to five feet) dense herbaceous cover. Herbaceous and woody vegetation in the fringe wetland was dominated by species with a wetland indicator status of facultative or wetter.

5. Small area of relatively thin vegetation cover in fringe wetland, view to north.

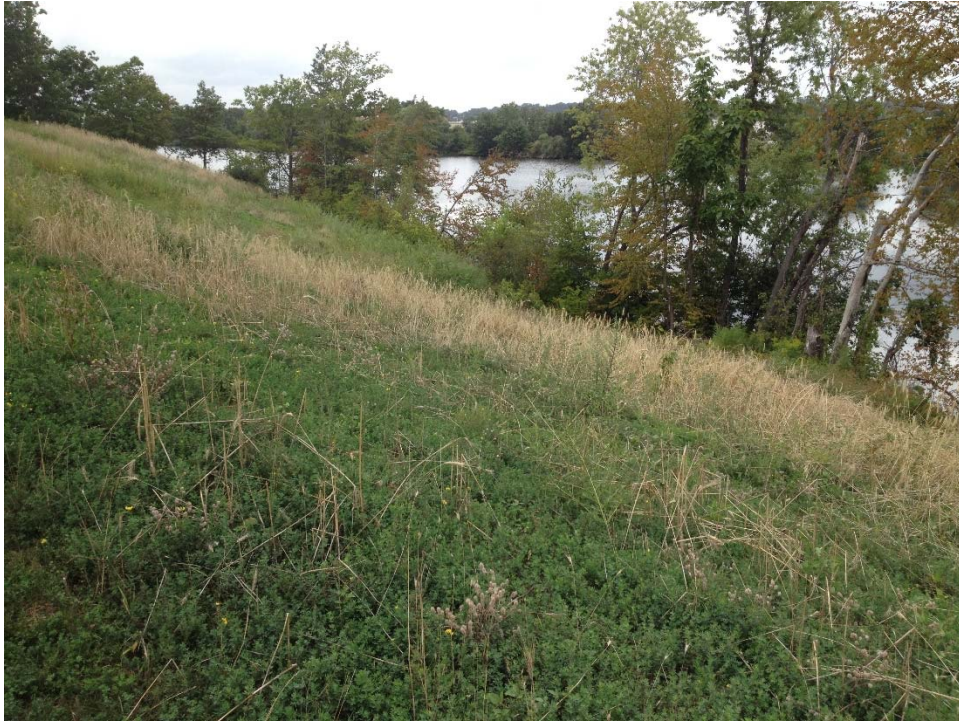
All areas of the perimeter wetlands were densely vegetated with grasses and herbaceous species. Vegetation coverage in the perimeter wetlands was 100%. As with the fringe wetland, herbaceous growth was sufficiently dense as to obscure the woody planted species, so these were not counted in this final inspection. Woody plants observed were healthy.

7. Densely vegetated perimeter wetland (50' buffer) view to west.

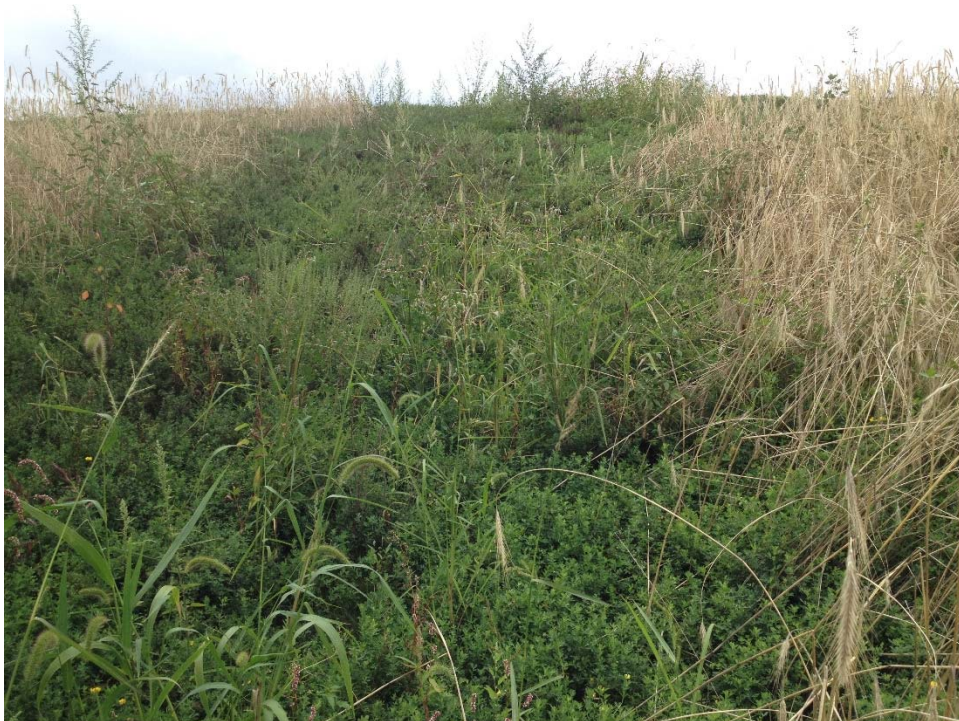
Soil Stability: No evidence of soil erosion was observed in the fringe wetland or perimeter wetland. Several erosion washouts had been documented in the perimeter wetland during the May 2016 monitoring. Those washouts have been repaired and were observed during this inspection to contain 100% vegetation cover.

8. Repaired former erosion washout in 50' buffer, Parcel C-1 north, view upslope to south.
