RI Department of Environmental Management Environmental Land Usage Restriction (ELUR) Annual Compliance Self-Evaluation Form

Site Name: Queen Ann Square RIDEM File No.: 2012-010 RIDEM Project Manager: Joseph T. Martella ELUR Recording Date: Owner Telephone Number: 401-845-5802	Property Owner: <u>City of Newport</u> Owner Mailing Address: <u>43 Broadway</u> Newport RI 02840 Inspection Date: <u>12/12/2016</u> E-Mail: swheeler@cityofnewport.com
This Annual Compliance Self-Evaluation Form is use of any active remediation systems (e.g. active) unless explicit, written permission has been	re SSDS, ongoing air or groundwater monitoring,

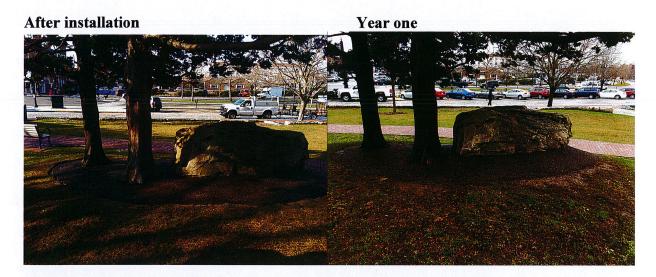
In 2015 a resilient rubber wear surface, http://kbius.com/kbi-products/kbi-flexi-pave/, was installed around the large stone to eliminate a dirt wear zone created when kids climb on the stone located in the center of the park. Below are photos following installation and one year later. In general this solution has worked exceptionally well but reseeding on the transition zone with grass will need to be an ongoing task,

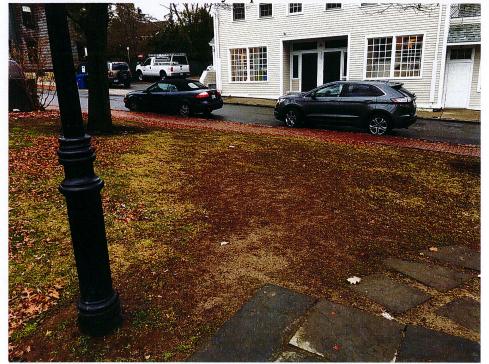
The QAS Trustees are monitoring a pedestrian "short cut" in the south east corner of the park accessing Mill Street. The grass is still intact but showing stress from excessive foot traffic. One option to be evaluated at the Spring of 2017 during the a QAS Trustee inspection is the purchase and installation of a Boston Garden Post and Chain fence to redirect foot traffic to a hardened path.

Pedestrian shortcut to Mill St. may require installation of Boston Garden Post & Chain fence.

b.	Overall Condition of Engineered Control(s) XGoodNon-compliantAcceptableNot Applicable (Sites where only groundwater is restricted)
c.	Are there any areas on the property that have broken concrete, cracked asphalt, potholes, eroded landscaping, etc.? _XYesNo
	If yes:
	Please provide a description of the area(s) of concern: Pedestrian foot traffic between the "Chimney" sitting room and to the east along Mill Street (see photo).
	Could water infiltrate through these areas into underlying contaminated soils? Yes NoX N/A; Infiltration Not Restricted
	When will the area(s) of concern be repaired? The area has been aerated and seeded. In the spring the Trustees will evaluate wear and consider installation of a Boston Garden Post and Chain fence to redirect foot traffic to an established walkway.
