**NONQUIT POND TRIBUTARIES
WATER QUALITY STUDY AND POLLUTANT SOURCE IDENTIFICATION
NATIONAL WATER QUALITY INITIATIVE**

**Prepared By: Office of Water Resources
Rhode Island Department of Environmental Management
235 Promenade St. Providence, RI 02908
June 2018**

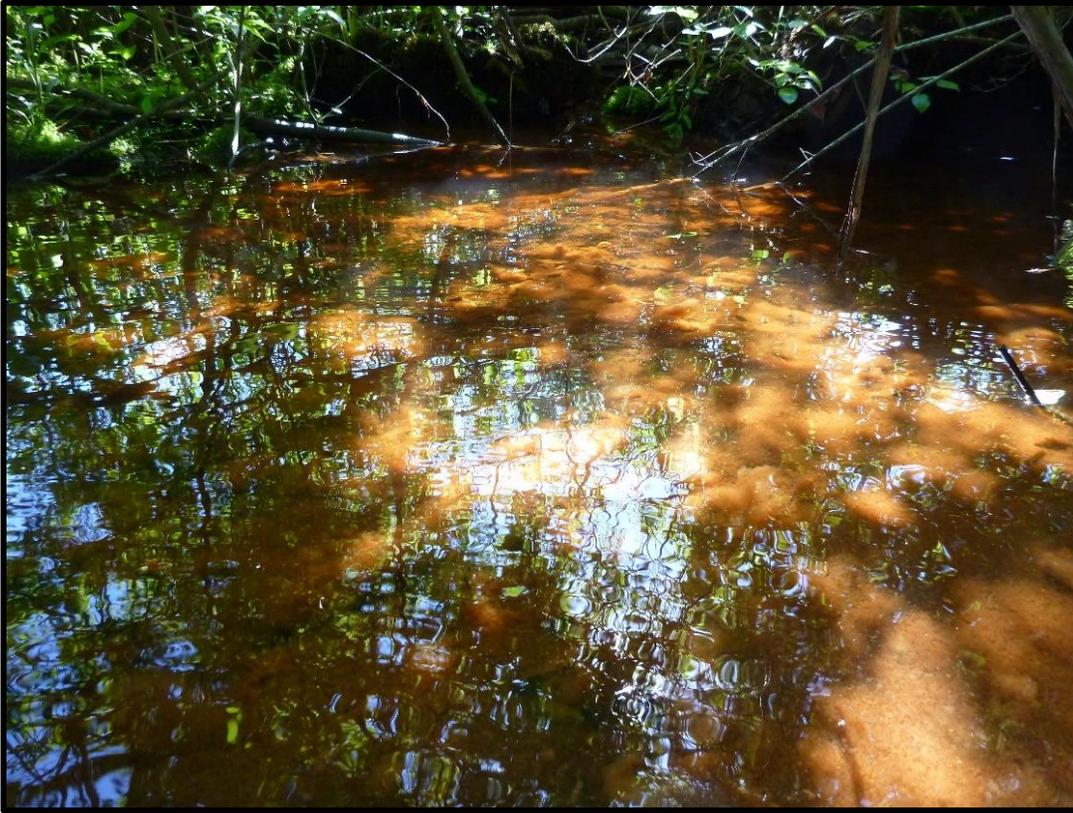
Total mean dry-weather total iron concentration exceeds DEM criteria. Iron floc was apparent in the wetland, upstream of the landfill access road ([Photo 1](#)). The source of iron was likely groundwater flow from the Tiverton landfill. Under anaerobic landfill conditions, iron is reduced (including both iron from waste and iron naturally found in soils). The reduced iron is highly soluble and is readily transported by groundwater. Once the reduced iron discharges to the wetland and hits the atmosphere, it oxidizes, producing the rust-colored iron floc.

Photo 1. Iron Flocculent in wetland north (upstream) of Tiverton landfill access road (return to: [Quaker Creek](#) or [Photo Key](#)).

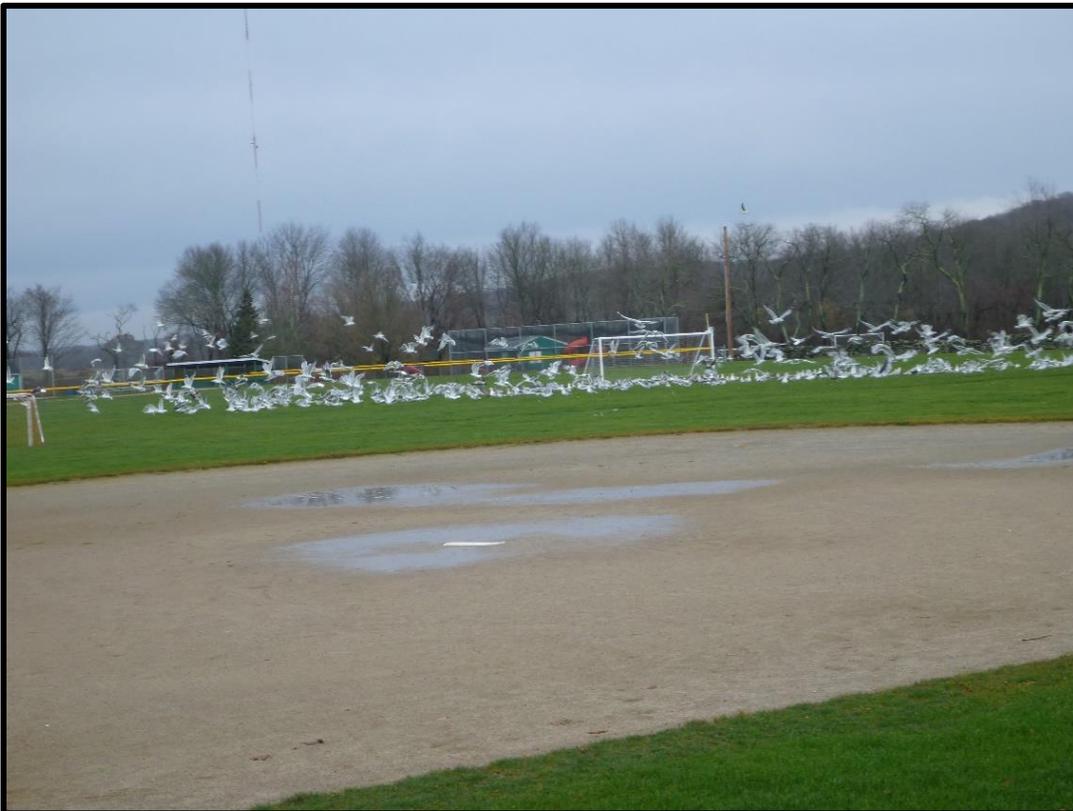
Photo 2. Seagulls at Town baseball field (return to: [Quaker Creek](#) or [Photo Key](#)).

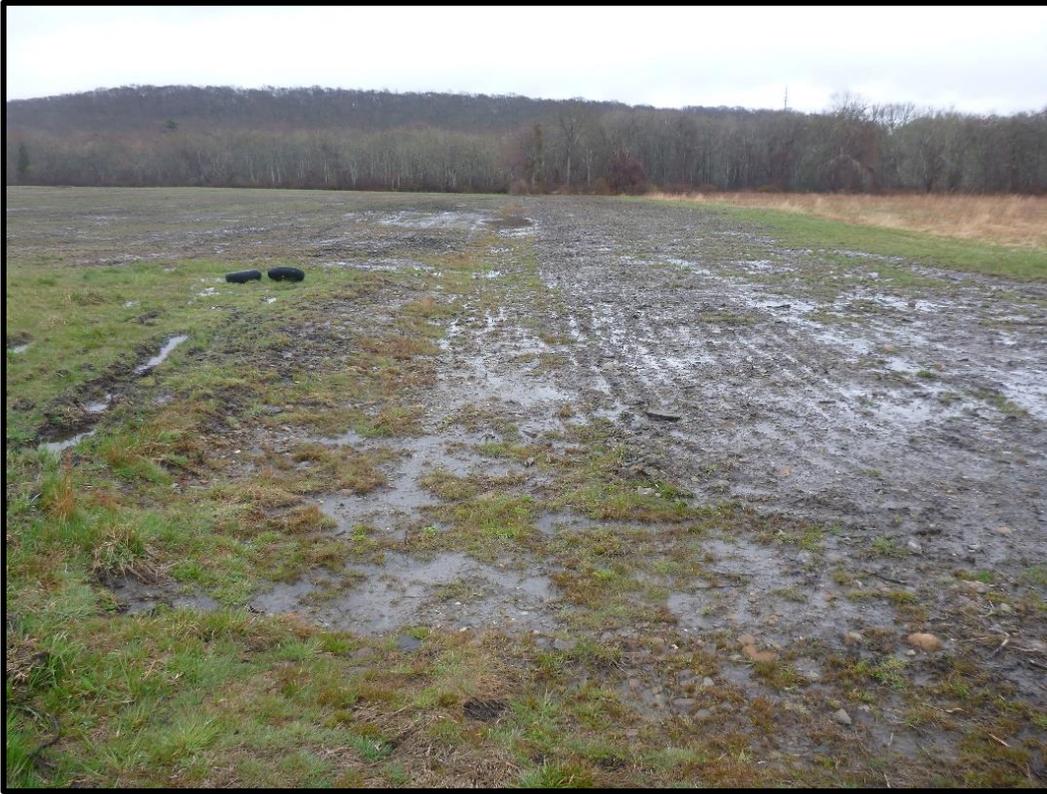
Photo 3. Tilled area in Pardon Gray Preserve bordering wetland corridor (return to: [Quaker Creek](#) or [Photo Key](#)).

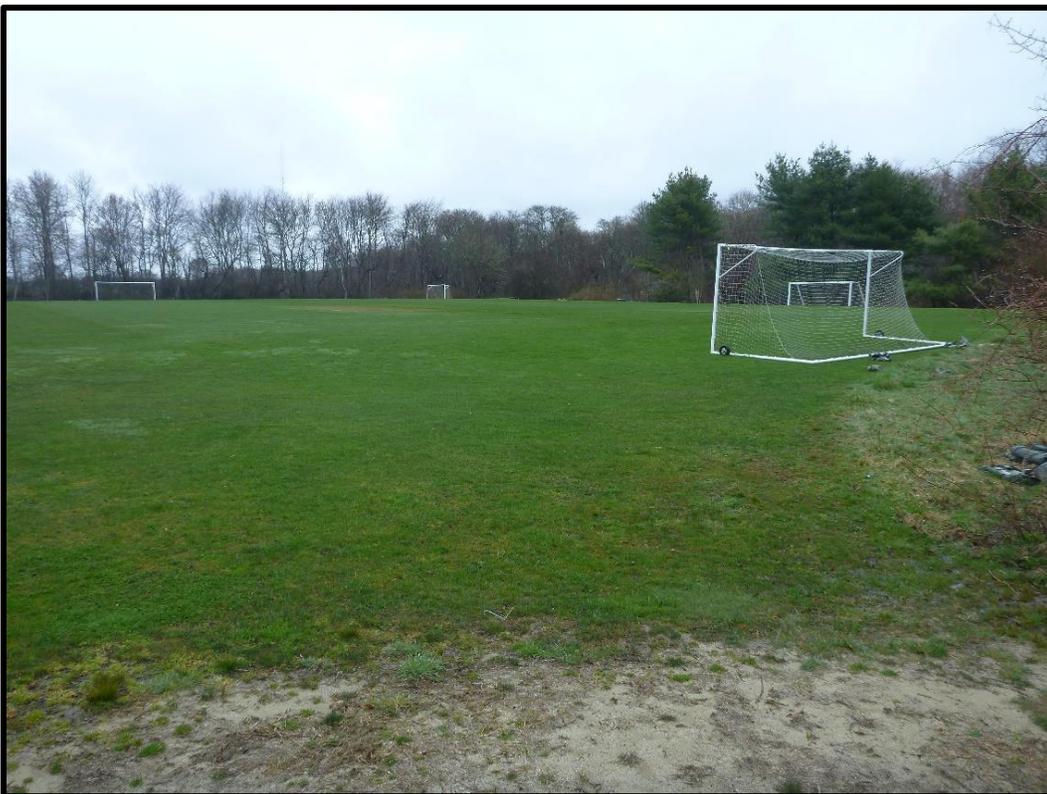
addition, the Town's soccer fields directly abut the wetland corridor associated with Quaker Creek ([Photo 4](#) and [Photo 5](#)). Several flows paths were observed in aerial photographs, which flow from the pasture to the wetland corridor.

Photo 4. Town soccer field bordering wetland corridor (return to: [Quaker Creek](#) or [Photo Key](#)).

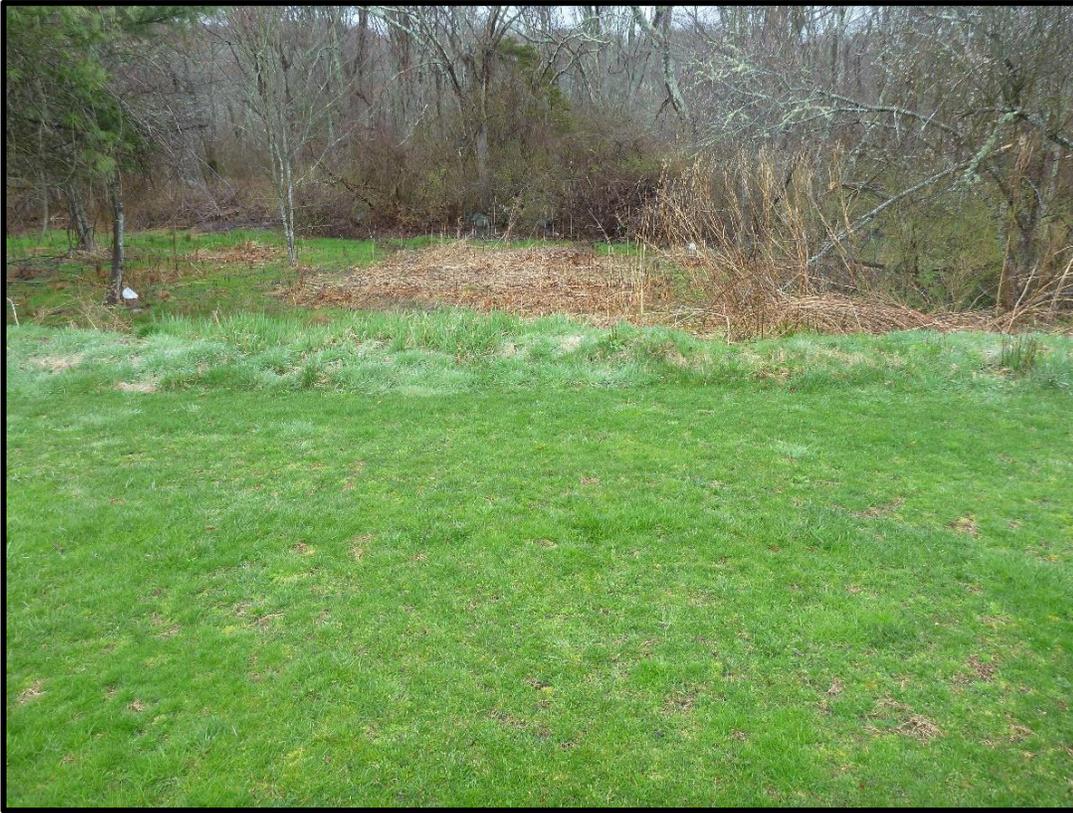
Photo 5. Wetland at bottom-of-slope of soccer field (return to: [Quaker Creek](#) or [Photo Key](#)).

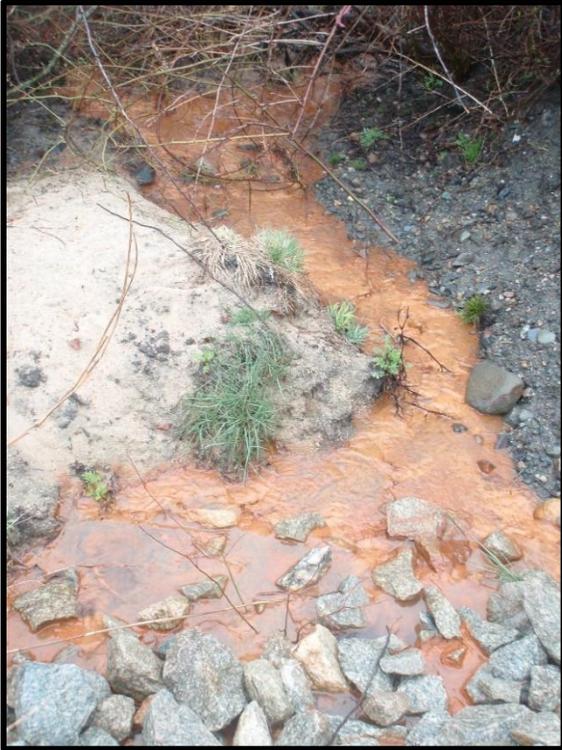
Photo 6. Iron flocculent in leachate as it flows out of small impoundment to landfill swale (return to: [pollution sources](#) or [Photo Key](#)).

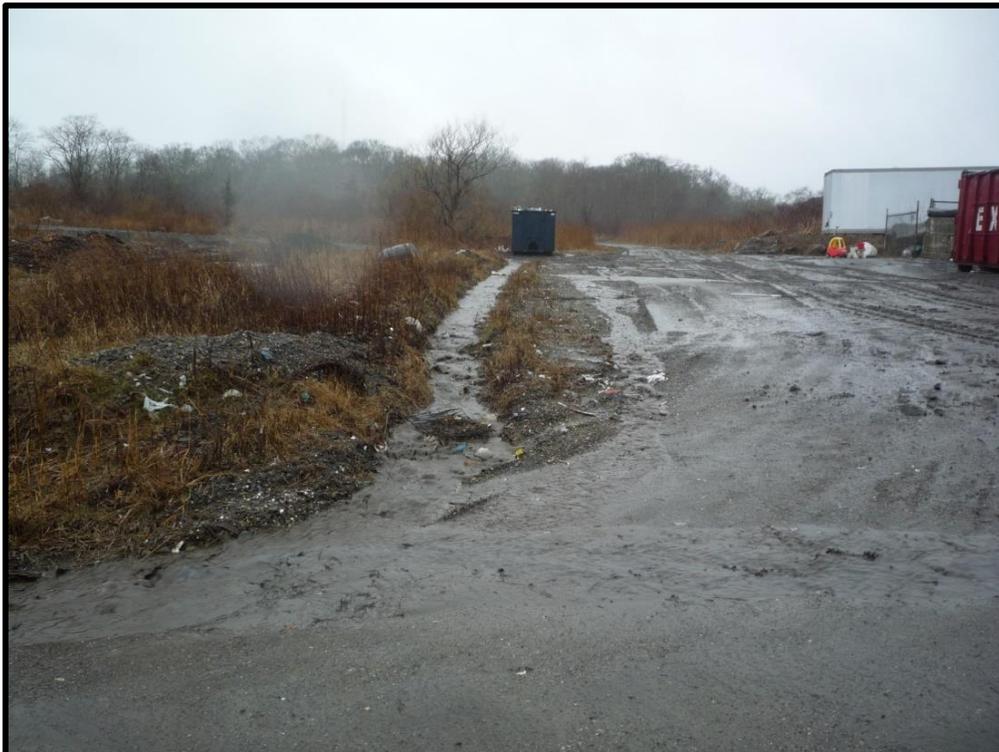
Photo 7. Turbid stormwater runoff from upper landfill (return to: [pollution sources](#) or [Photo Key](#)).

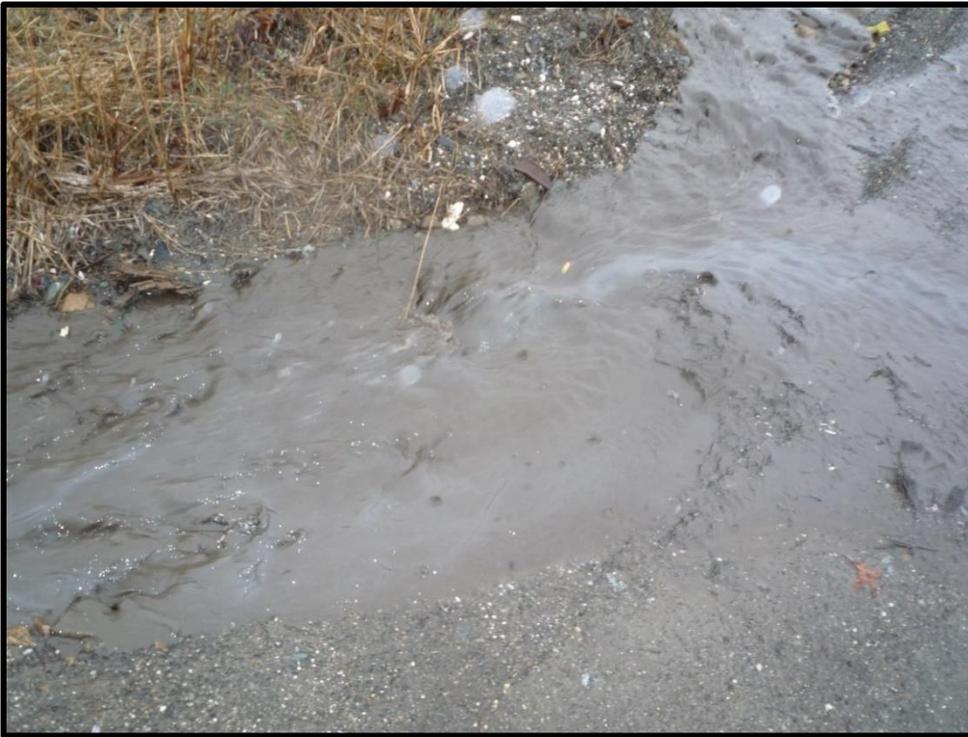
Photo 8. Closeup of previous photograph showing petroleum sheen (return to: [pollution sources](#) or [Photo Key](#)).

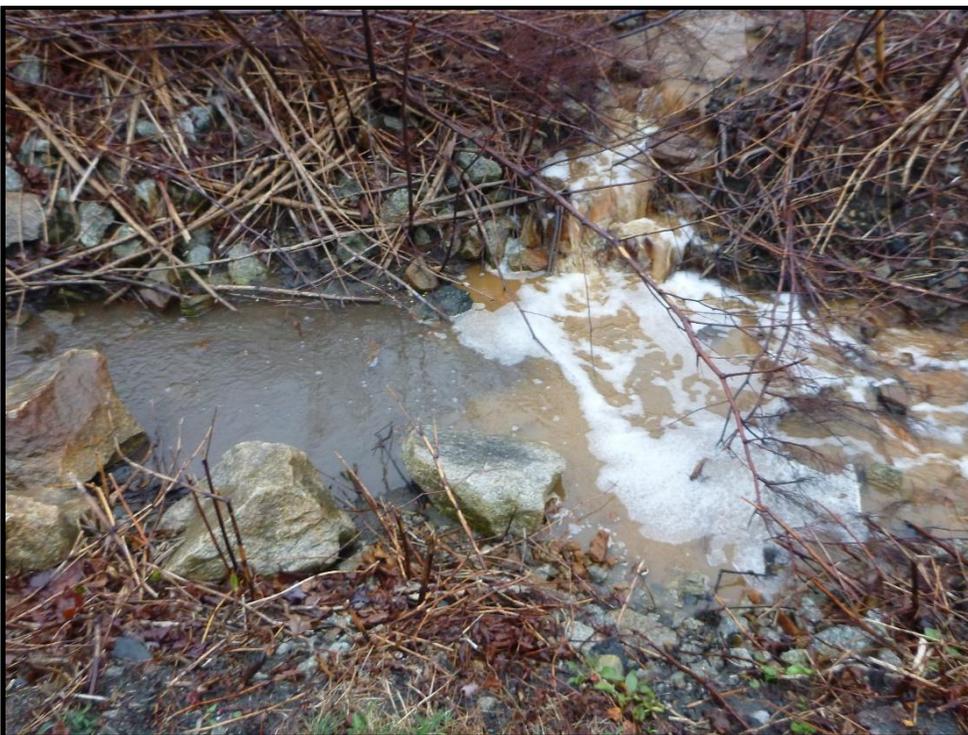
Photo 9. Stormwater runoff from upper landfill on left mixing with iron-rich landfill leachate on right (return to: [pollution sources](#) or [Photo Key](#)).

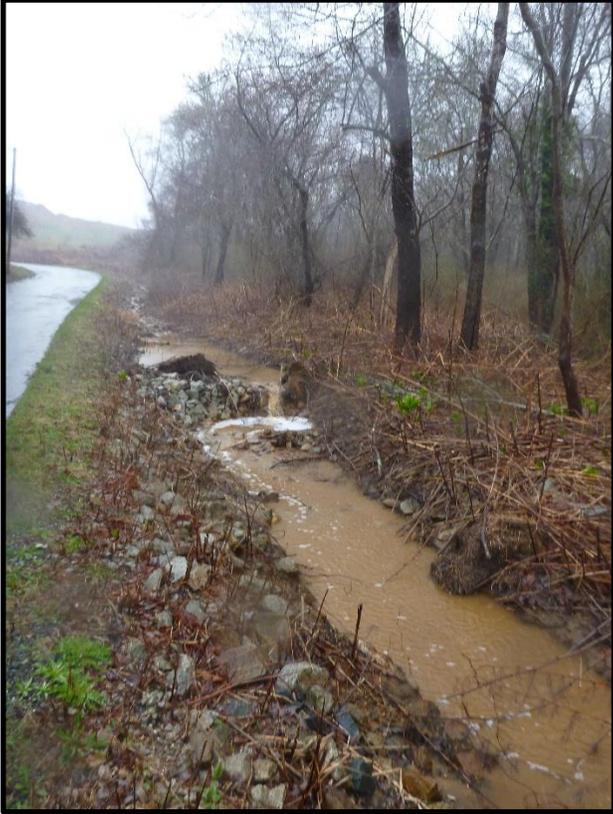
Photo 10. Landfill swale adjacent to access road
(return to: [pollution sources](#) or [Photo Key](#)).

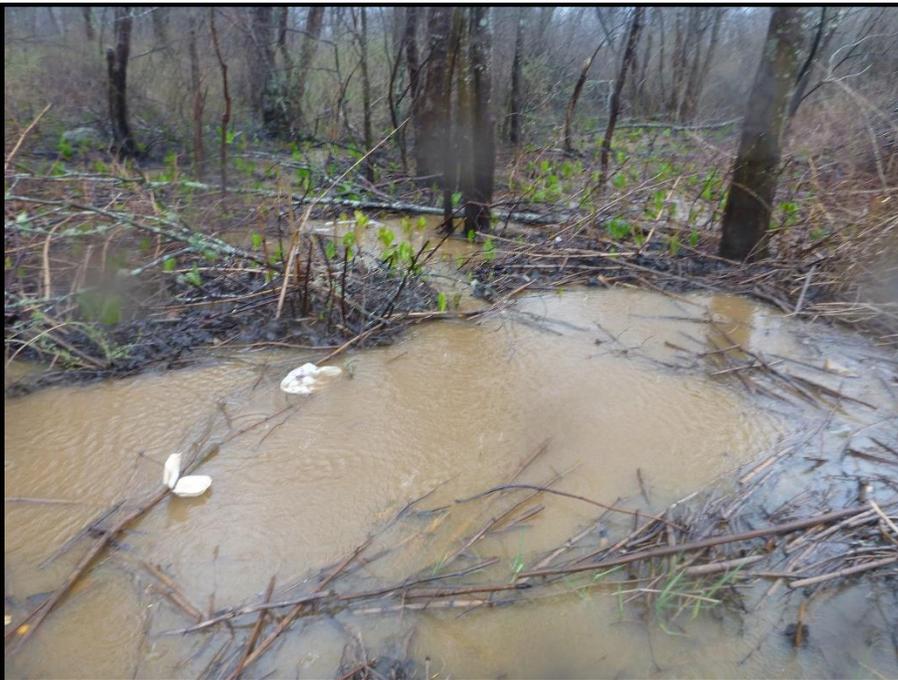
Photo 11. Flow from swale entering wetland (return to: [pollution sources](#) or [Photo Key](#)).

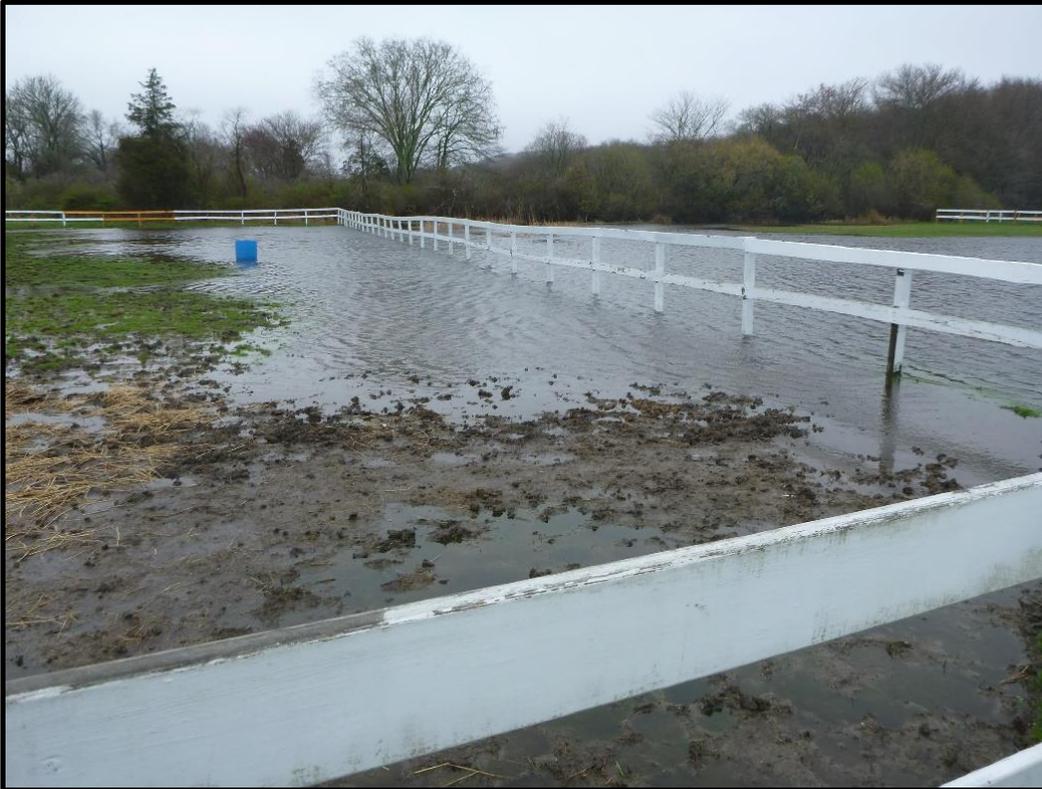
Photo 12. Flooded lower paddock on western side of upstream farm pond (return to: [pollution sources](#) or [Photo Key](#)).

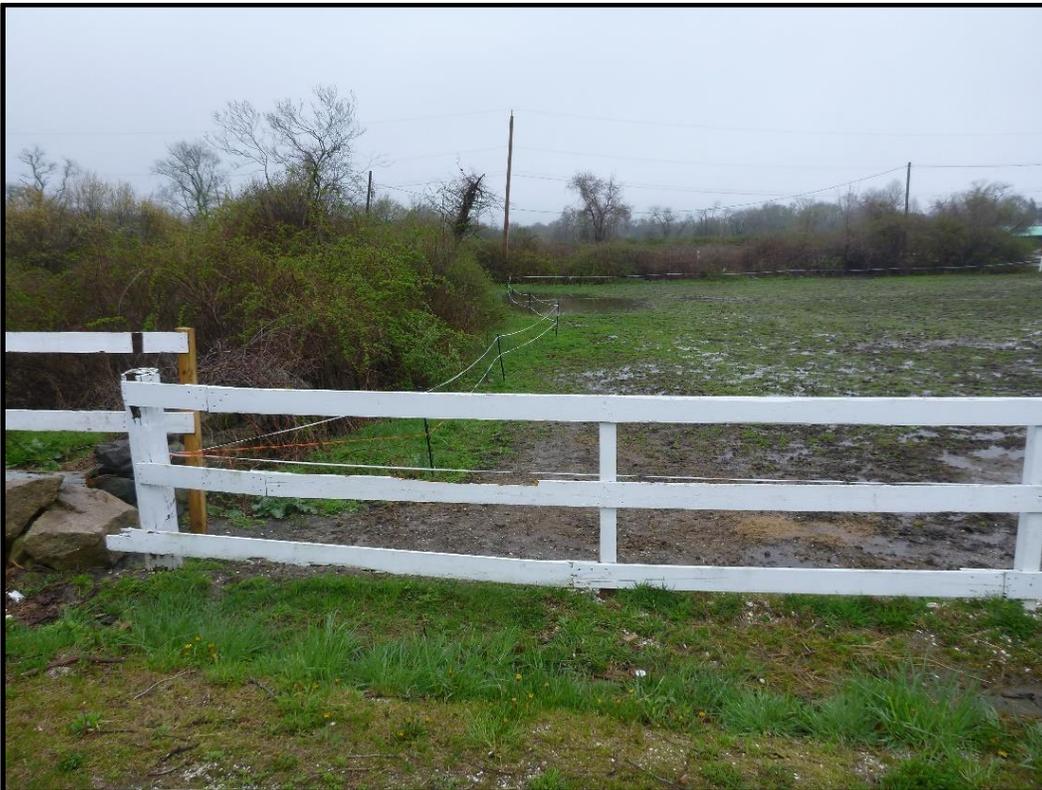
Photo 13. Saturated muddy corral adjacent to western side of stream between farm ponds (return to: [pollution sources](#) or [Photo Key](#)).

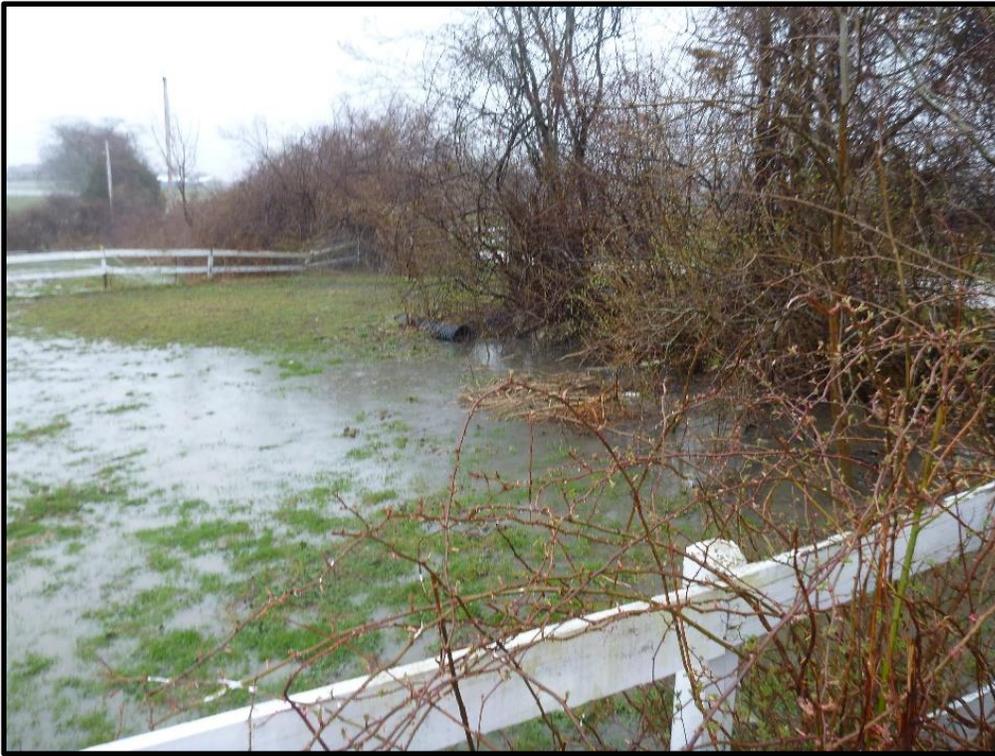
Photo 14. From bus depot looking east showing saturated paddock area west of stream between farm ponds (return to: [pollution sources](#) or [Photo Key](#)).

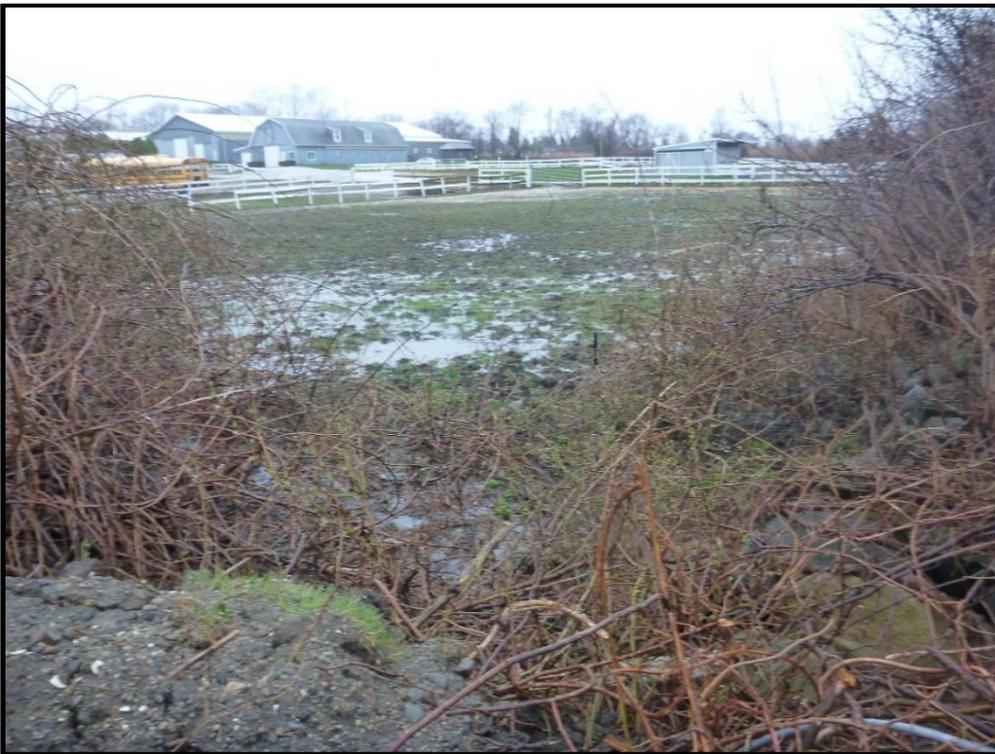
Photo 15. Inlet of downstream farm pond looking northwest. Saturated pasture adjacent to western streambank between farm ponds (return to: [pollution sources](#) or [Photo Key](#)).

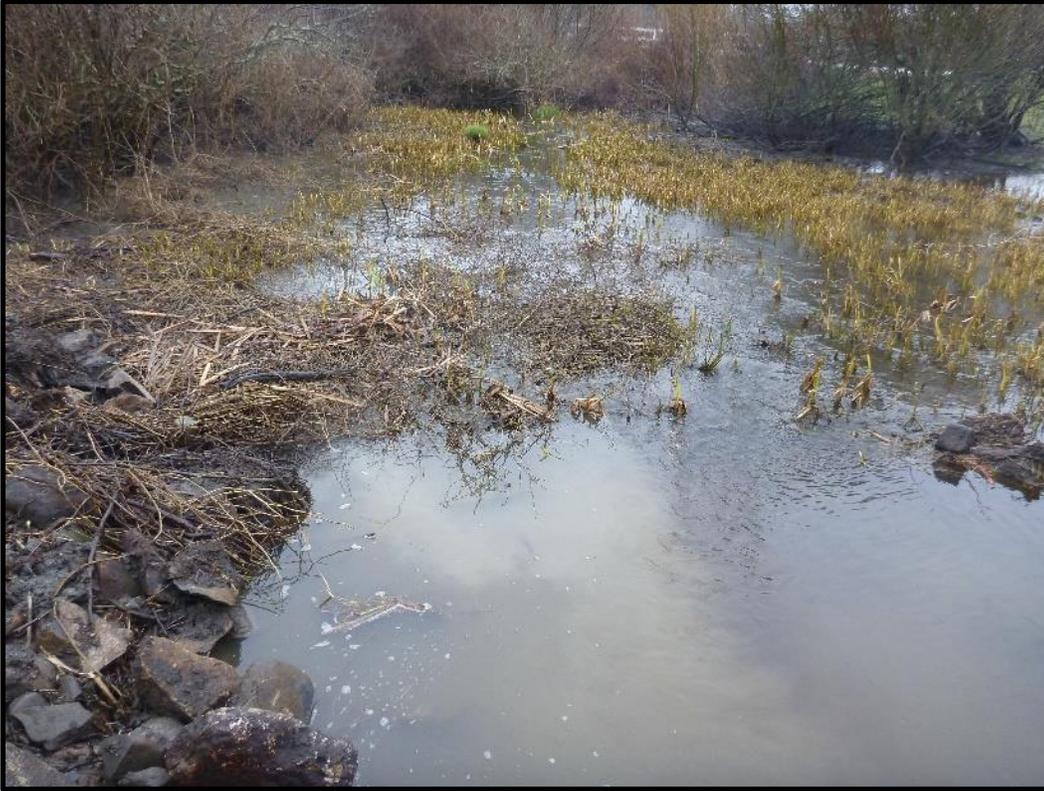
Photo 16. Inlet of downstream farm pond looking north, showing turbid runoff on left from corrals shown in above photo (return to: [pollution sources](#) or [Photo Key](#)).

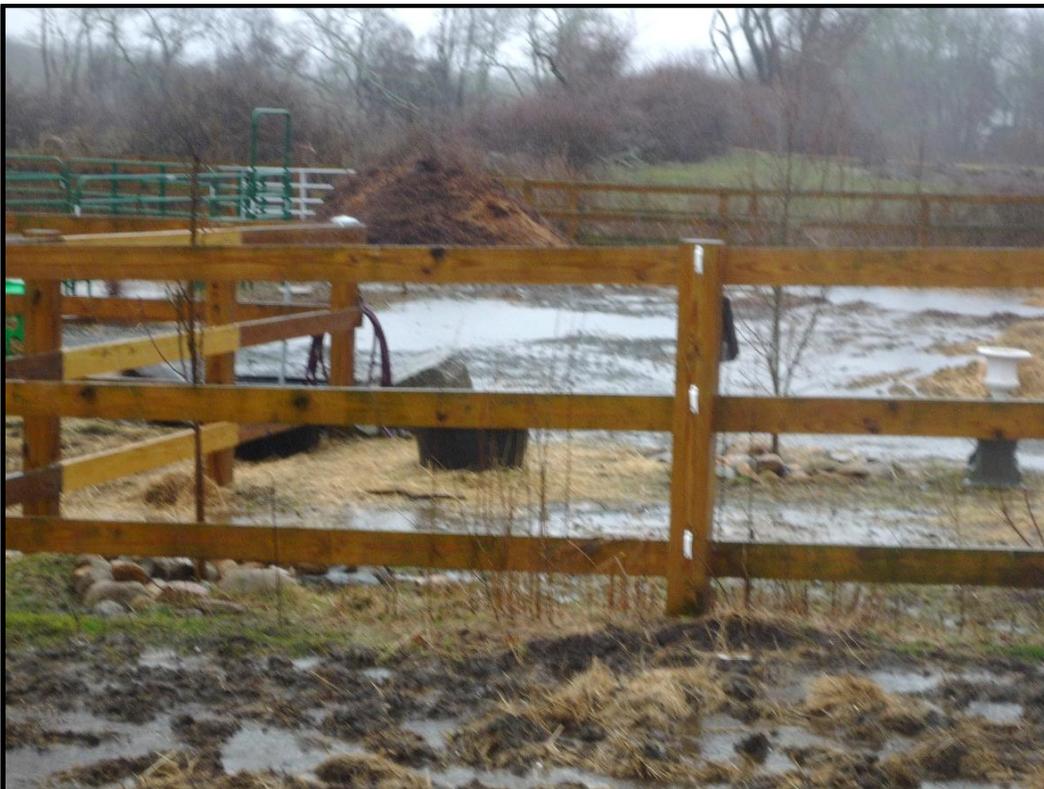
Photo 17. Manure pile near barn of lower equestrian center up-gradient of corrals to west of stream between farm ponds (return to: [pollution sources](#) or [Photo Key](#)).

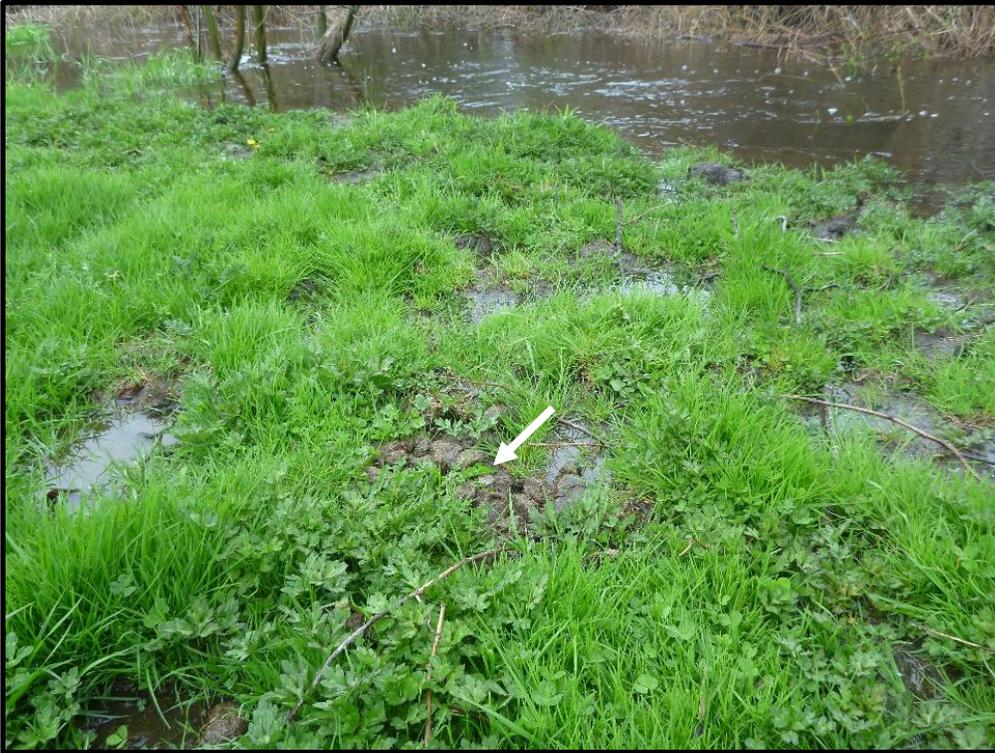
Photo 18. Manure in wet area adjacent to eastern streambank, between farms ponds.
Note manure in foreground (return to: [pollution sources](#) or [Photo Key](#)).

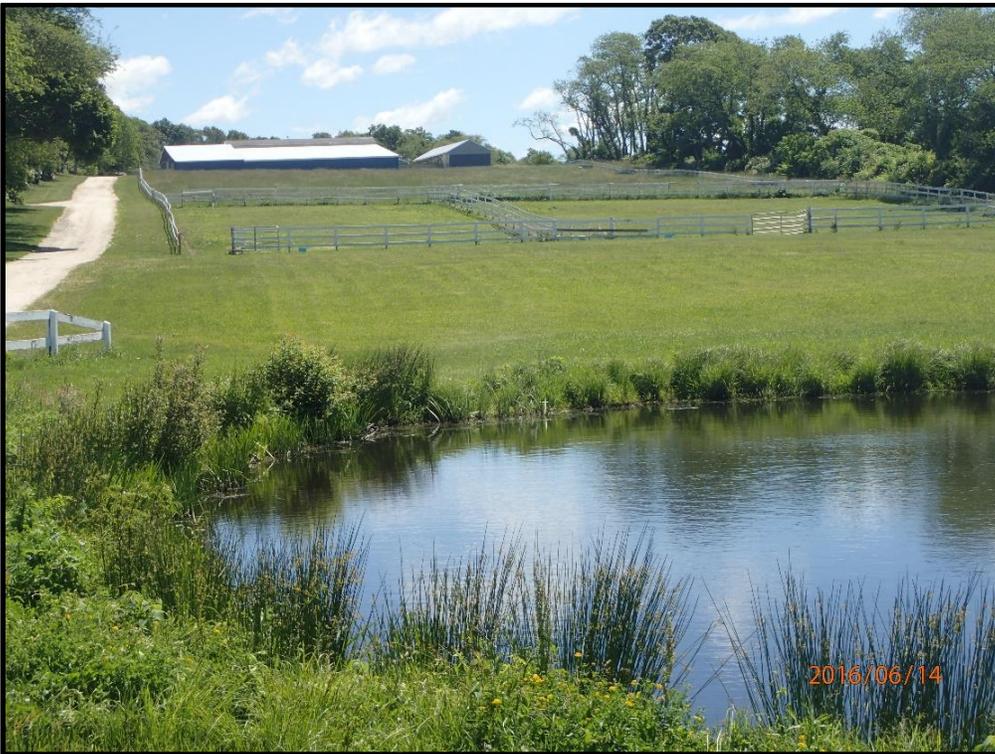
Photo 19. Downstream farm pond and pasture looking east. Livestock have access to pond in foreground (return to: [pollution sources](#) or [Photo Key](#)).

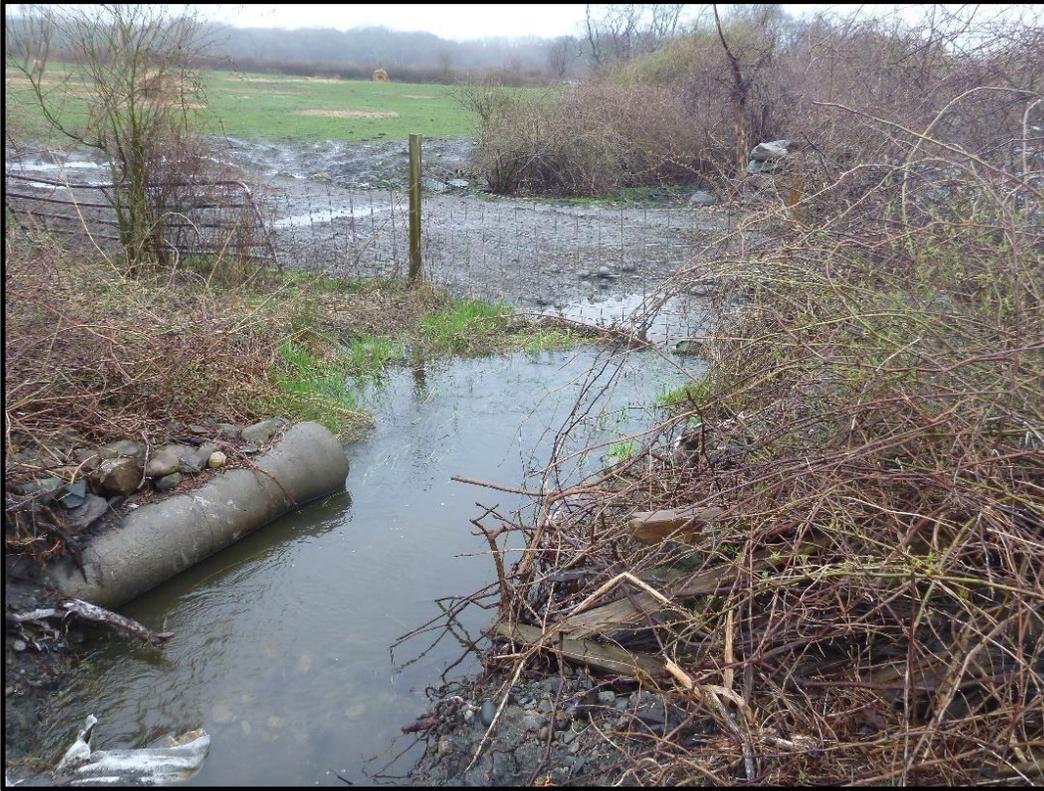
Photo 20. Northern end of cattle pasture looking southwest. Note cattle have access to stream (return to: [pollution sources](#) or [Photo Key](#)).

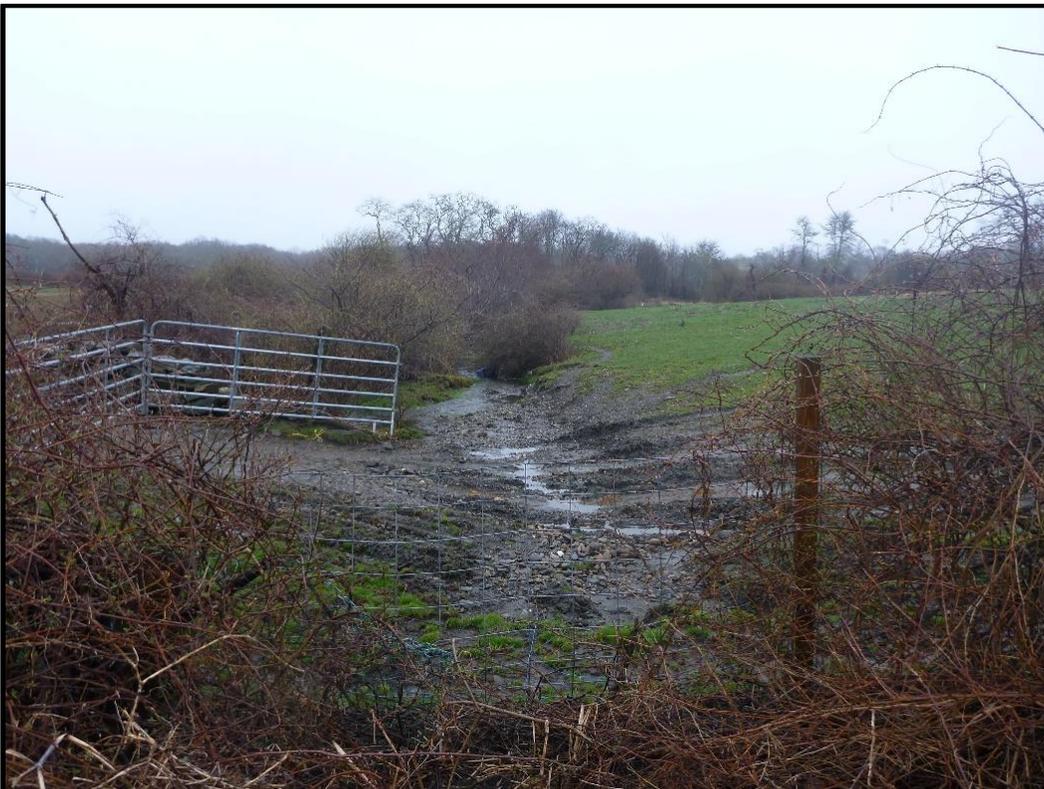
Photo 22. Southern end of cow pasture where cows have access to the stream (return to: [pollution sources](#) or [Photo Key](#)).

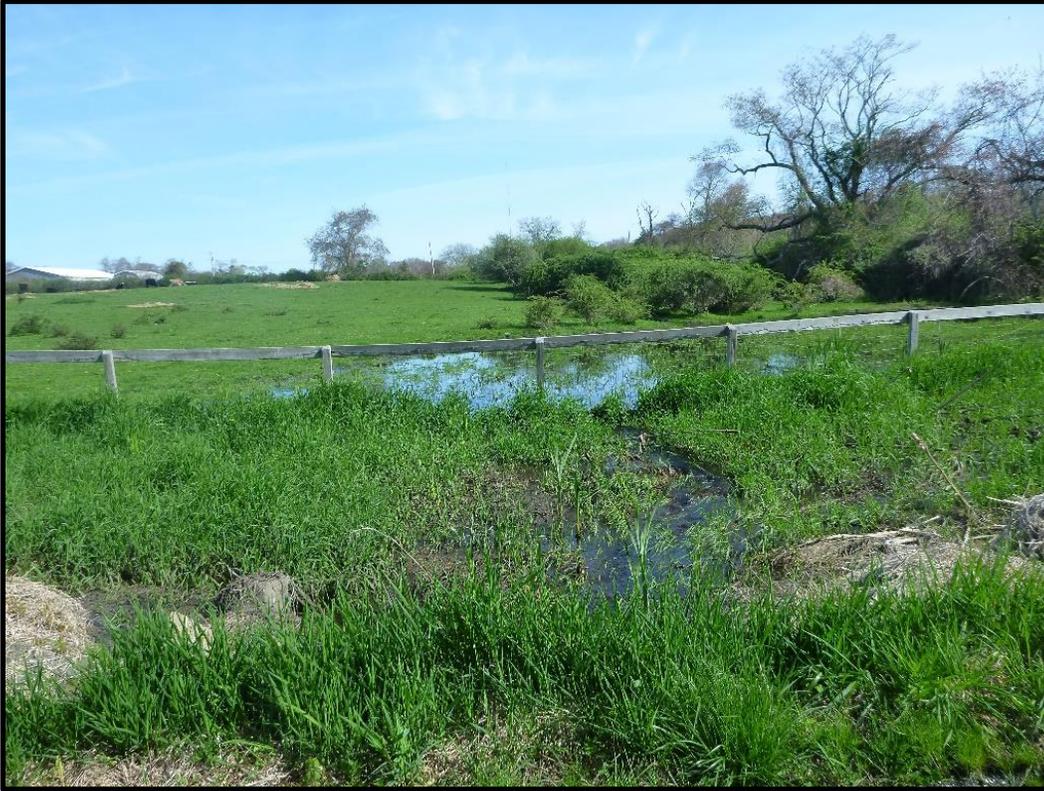
Photo 23. Excavated area to the east of stream and Station Q2 (return to: [pollution sources](#) or [Photo Key](#)).

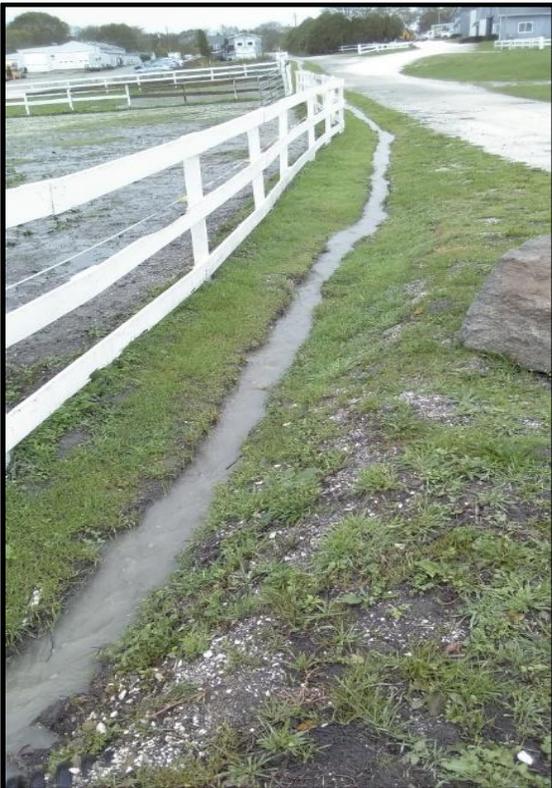
Photo 26. Flow from driveway ditch, shown in photo above, discharging to stream, downstream of upper farm pond (return to: [pollution sources](#) or [Photo Key](#)).

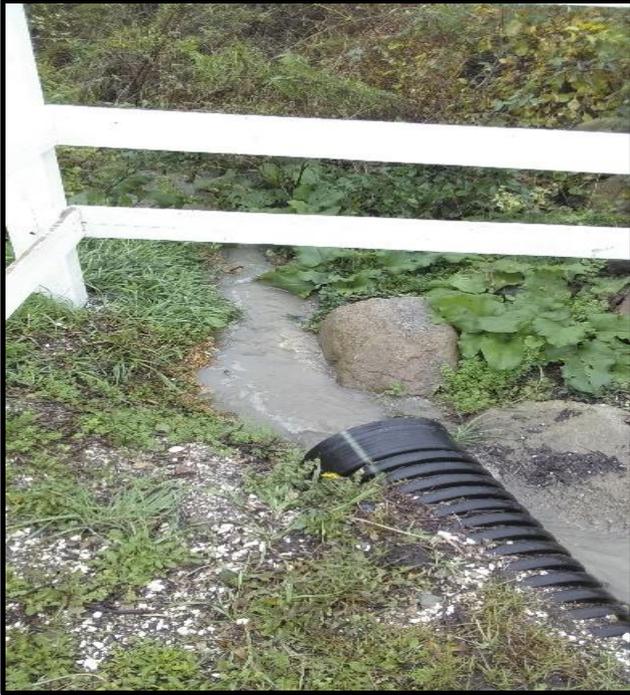
Photo 27. Flow from driveway ditch discoloring flow in the stream. Note that there was no flow from upper pond outlet as shown in photo (return to: [pollution sources](#) or [Photo Key](#)).

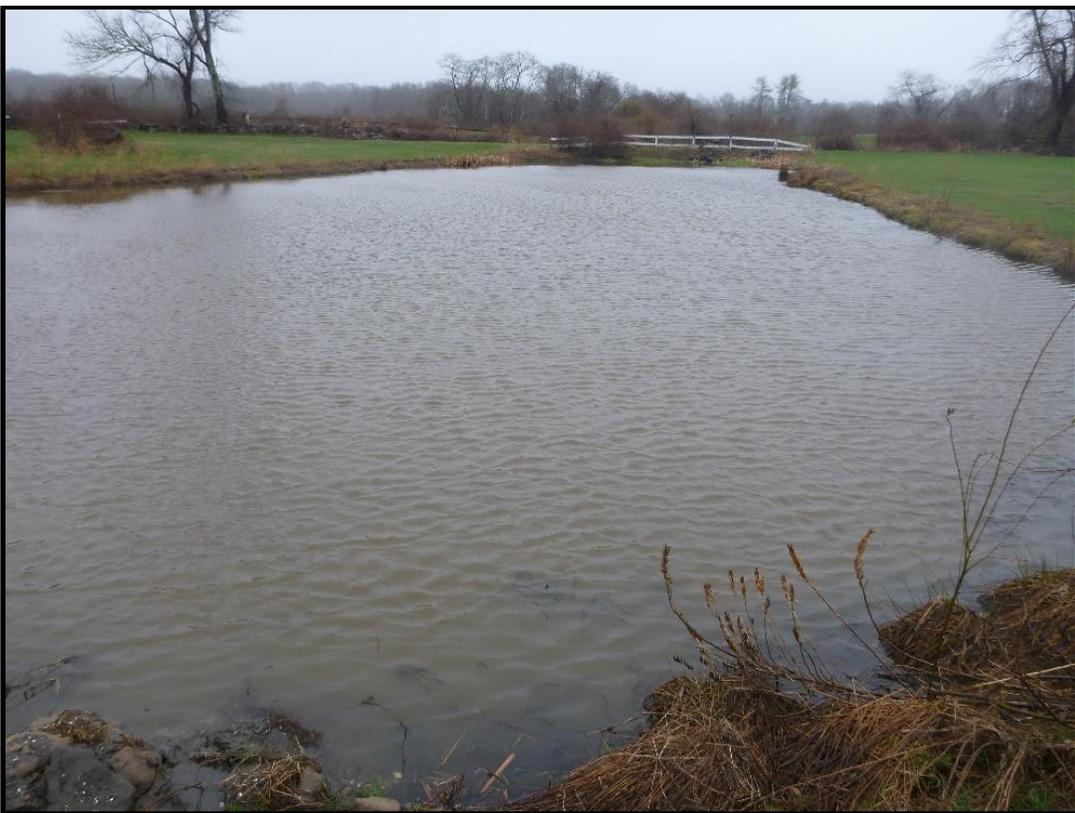
There was a significant increase in TP during wet weather at Station Q4. The increase in TP may have been caused by runoff from the pasture (cattle farm), in the northwestern portion of the watershed. Cattle access to the hydrologically connected farm pond is of particular concern ([Photo 30](#)). Stormwater runoff from a roadside ditch (Main Rd.) was observed discharging into the farm pond, and was also a potential source of phosphorus ([Photo 31](#)).

Photo 30. Farm pond in cattle pasture. Note muddy area where cows have access to the pond (return to: [pollution sources](#) or [Photo Key](#)).

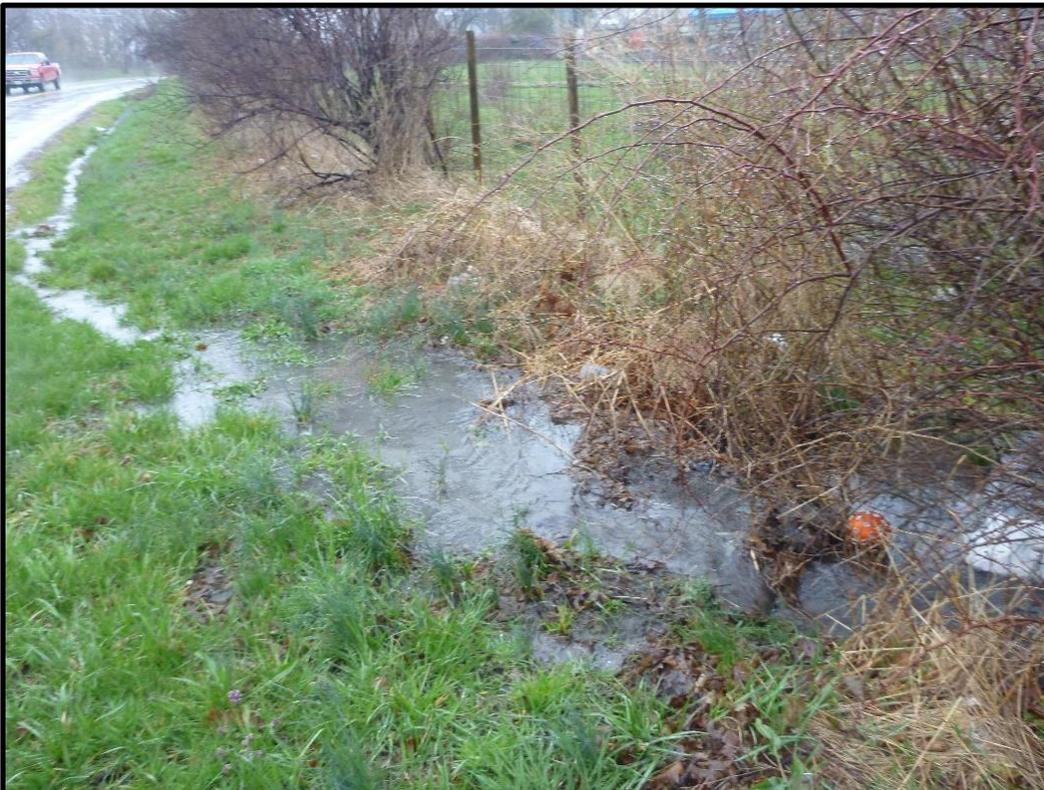
Photo 32. Hay field with approximately 40 ft. of vegetated buffer from stream (return to: [pollution sources](#) or [Photo Key](#)).

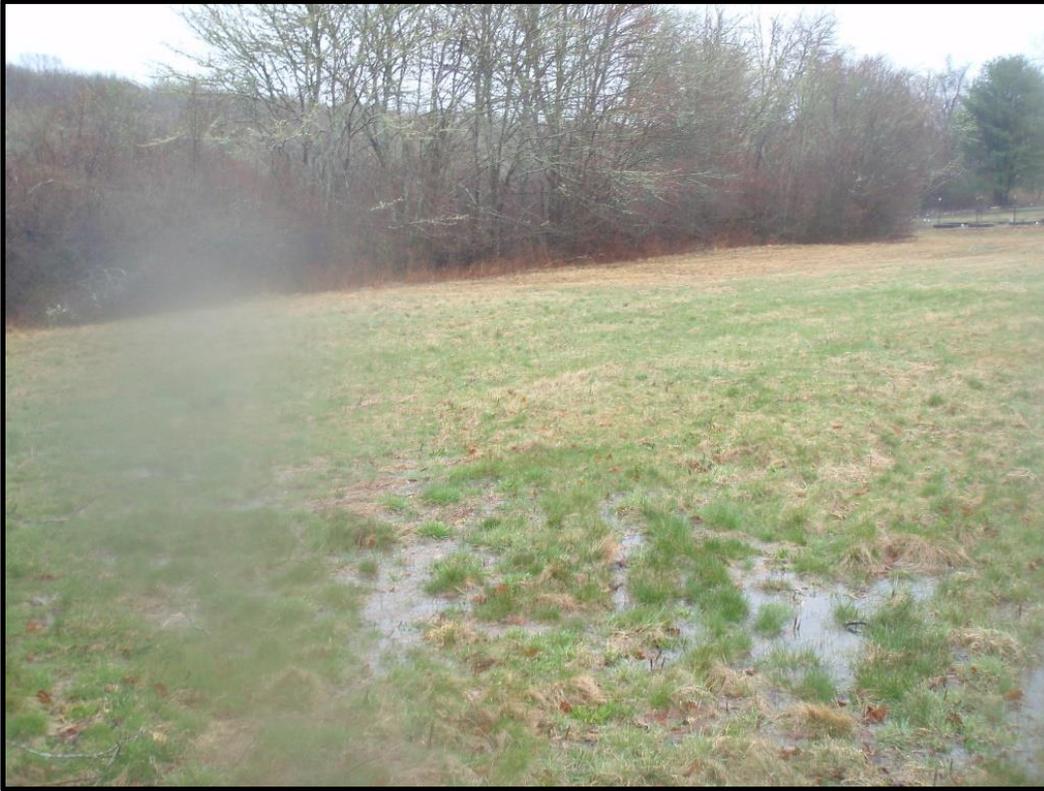
Photo 33. Residential lawn with approximately 40 ft. of vegetated buffer from stream (return to: [pollution sources](#) or [Photo Key](#)).

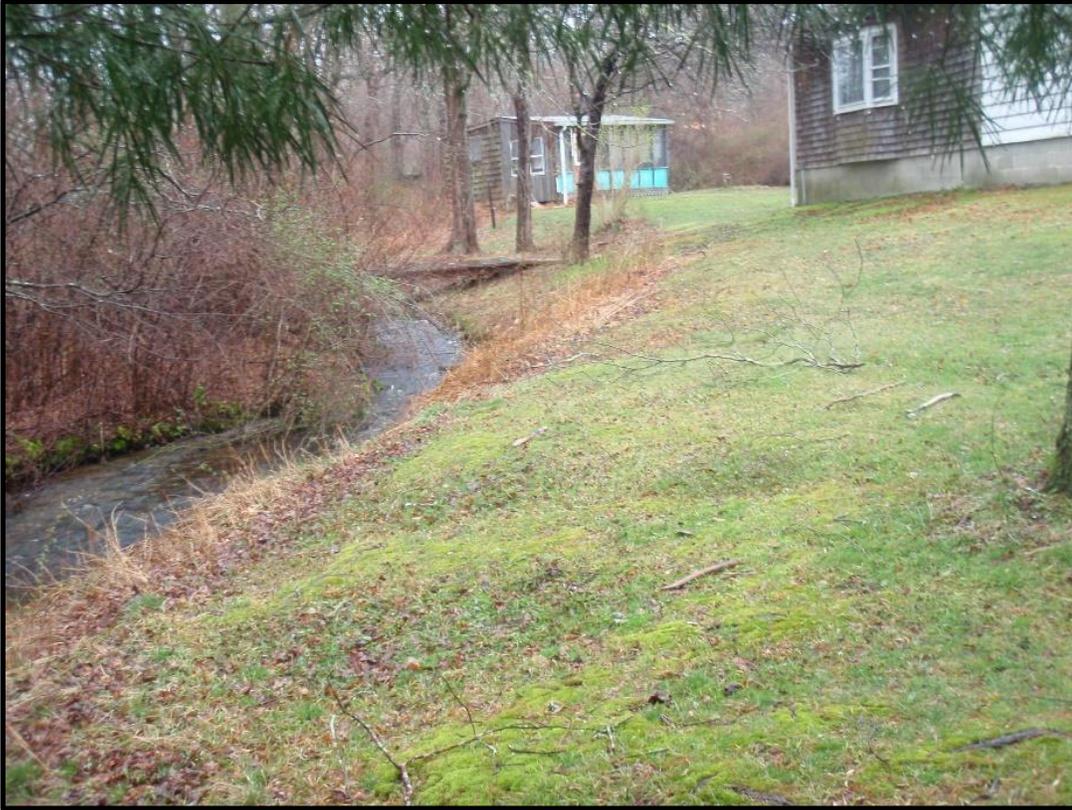
Photo 35. Confluence of southwest and northeast forks of the tributary showing grazed pasture straddling stream. Goat barn at rear of photo and aviary in upper right (return to: [pollution sources](#) or [Photo Key](#)).
