**NONQUIT POND TRIBUTARIES
WATER QUALITY STUDY AND POLLUTANT SOURCE IDENTIFICATION
NATIONAL WATER QUALITY INITIATIVE**

**Prepared By: Office of Water Resources
Rhode Island Department of Environmental Management
235 Promenade St. Providence, RI 02908
June 2018**

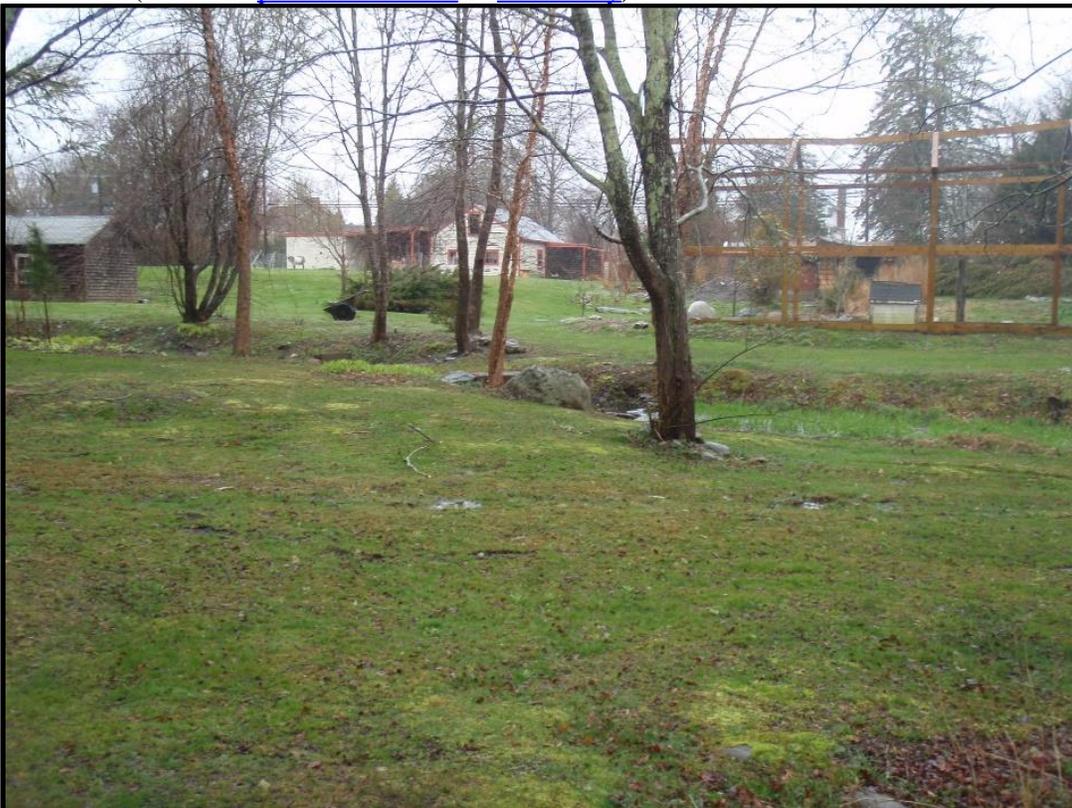
Photo 36. Hog pen in right-center of photograph approximately 70 ft. from stream (return to: [pollution sources](#) or [Photo Key](#)).

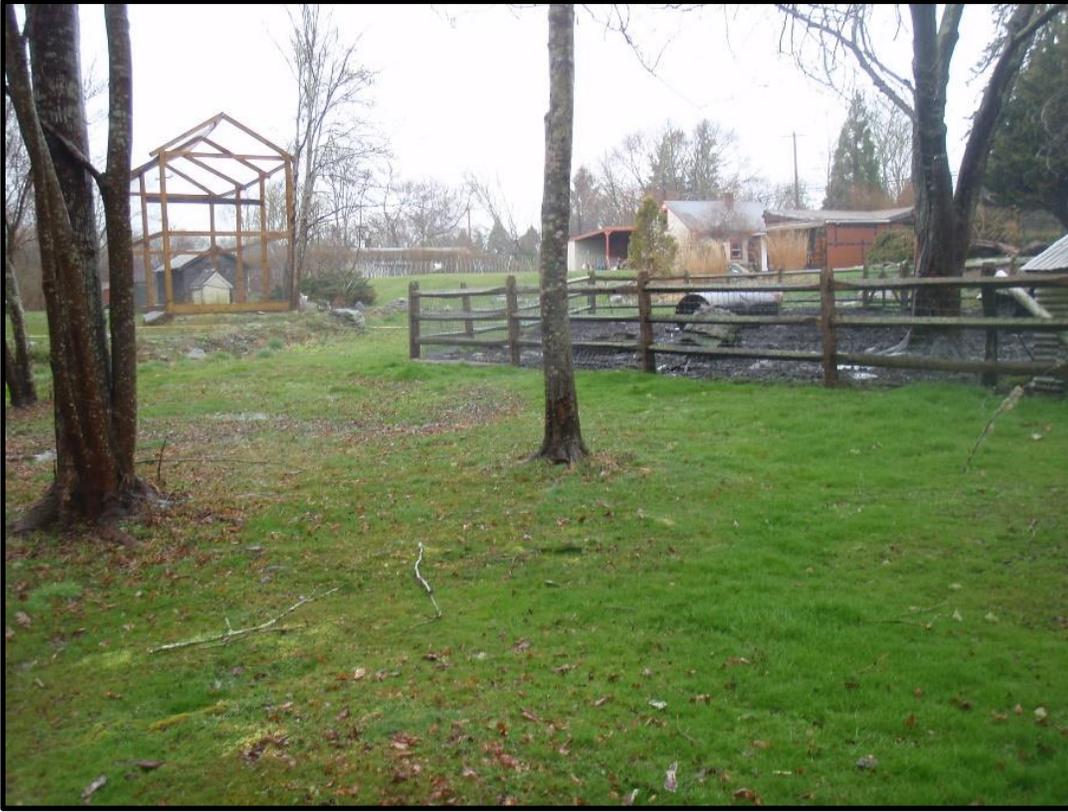
Photo 37. Grazed pasture adjacent to stream (return to: [pollution sources](#) or [Photo Key](#)).

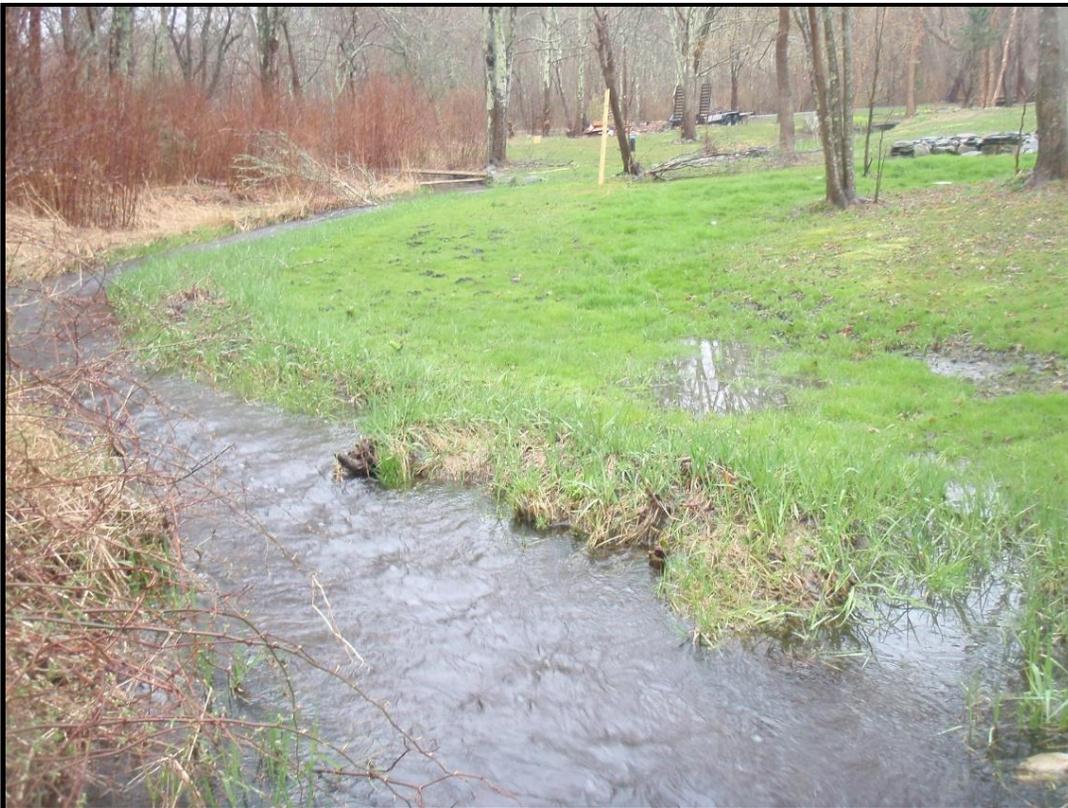
Photo 38. Closeup of above photo. Manure adjacent to stream (return to: [pollution sources](#) or [Photo Key](#)).

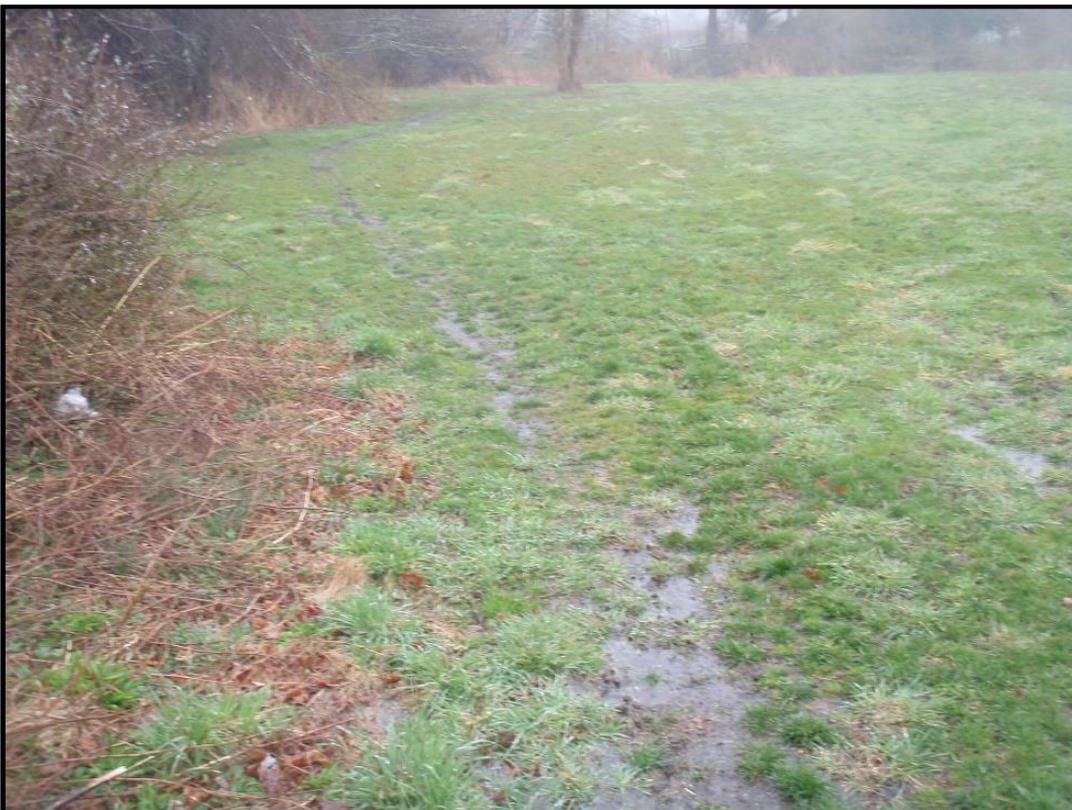
Photo 40. Residential lawn with no vegetated buffer adjacent to the stream at left (return to: [pollution sources](#) or [Photo Key](#)).

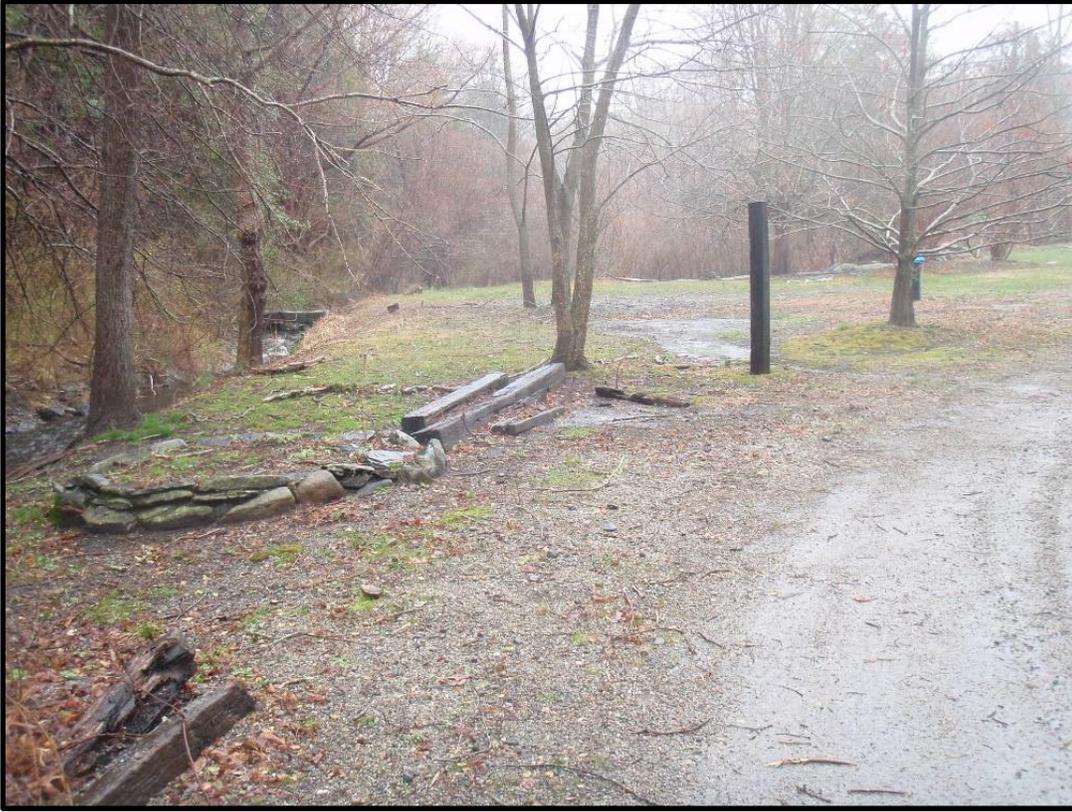
Photo 41. Lawn in commercial area extending to streambank at Station Bt (return to: [pollution sources](#) or [Photo Key](#)).

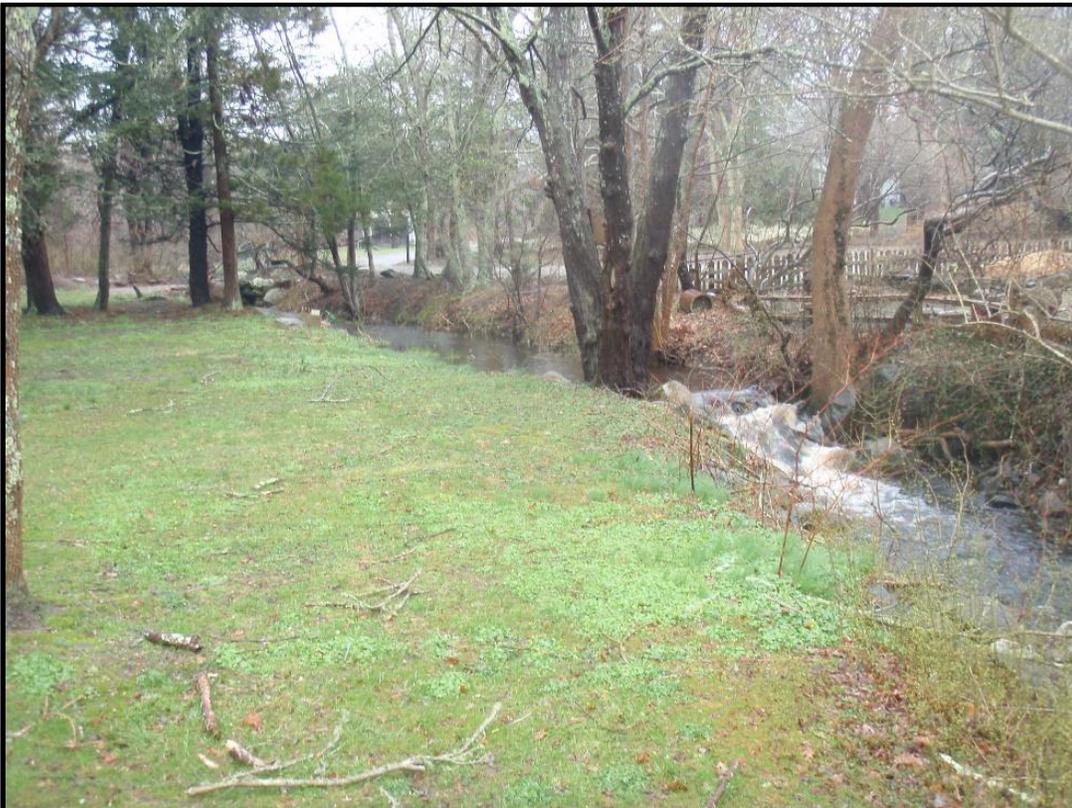
As discussed above, a smaller stream discharges into the unnamed tributary to Borden Brook. This western fork of the unnamed tributary arises from a wetland. There is a farm pond located within the wetland, that is separated from an adjacent crop field by a 40-ft. vegetative buffer ([Photo 42](#)). The wetland is seasonally grazed, as evidenced by closely cropped grass and clumps of old manure ([Photos 43 and 44](#)). Apparently, cattle are confined in a fenced enclosure to another part of the farm, during the winter. The pasture is part of a large farm that is mostly located in the subwatershed of an unnamed tributary to Nonquit Pond, located to the west.

Photo 42. Small farm pond at edge of wetland. Cattle have access to the farm pond (return to: [pollution sources](#) or [Photo Key](#)).

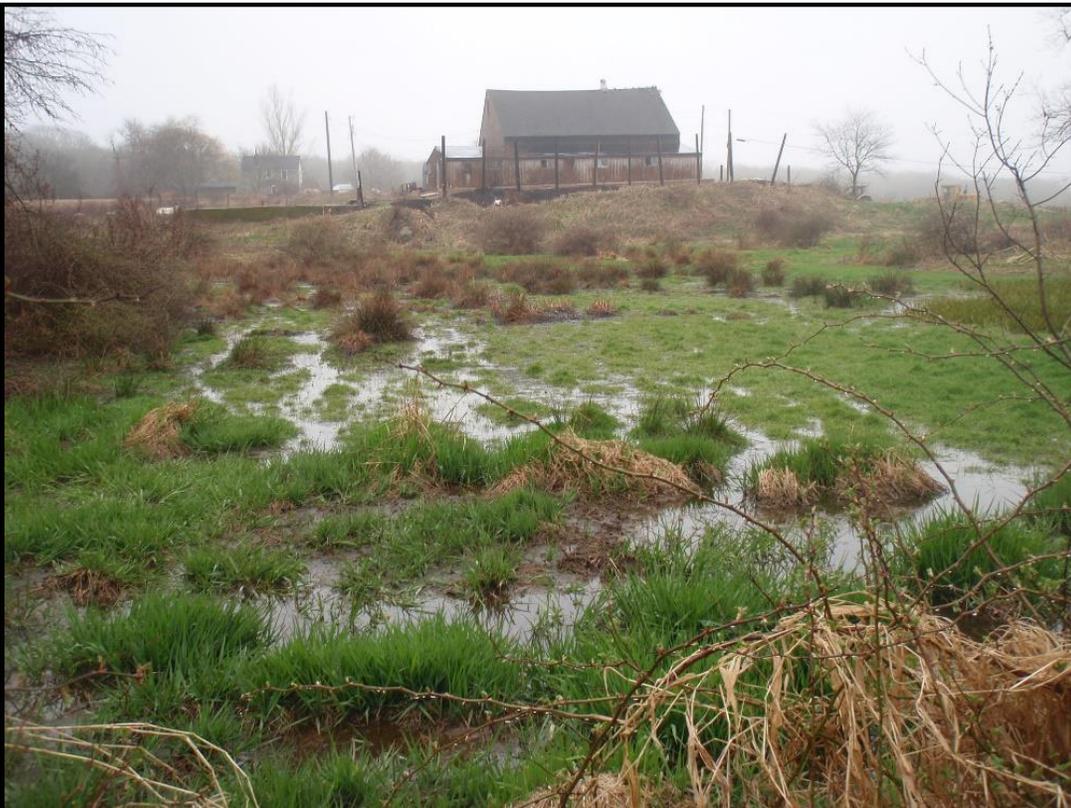
Photo 44. Pasture adjacent to wetland headwaters. Note close-cropped grass (return to: [pollution sources](#) or [Photo Key](#)).

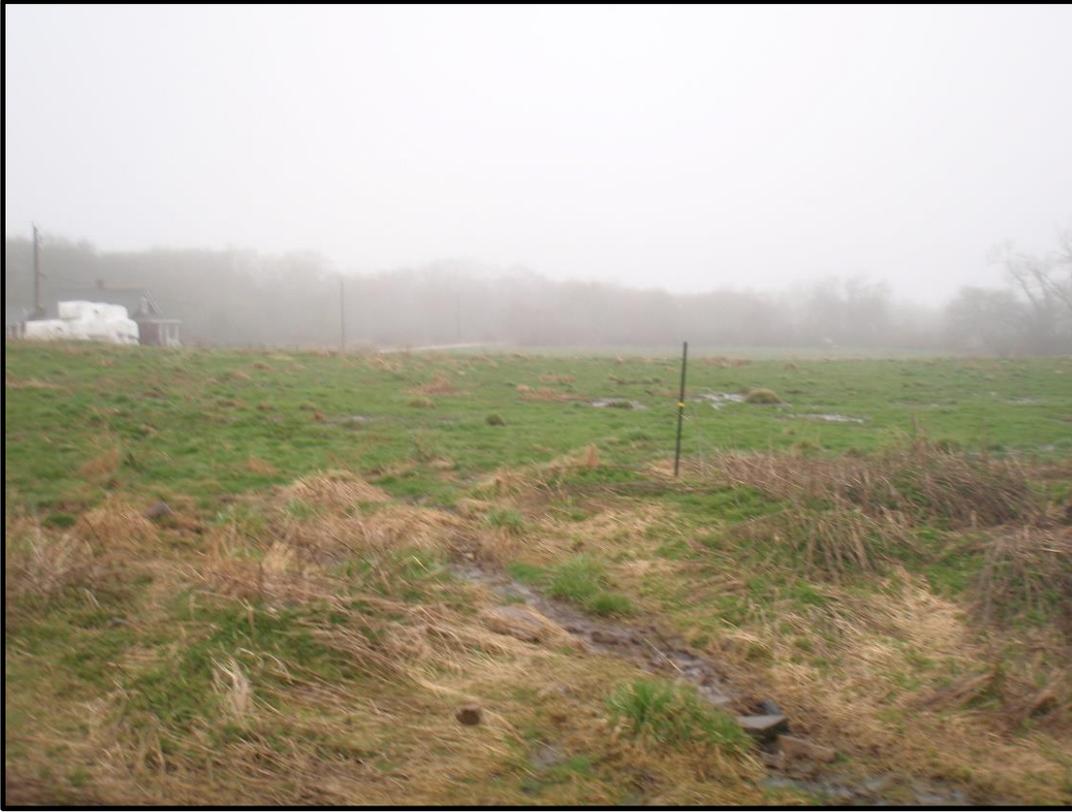
There was a large (approximately 130 x 40 x 10 ft.) silage pile located immediately adjacent to the wetland that forms the headwaters of this western fork of the unnamed tributary ([Photos 45 through 47](#)). The silage

pile is located on a paved drive, immediately adjacent to the wetland. There was a very strong fetid odor emanating from the silage pile. There was heavy growth of filamentous algae in the stream and headwater wetlands, immediately downstream of the silage pile. A white scum covered much of the algae ([Photos 48 and 49](#)). The pile was on farm property with approximately a dozen head of cattle (cows apparently do not have access to the silage area during winter, but apparently have access at other times of year). Inspection of aerial photographs of various years shows that the pile is up to 170 ft. long.

Photo 45. Silage pile at headwaters of southwestern fork of Borden Brook tributary (approx. 130 x 40 x 10 ft.) (return to: [pollution sources](#) or [Photo Key](#)).

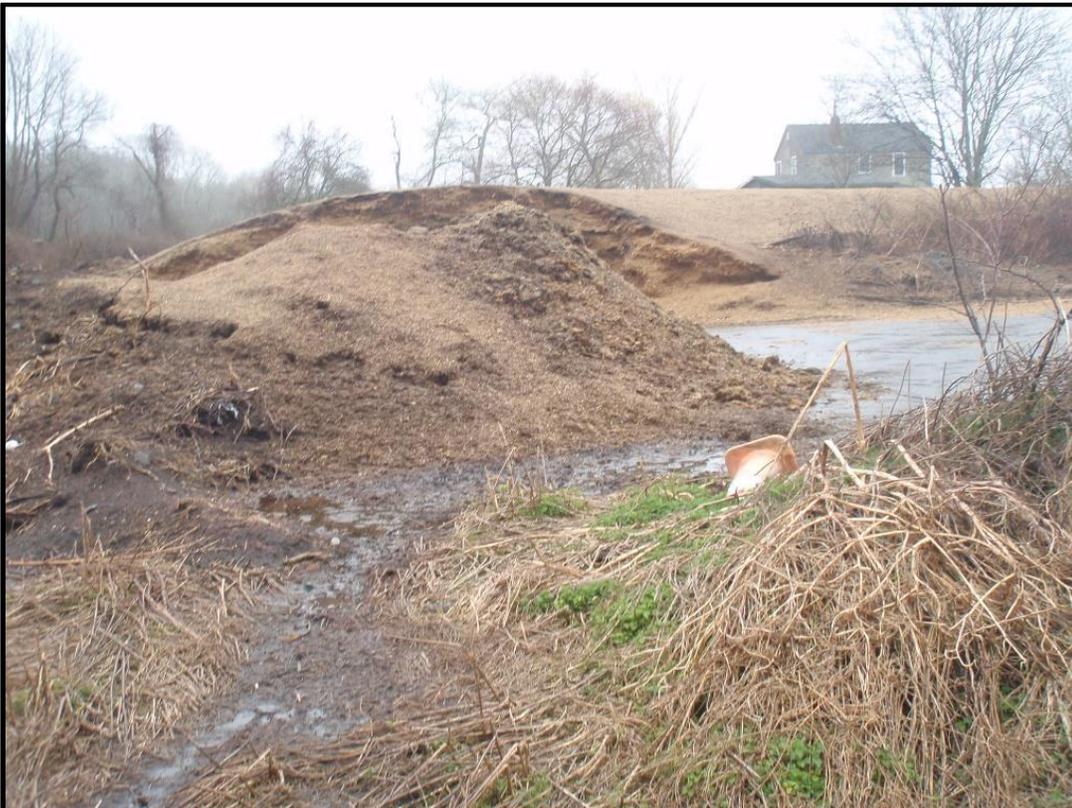
Photo 46. Closeup of silage adjacent to paved drive (return to: [pollution sources](#) or [Photo Key](#)).

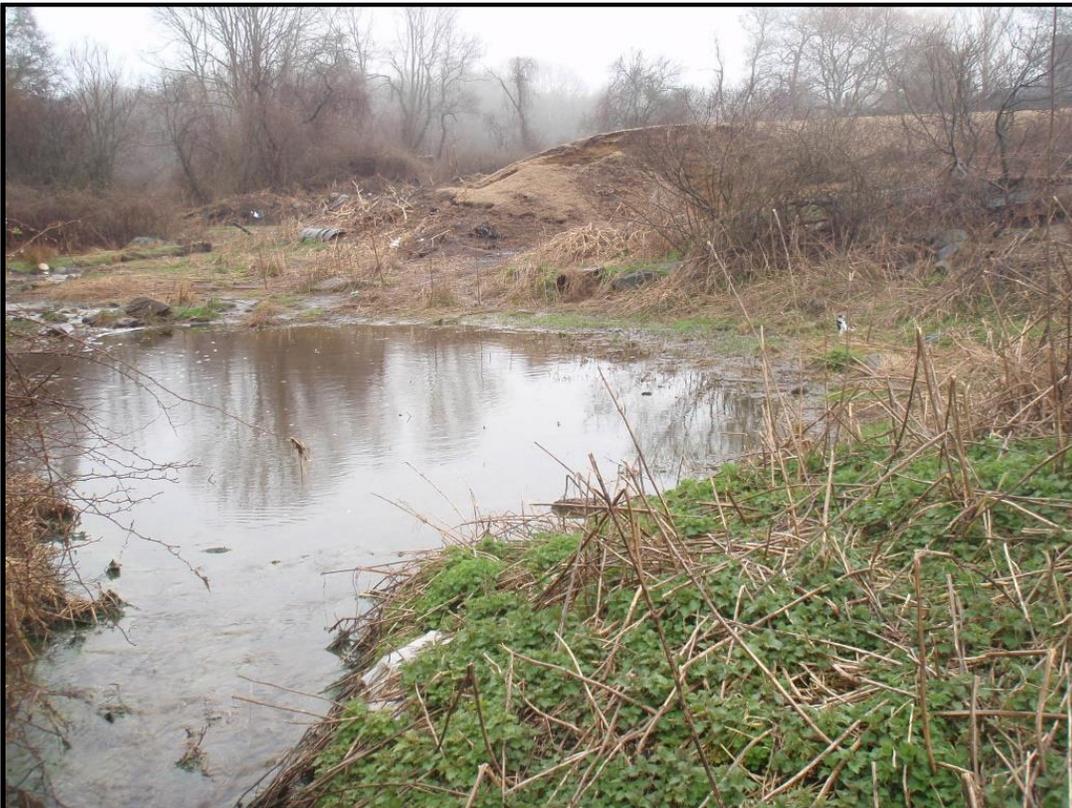
Photo 48. Filamentous algae with white scum (potentially dead algae) immediately downstream of silage pile (return to: [pollution sources](#) or [Photo Key](#)).

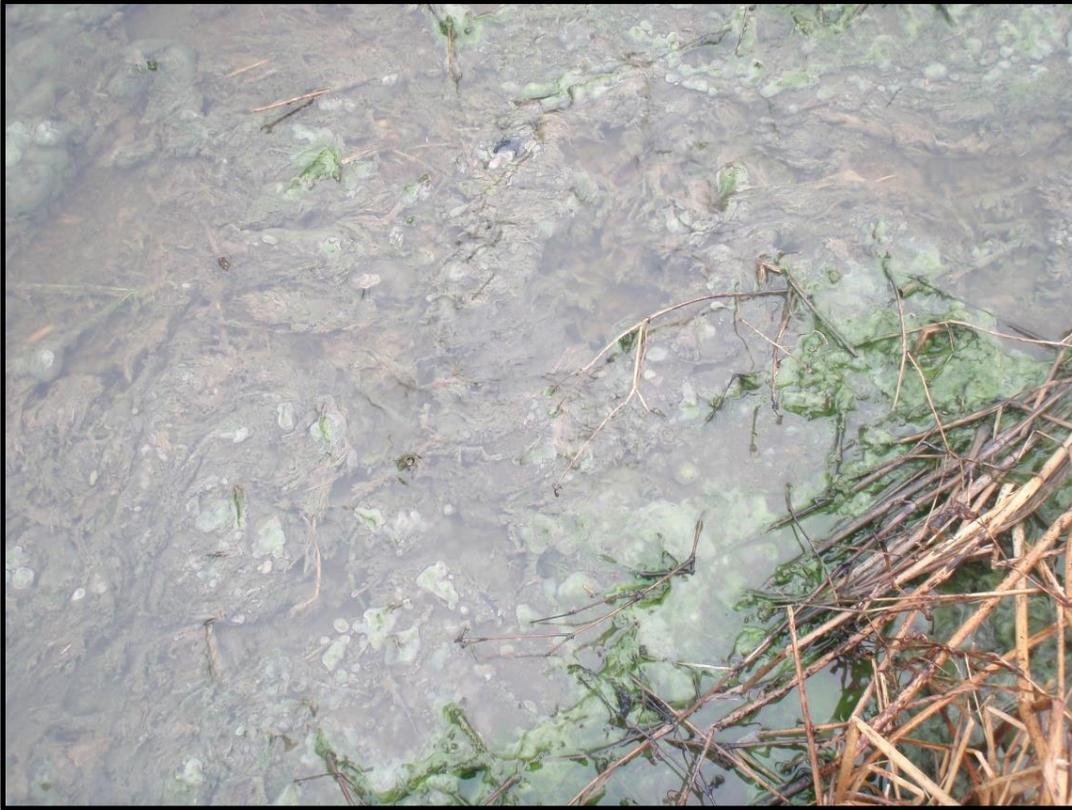
Photo 49. Filamentous algae further downstream (return to: [pollution sources](#) or [Photo Key](#)).

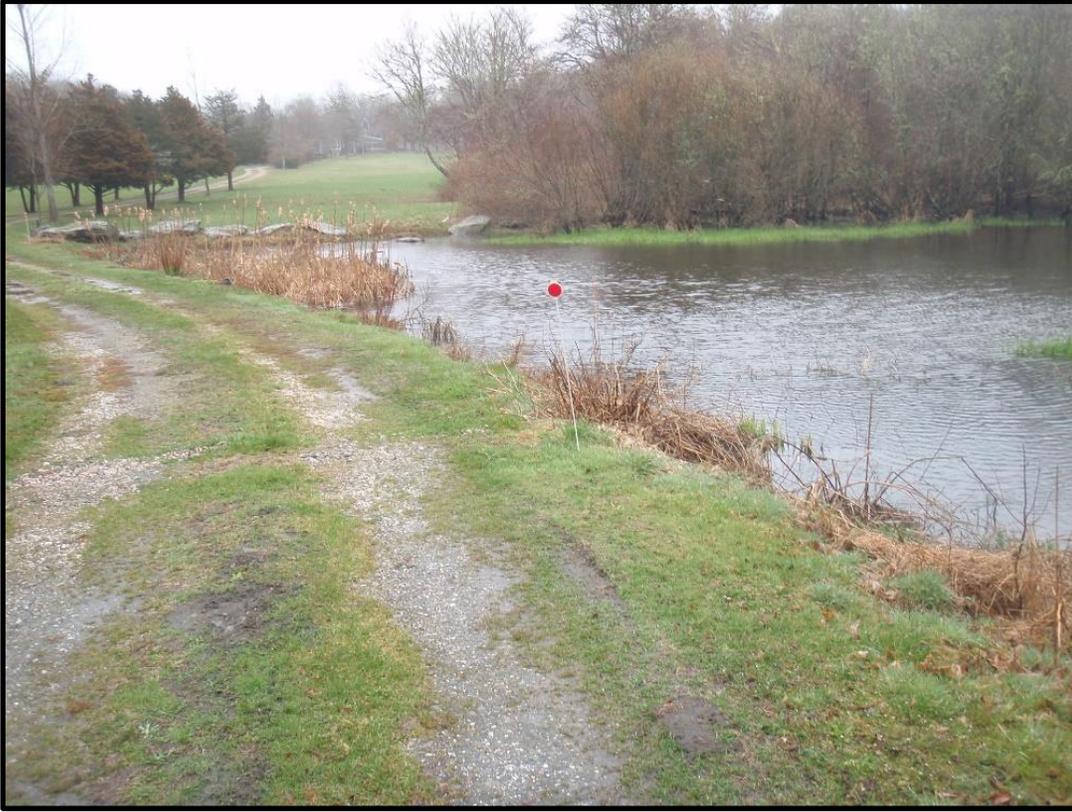
The western fork of the tributary then flows through upland forest and into another small farm pond on what is now a 14-acre residential lot. Lawn extends down to the pond's edge at this location ([Photo 50](#)). Prior to the confluence with the northeastern fork of the tributary, the stream flows past a hay field and three residential lots ([Photos 51 and 52](#)). There is a 10-60 ft. vegetated buffer at the lower end of the stream.

Photo 51. Hay field with 40-50 ft. vegetated buffer from stream (return to: [pollution sources](#) or [Photo Key](#)).

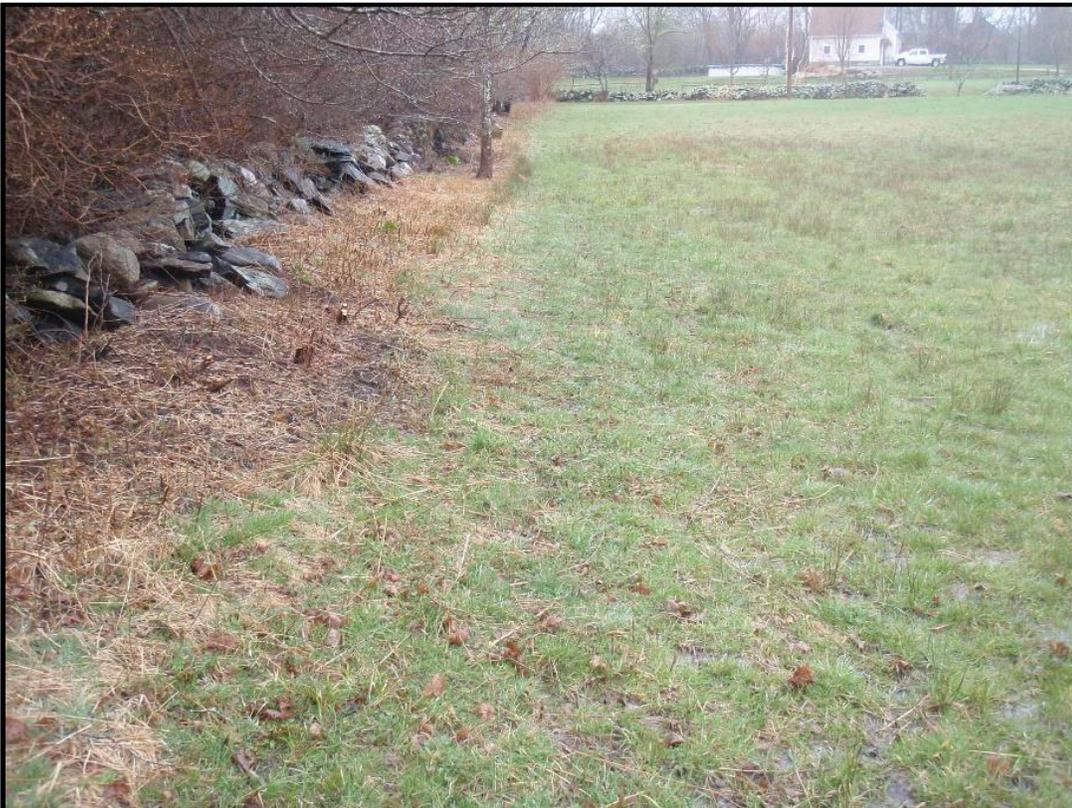
Photo 52. Residential lawns with 20-30 ft. buffer from stream (return to: [pollution sources](#) or [Photo Key](#)).

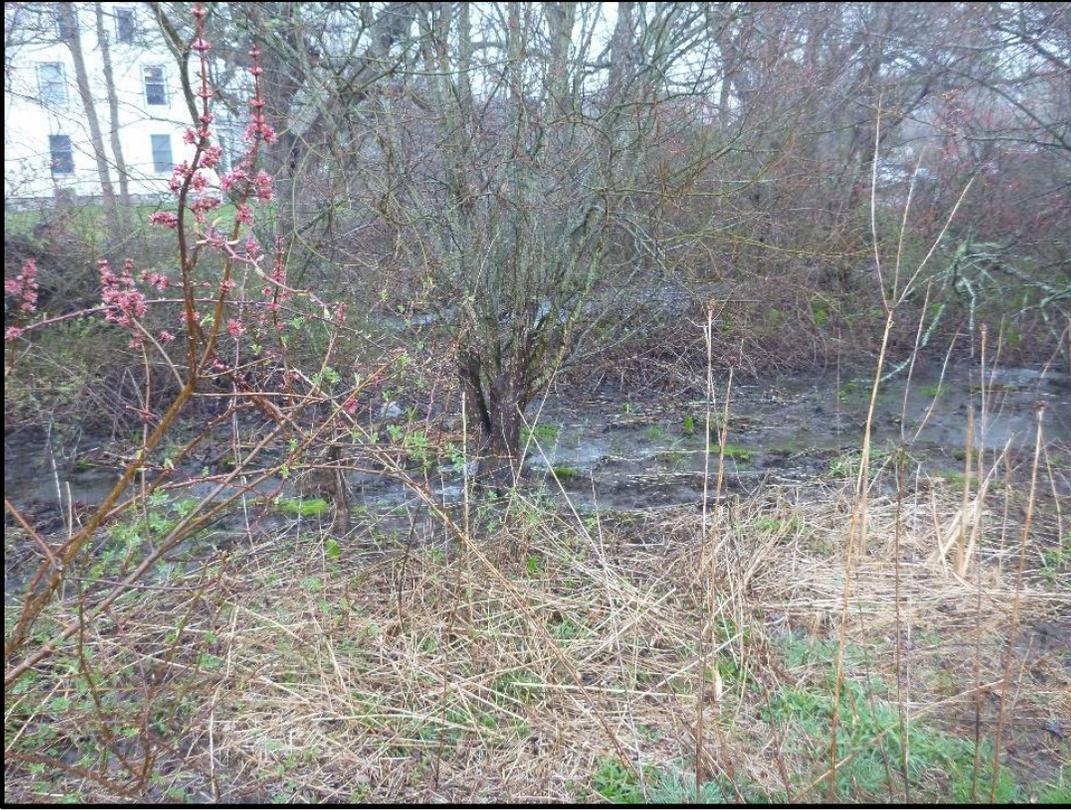
Photo 54. Residential lawn approximately 30 ft. from Borden Brook (return to: [pollution sources](#) or [Photo Key](#)).

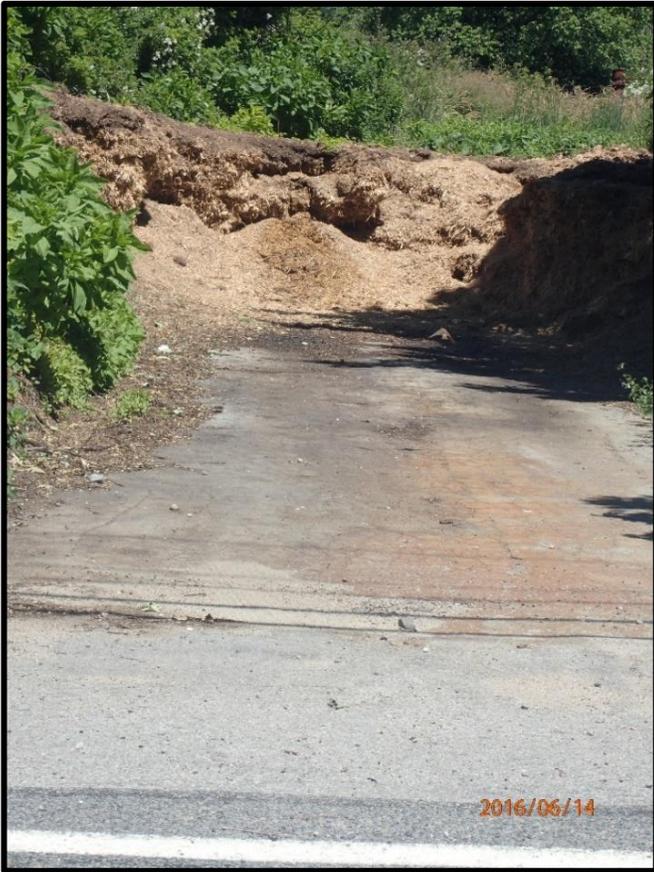
There are several different land uses in the central and western portions of the subwatershed, including pastures, an equestrian center, residential areas, hay fields, and a crop field. Although these properties are distant to Borden Brook, the road could potentially provide a pathway for polluted stormwater runoff, to reach the stream. An example of this is a manure pile, located next to a hayfield, adjacent to the north side of East Road. The manure pile is located at the end of a short paved sunken drive, near the roadway ([Photo 55](#)). Another example is a chicken pen at the top-of-bank of a roadway ditch on the southern shoulder of East Road ([Photo 56](#)).

Photo 56. Chicken pen adjacent to roadside ditch on southern side of East Road (return to: [pollution sources](#) or [Photo Key](#)).

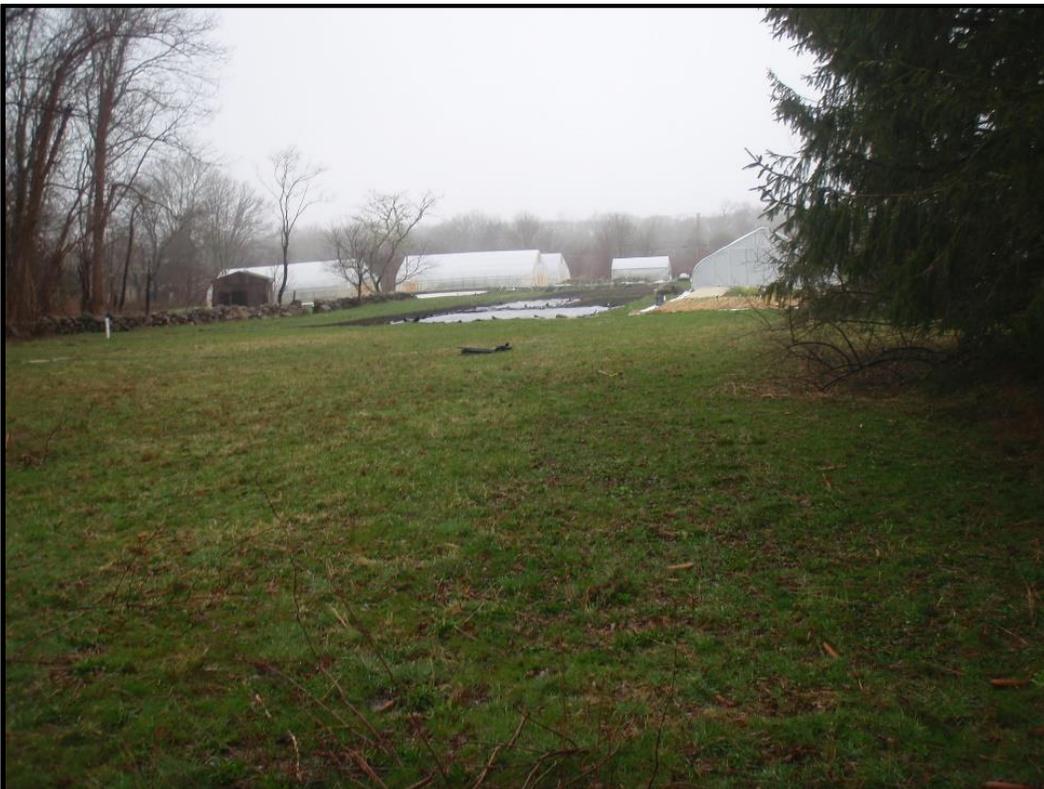
field (Photos 58 and 59), through another residence (Photo 60), and through a pasture (Photos 61 through 64), with no vegetated buffer in places. The tributary then flows past a couple of residential properties, where there is again no significant vegetated buffer (Photo 65).

Photo 59. Lawn adjacent to stream associated with crop field in above photo (return to: [pollution sources](#) or [Photo Key](#)).

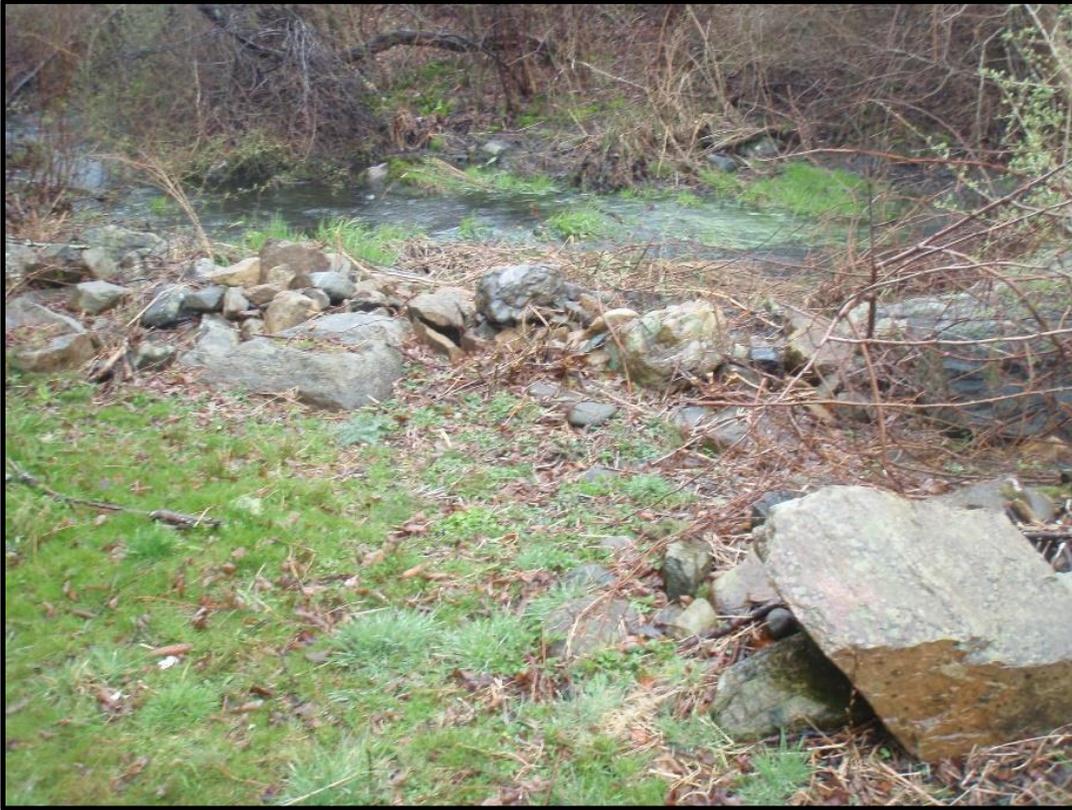
Photo 60. Residential lot with land recently cleared to streambanks (return to: [pollution sources](#) or [Photo Key](#)).

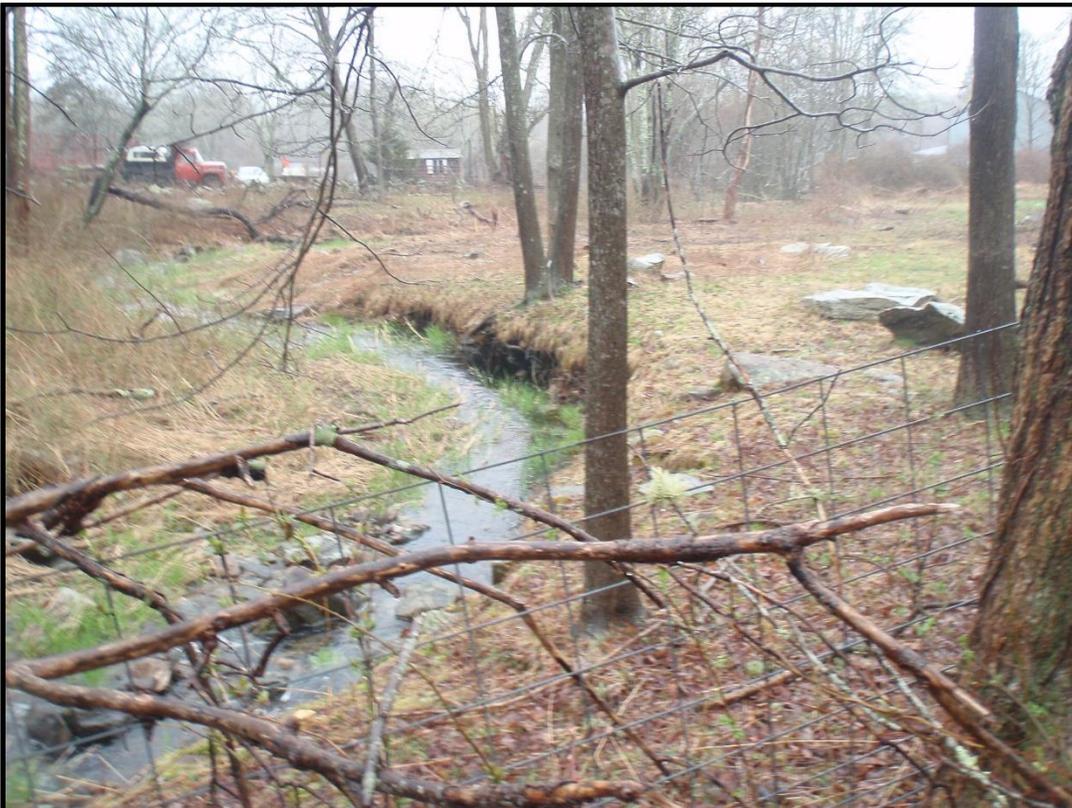
Photo 61. Eastern edge of grazed pasture with no vegetated buffer along stream (return to: [pollution sources](#) or [Photo Key](#)).

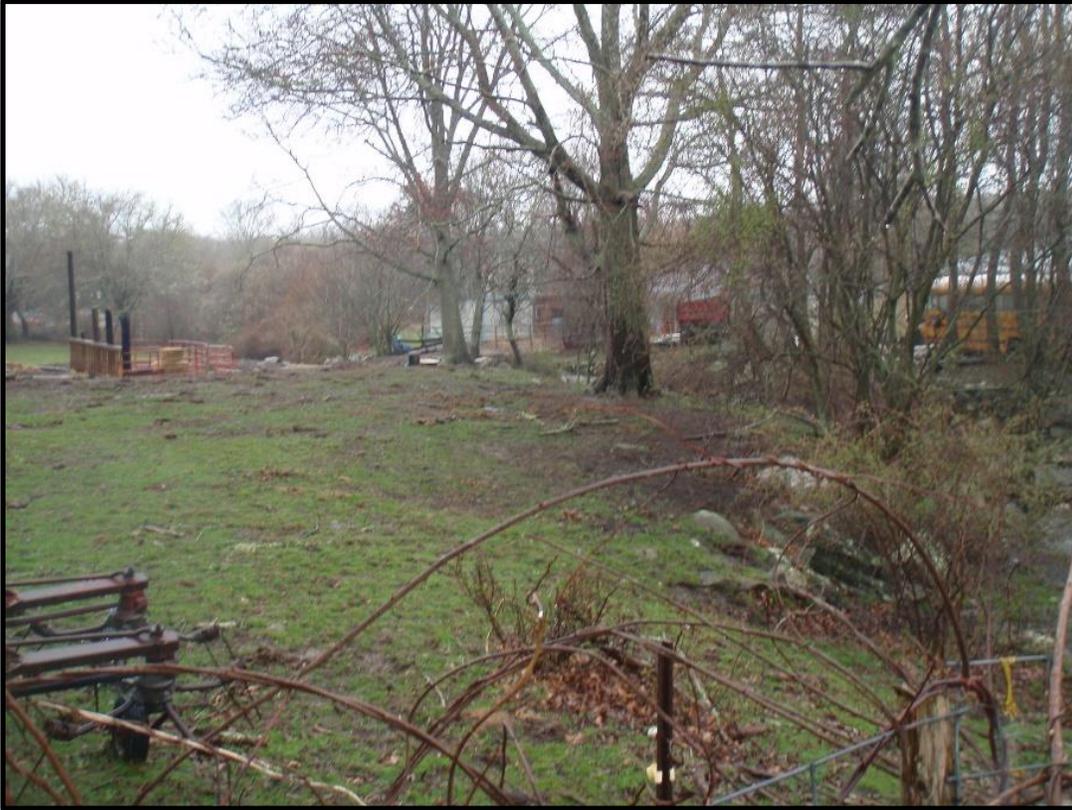
Photo 62. Grazed pasture from same location as above photo. Cattle have access to stream (return to: [pollution sources](#) or [Photo Key](#)).

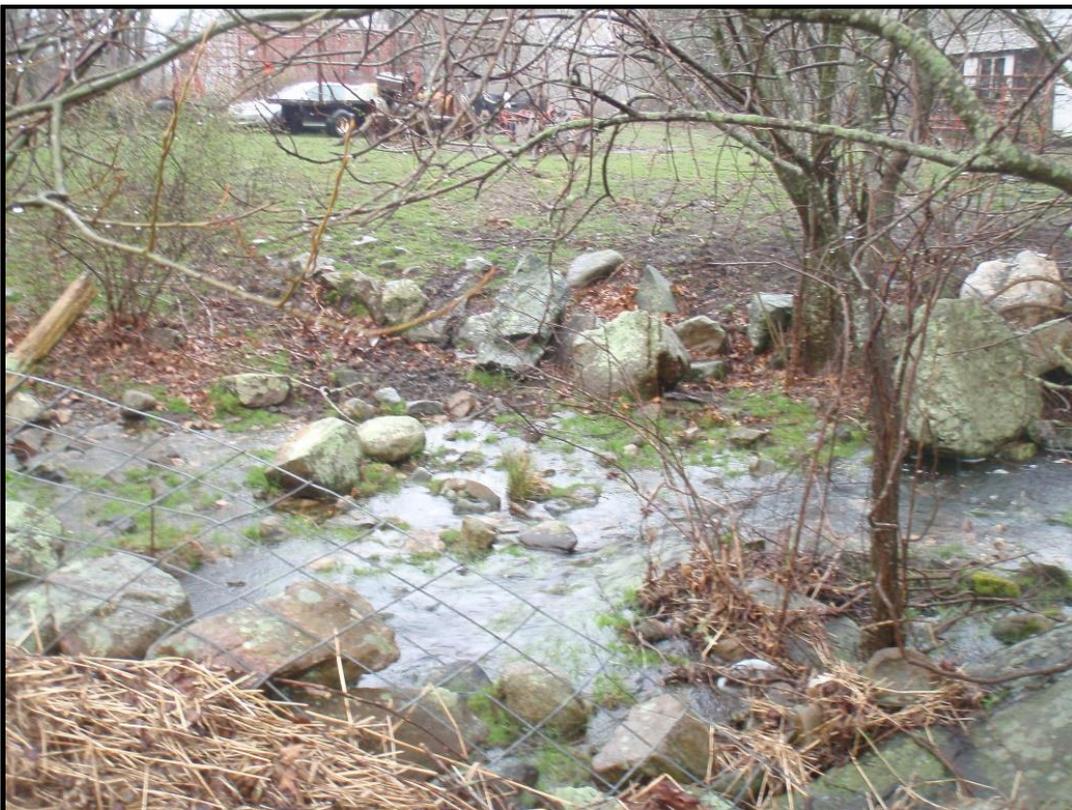
Photo 63. Western end of grazed pasture (return to: [pollution sources](#) or [Photo Key](#)).

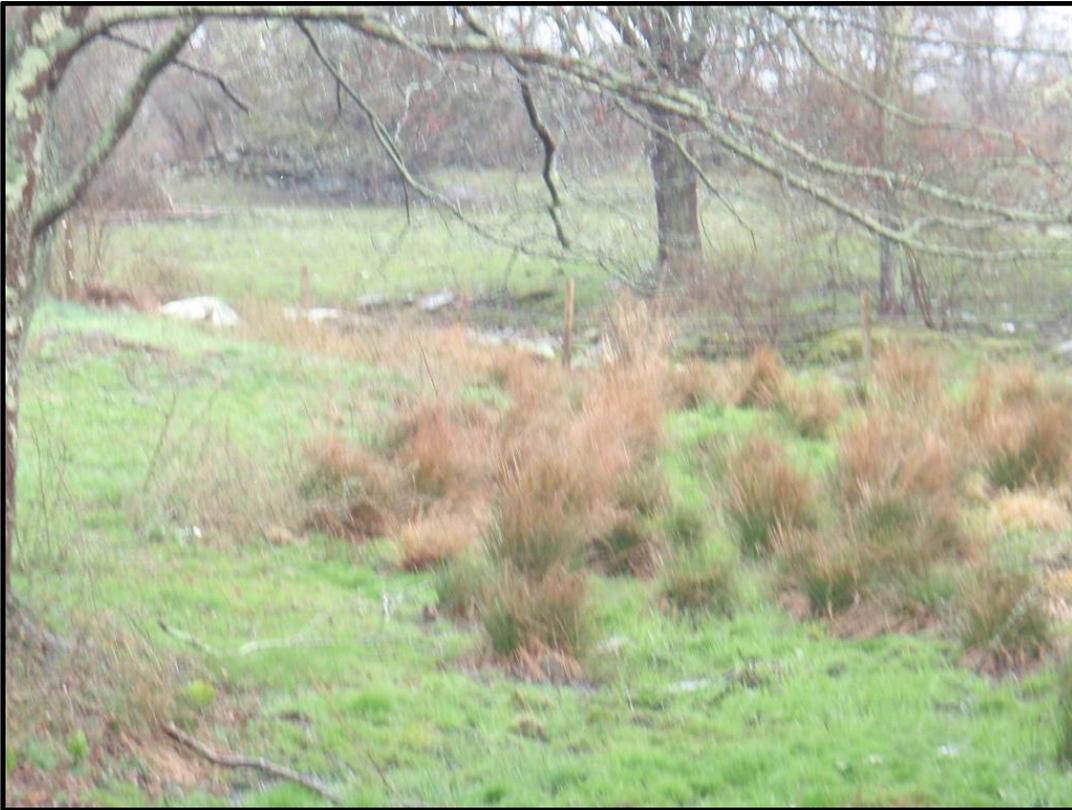
Photo 64. Stream flowing along western end of grazed pasture (return to: [pollution sources](#) or [Photo Key](#)).

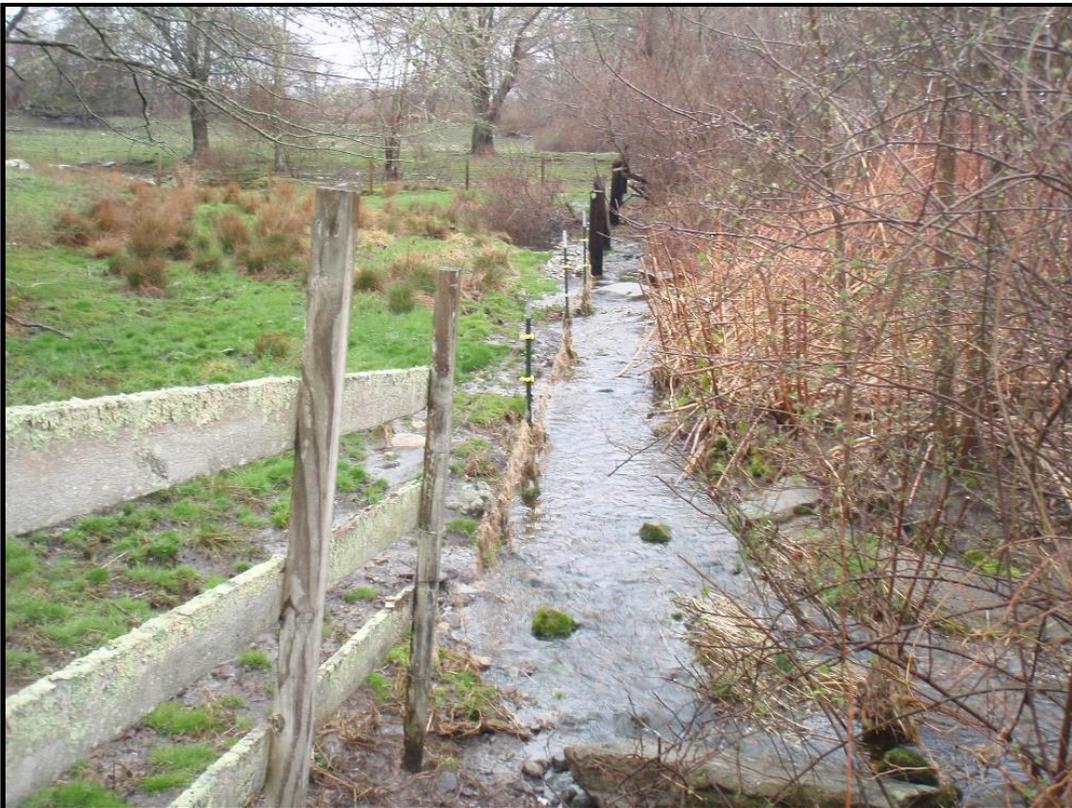
Photo 65. Residential lawn extending to top-of-bank of Borden Brook (return to: [pollution sources](#) or [Photo Key](#)).

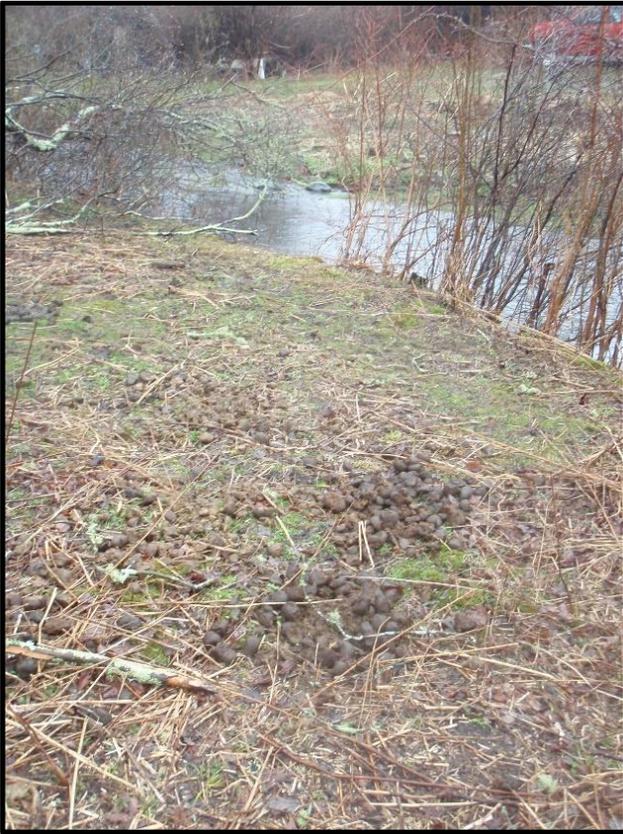
Photo 67. Pasture on western bank of Borden Brook (return to: [pollution sources](#) or [Photo Key](#)).

There is a pasture (i.e. actively grazed area) that straddles the stream, between the confluence with Quaker Creek and a sharp bend in the river. Much of the pasture directly abuts the stream, with no vegetated buffer, and with clumps of manure in close proximity to the stream (Photos 66 and 67). A bridge allows animal access from barns on the west side of the river to its eastern bank (Photo 68). A manure pile was observed approximately 30 ft. from the river's western bank (Photo 69). Much of the pasture is seasonally wet and mucky, especially areas immediately adjacent to the stream.

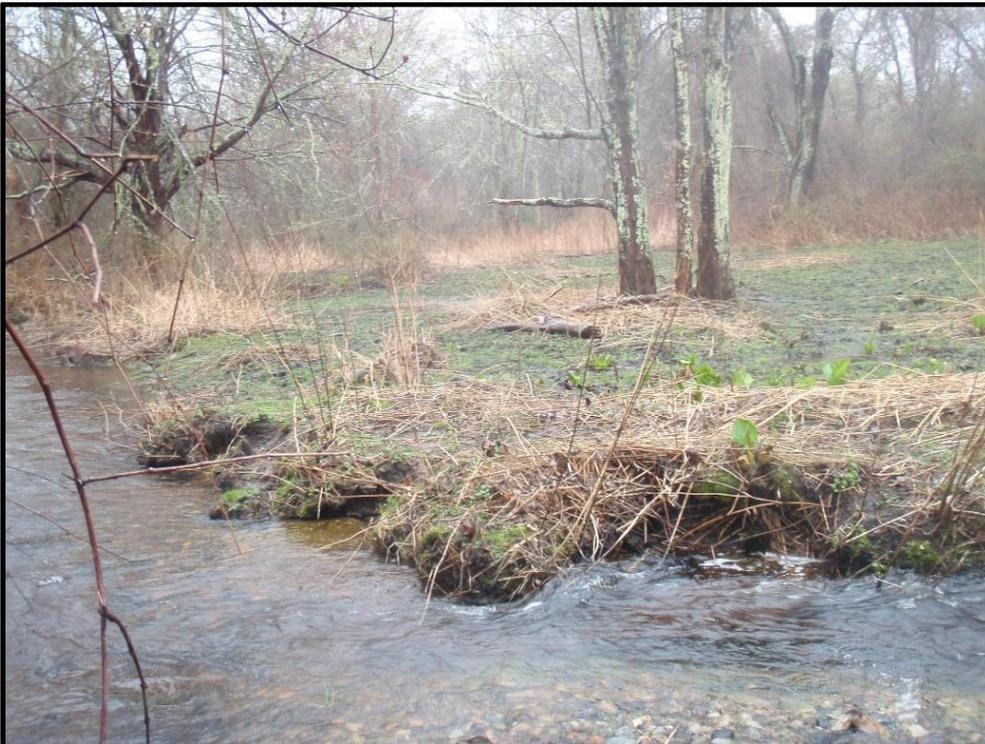
Photo 68. Bridge over Borden Brook connecting pastures on east and west sides of the river
(return to: [pollution sources](#) or [Photo Key](#)).

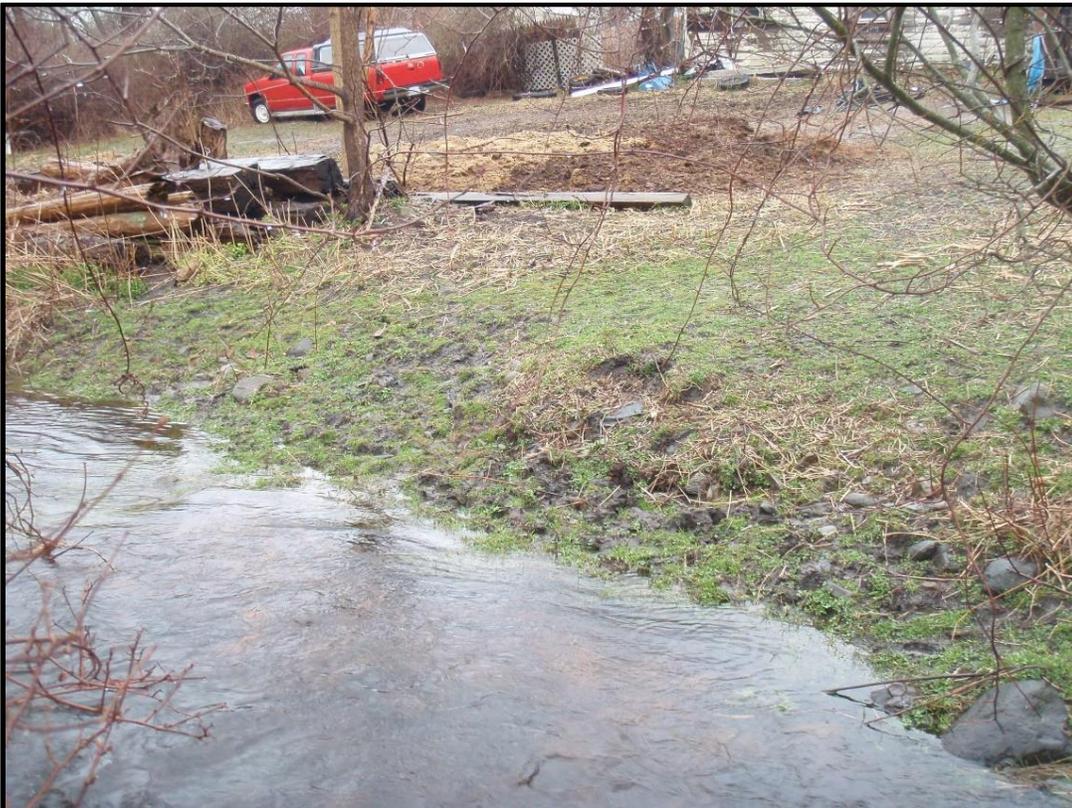
Photo 70. Rear of small ponded area in Borden Brook with commercial buildings on Main Road (return to: [pollution sources](#) or [Photo Key](#)).

The stream flows through a broad wetland corridor, downstream of the pasture. A hayfield borders the wetland corridor to the north of the stream. An unnamed tributary discharges to Borden Brook to the rear of commercial properties on Main Road. There is a small pond immediately downstream of the confluence of Borden Brook and the tributary (Photo 70). Station B3 was located at an old mill dam, at the downstream end of the pond, approximately 700 ft. upstream of Nonquit Pond (Photos 71 and 72). The flow over the mill dam had a strong orange tinge, which may be the result of natural acids coloring the water. There are commercial properties on Main Road, adjacent to Station B3, including offices and several small retail shops, including a metal working shop. Several of these commercial properties have lawns that extend to the top of the streambank (Photo 73). There are also several commercial and residential properties in the northwest part of the subwatershed, in the Four Corners area, near the intersection of Main Road and East Road.
