**NONQUIT POND TRIBUTARIES
WATER QUALITY STUDY AND POLLUTANT SOURCE IDENTIFICATION
NATIONAL WATER QUALITY INITIATIVE**

**Prepared By: Office of Water Resources
Rhode Island Department of Environmental Management
235 Promenade St. Providence, RI 02908
June 2018**

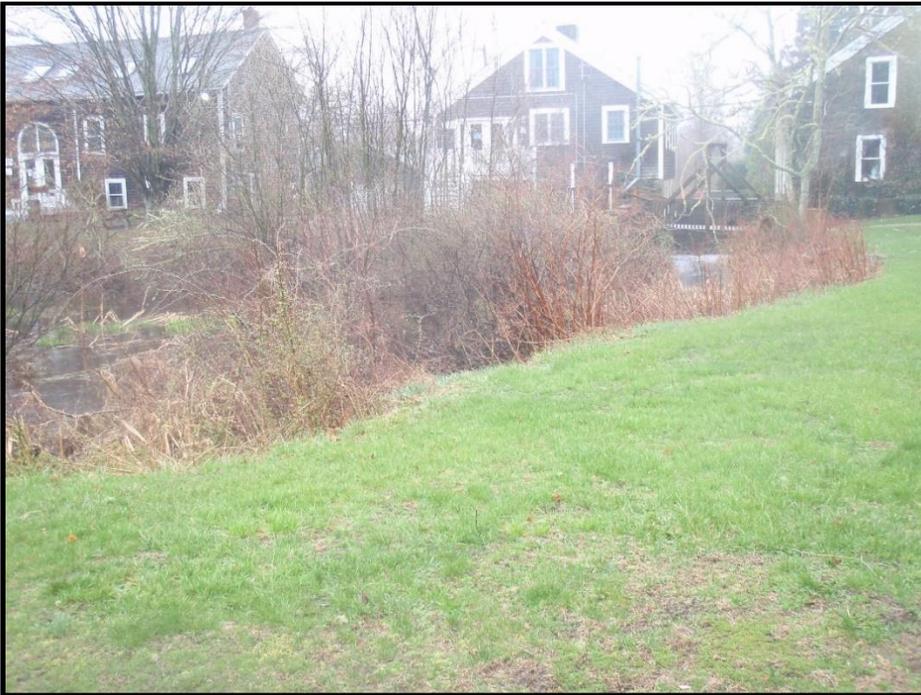
Photo 71. Ponded area in Borden Brook. Photo taken from footbridge at Station B3 (return to: [pollution sources](#) or [Photo Key](#)).

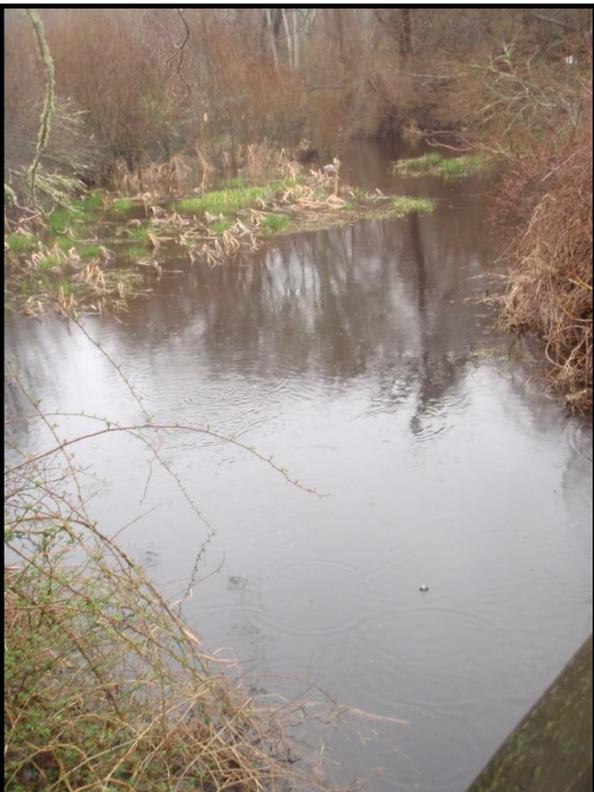
Photo 72. Mill dam between buildings on Main Road at footbridge at Station B3. Note orange color (return to: [pollution sources](#) or [Photo Key](#)).

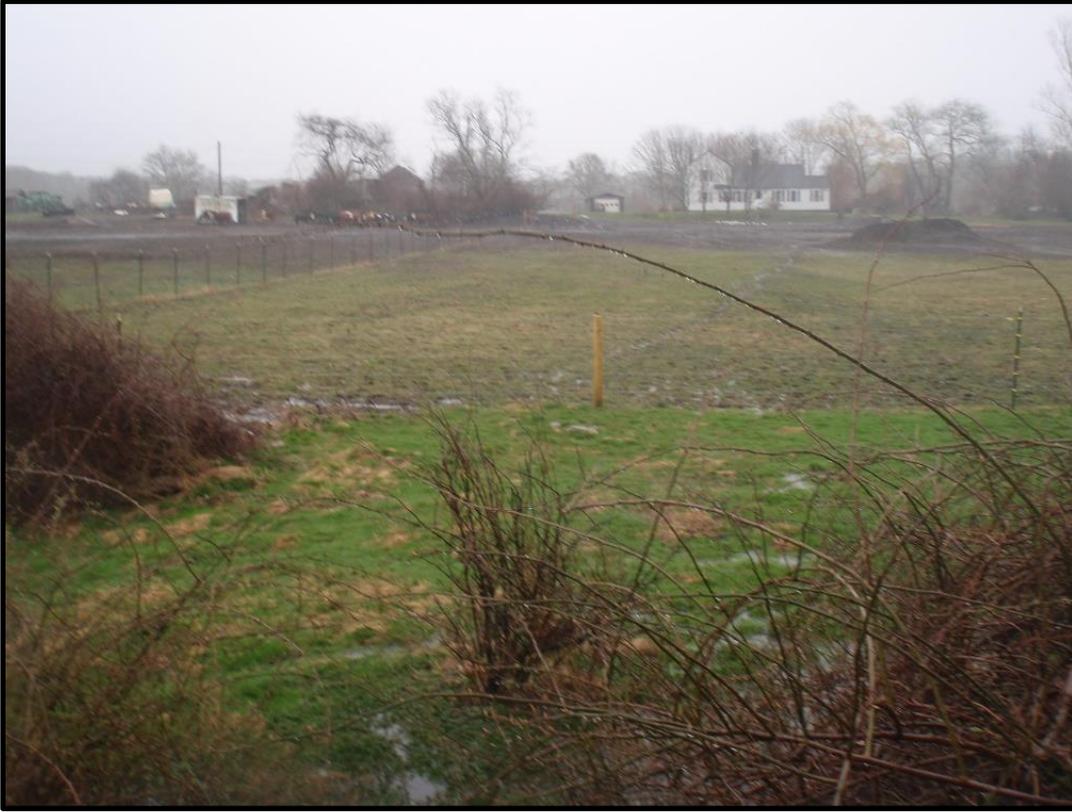
Photo 77. Low earthen berm around eastern corner of wetland with pasture in the background (return to: [pollution sources](#) or [Photo Key](#)).

Inspection of aerial photographs as well as field observations revealed that cows graze within the wetland at the headwaters of the stream. Cattle have access to saturated and flooded areas along much of the perimeter of the wetland. However, it appears that during the winter, cattle are restricted to a fenced area at least 50 ft. east of the wetland ([Photos 75 and 76](#)). There is an earthen berm, along the perimeter of the corner of the wetland, where it lies closest to the eastern pasture ([Photo 77](#)). At other times of year, cattle graze within the wetland, particularly in a significant area of standing water to the north of the forested portion of the wetland ([Photos 78 and 79](#)), including a small farm pond ([Photo 80](#)). Cows also graze in wet meadows on the southeastern side of the wetland ([Photo 81](#)). A pasture area to the west of the wetland appears to have a better-quality forage ([Photo 82](#)). However, the southern portion of the pasture, adjacent to the forested wetland is seasonally saturated, and cattle have direct access to the stream at the northeast corner of the pasture ([Photo 83](#)).

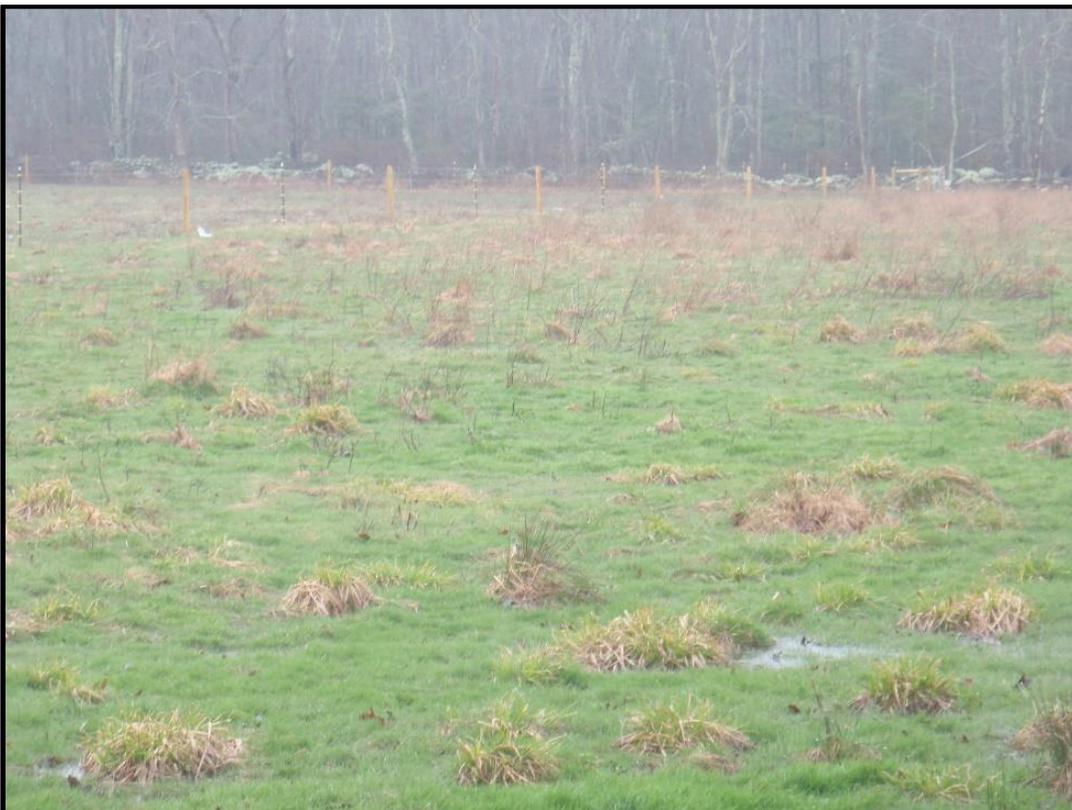
Photo 78. Grazed pasture within flooded marsh (return to: [pollution sources](#) or [Photo Key](#)).

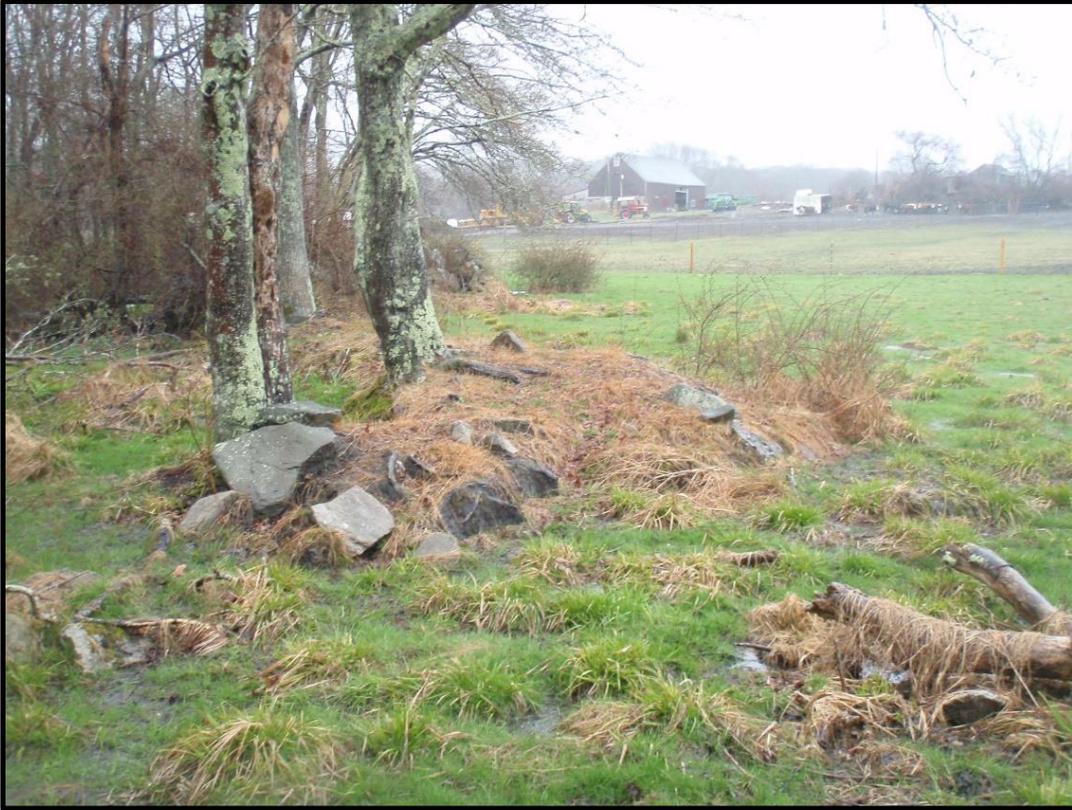
Photo 79. Grazed pasture in wetland (return to: [pollution sources](#) or [Photo Key](#)).

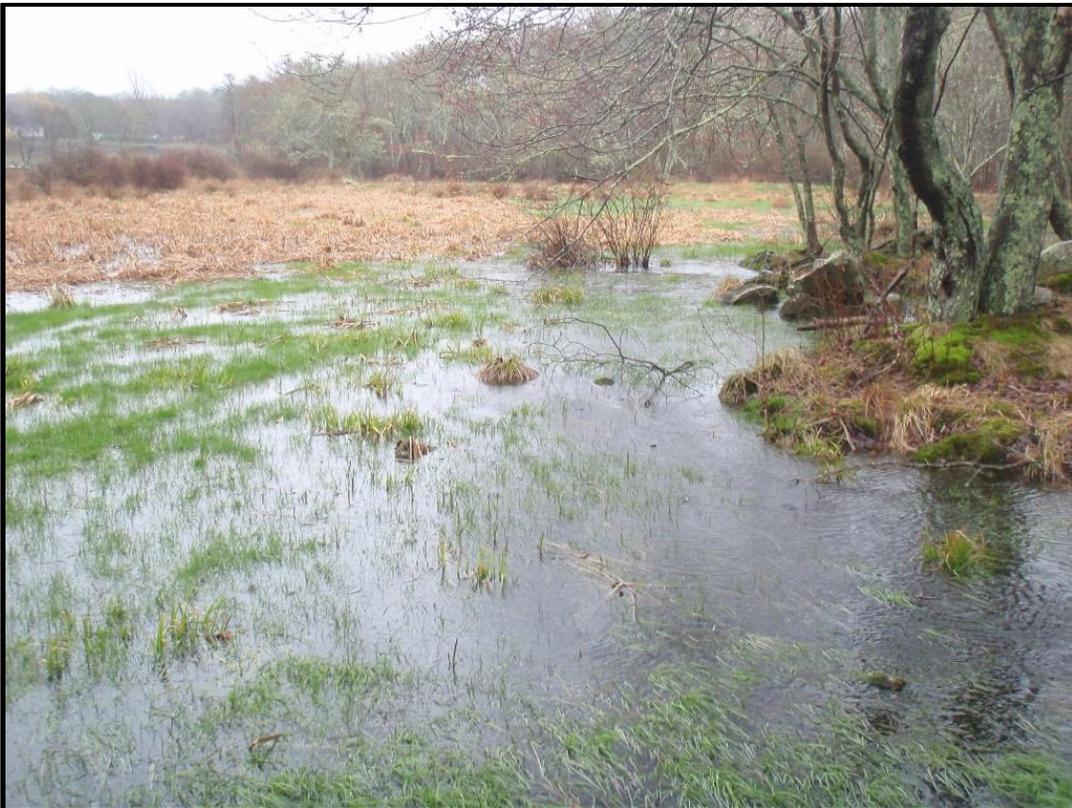
Photo 80. Cattle have access to small farm pond on northern side of wetland (return to: [pollution sources](#) or [Photo Key](#)).

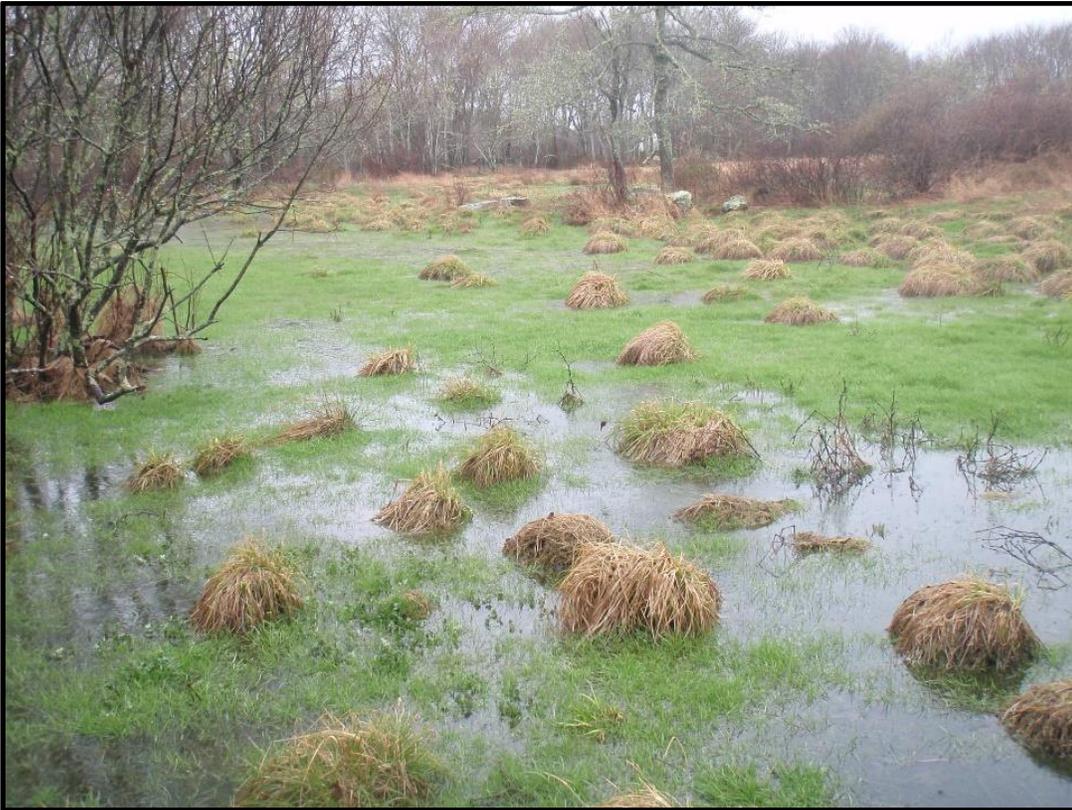
Photo 81. Saturated grazed area on southeastern side of wetland (return to: [pollution sources](#) or [Photo Key](#)).

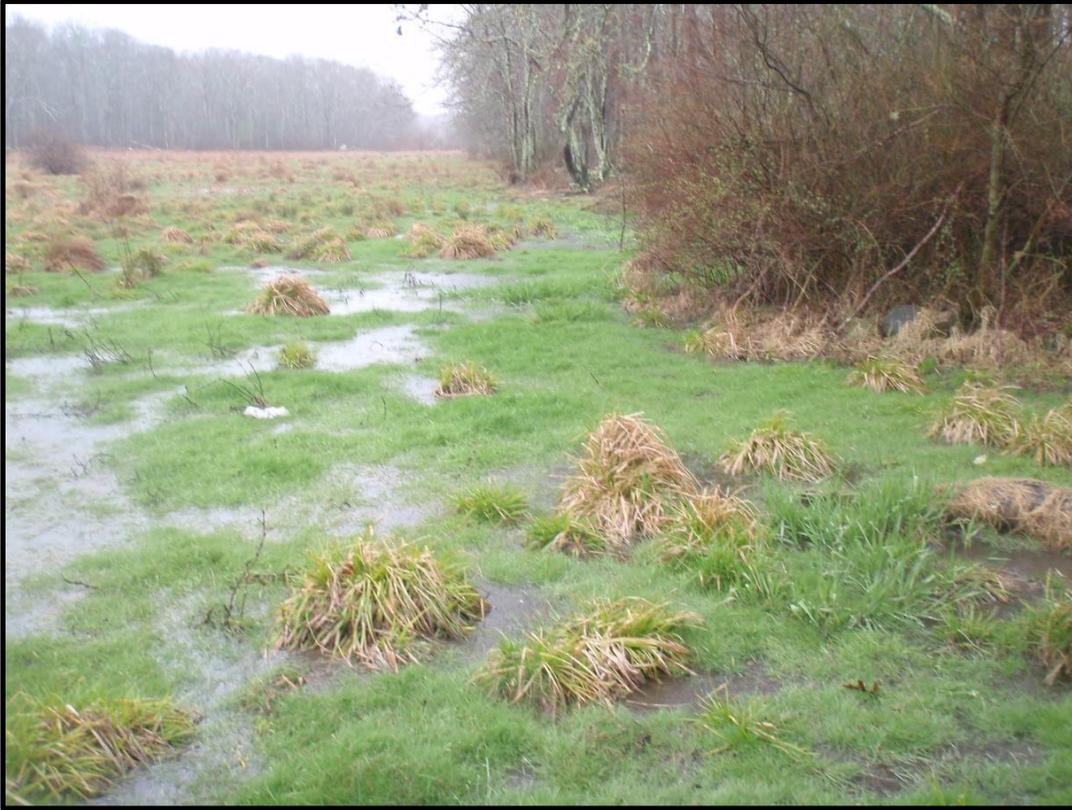
Photo 83. Grazed pasture adjacent to flooded wetland and stream (return to: [pollution sources](#) or [Photo Key](#)).

The mean dry-weather TP concentration (333 ug/l) was more than three times higher than the EPA guidance value (Table 13). The probable source was cows grazing in the wetland, which forms the headwaters of the northeastern fork of the unnamed tributary to Nonquit Pond (Figure 14). As previously discussed, cows have access to most of the perimeter of the wetland, including flooded areas adjacent to the stream. Inspection of historic aerial photographs shows cattle in the flooded area. Cattle were observed in the subject area, during at least one field inspection.

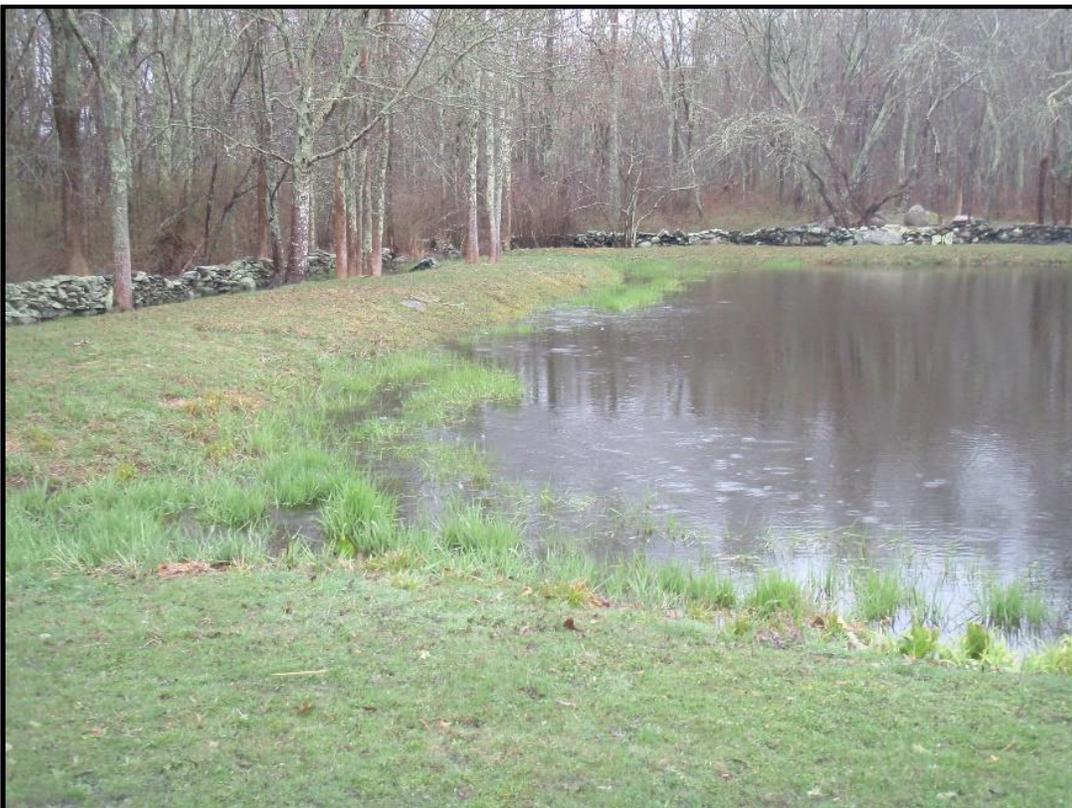
Photo 87. Residential lawn to edge of streambank (return to: [pollution sources](#) or [Photo Key](#)).

The lower portion of the northeast fork of the unnamed tributary, downstream of Station N1, flows along the edge of a residential lawn. Downstream of Main Road, the northeast fork flows along the northern edge of the crop field, discussed above, with 0-15 ft. of vegetated buffer. The northeast fork then flows across a stone wall, forming a property boundary between the crop field and residential lots. The tributary then flows parallel to the stone wall, at the rear of five residential lots. With the exception of one residential lot with a 50-ft. vegetative buffer, the remaining lots have lawns that extend to the top-of-bank of the tributary ([Photo 87](#)). Turbid runoff was observed in an erosional swale at the northern edge of the cornfield, which discharges to the tributary near the confluence of its two forks ([Photo 88](#)). The two forks of the unnamed tributary converge just upstream of Station N2, which is located approximately 400 ft. upstream of Nonquit Pond.

There was also a significant wet-weather increase in mean TN at Station N2. Nitrogen was mainly in the form of organic-N. Probable sources include the crop field, located downstream of Main Road, and the residential lawn located south of Bettencourt Lane. Both areas have an inadequate vegetated buffer, adjacent to the stream. Another potential source is the decay of organic material, and to a lesser extent wildlife waste, within the extensive swamp associated with the upper reaches of the stream.

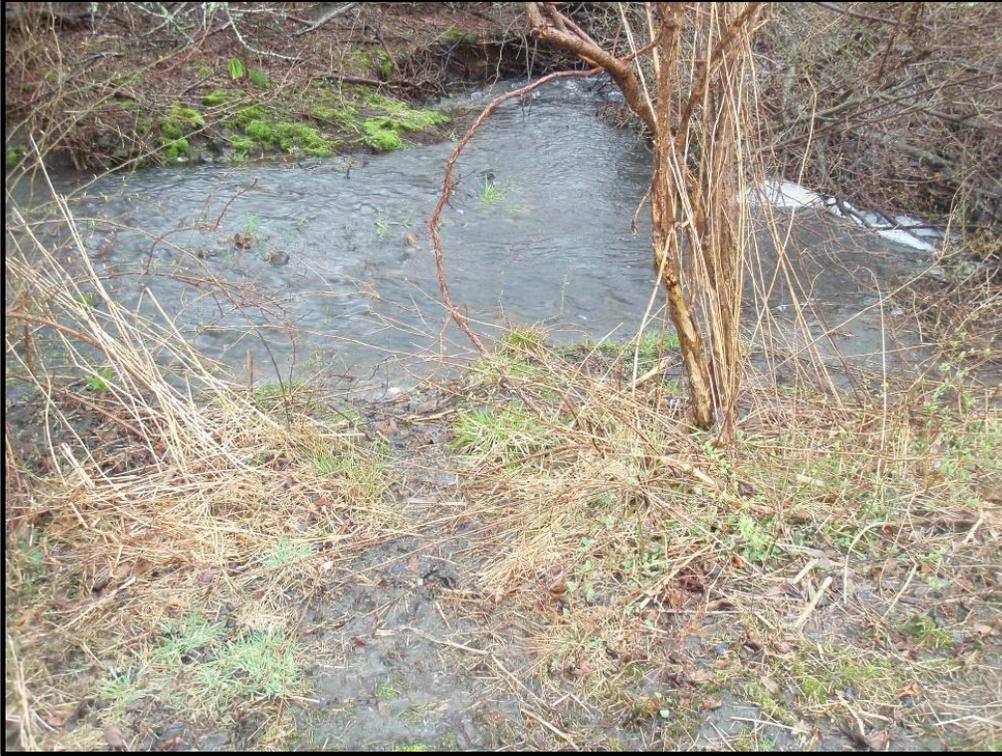
Photo 88. Erosional swale on edge of corn field flowing towards stream and Station N2
(return to: [pollution sources](#) or [Photo Key](#)).

source of turbidity is the crop field, located immediately downstream of Main Road. Bare soil and relatively steep gradients in this area create favorable conditions for soil transport to the stream.
