2020 Biennial Inspection Report

Flat River Reservoir Dam Coventry, Rhode Island RI Dam ID No. 167

RTG Project No. 20102.00

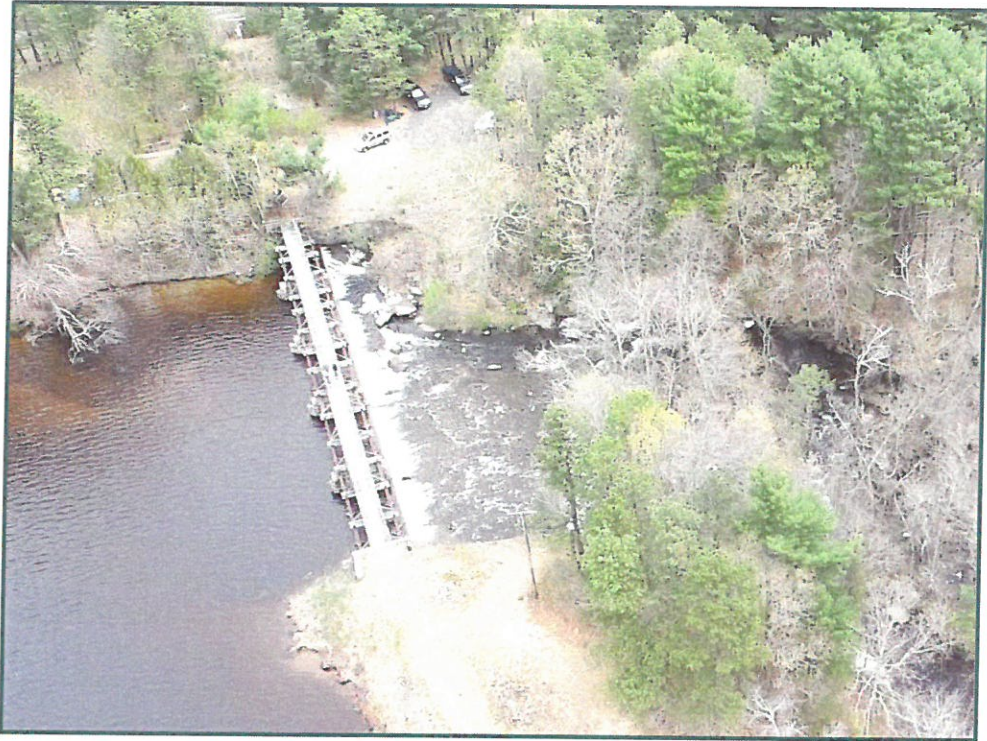
Photo No. 1:
Spillway, looking northeast,
photo taken on May 11, 2020.

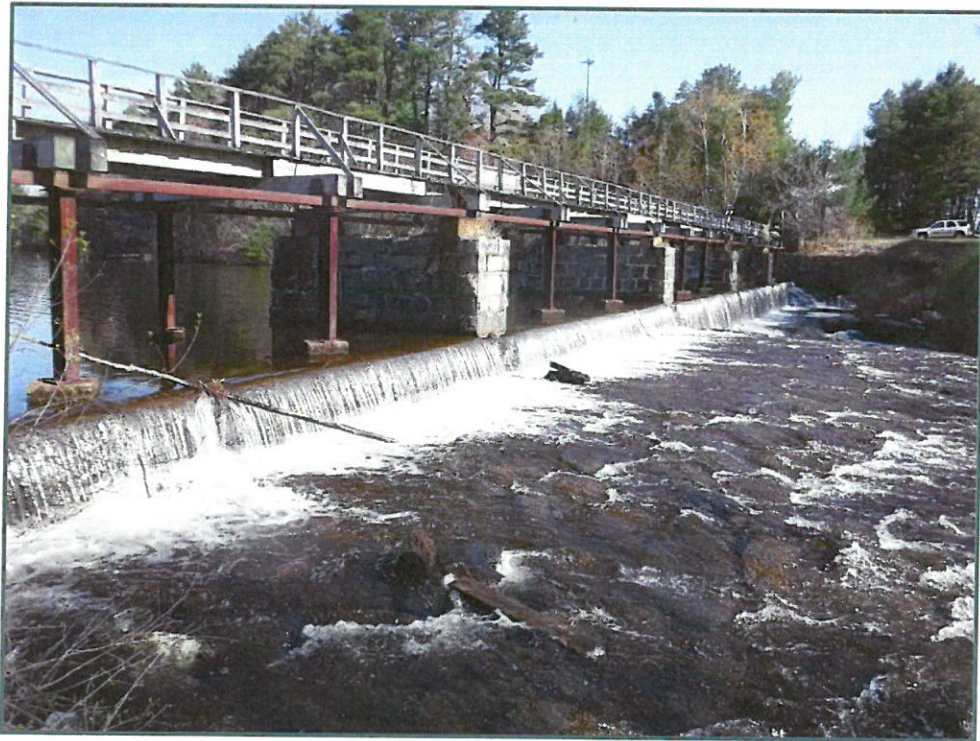
Photo No. 2:
Spillway, looking north,
photo taken on May 11, 2020.

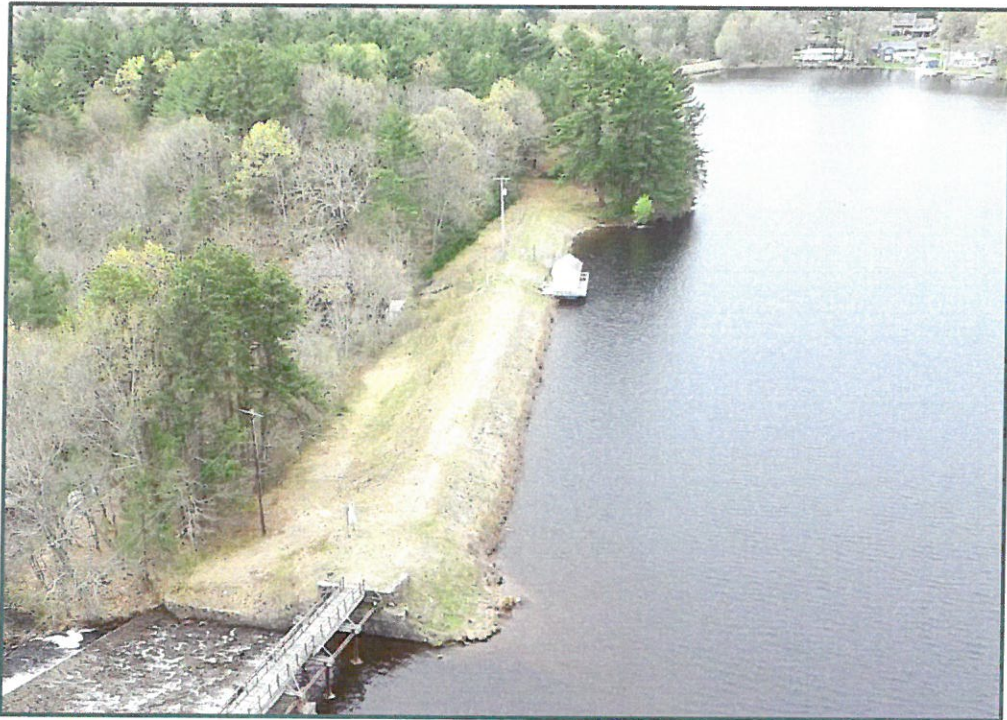
The north embankment is about 500 feet long and about 15 feet wide at the crest (Figure 1-2). The embankment is about 25 feet high (max) with side slopes ranging from about 1.75H:1V (Upstream Slope) to about 1.6H:1V (Downstream Slope). Access ways exist along the downstream slope facilitating vehicular access to the left and right sides of the downstream outlet structure (Figure 1-2, Photo No. 11).

Photo No. 11:
North embankment, looking south,
photo taken on May 11, 2020.

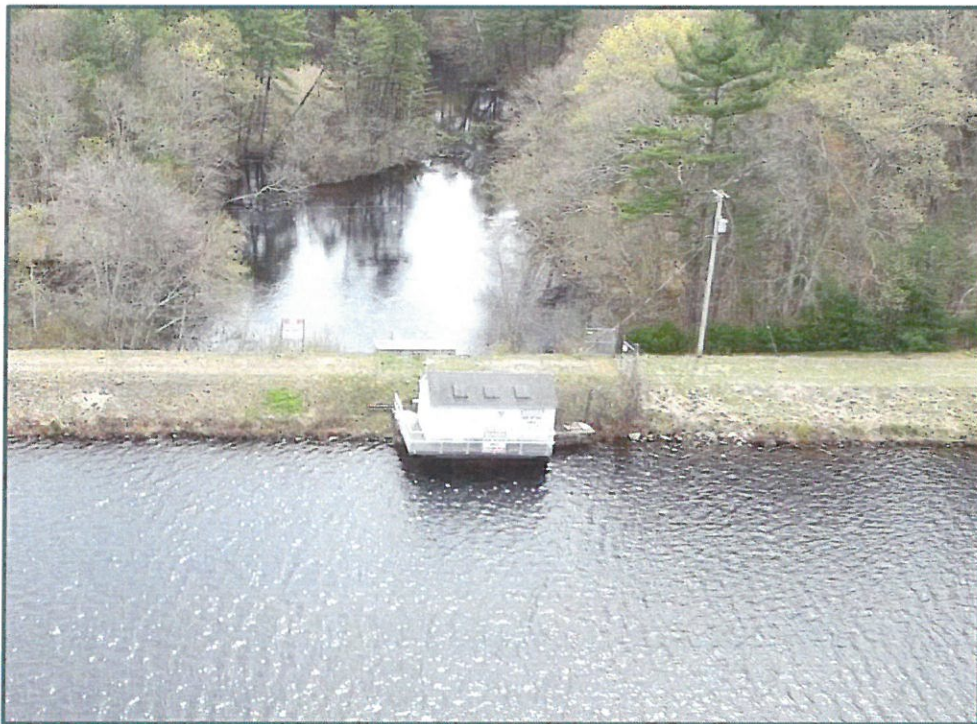
Photo No. 18:

The gate house is located on the upstream side of the north embankment towards its southern end (Figure 1-2, Photo No. 18). It houses the gate operators for the Dam's three (3) 48-inch-diameter low-level outlet pipes and their electric-powered actuators. The low-level outlet pipes are constructed of cast iron and extend from the gate house to a downstream concrete outlet structure where water is discharged to the downstream channel. A timber trash rack exists immediately upstream of the low-level outlet pipes.

Gatehouse and downstream outlet structure, looking east, photo taken on May 11, 2020.

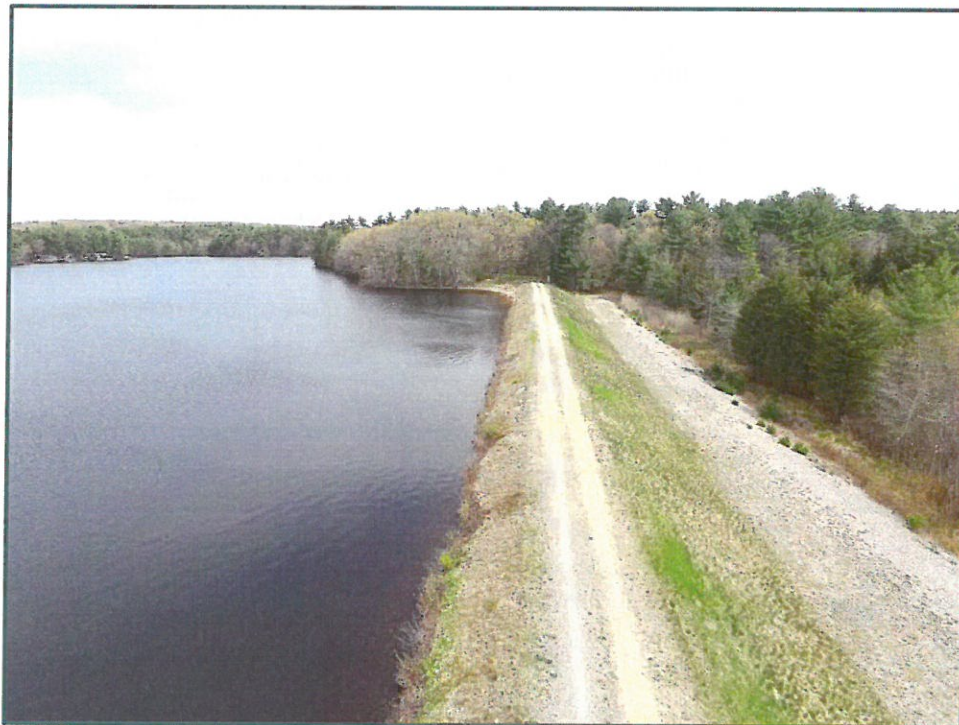
The south embankment is about 700 feet long and about 15 feet wide at the crest (Figure 1-2). The embankment is about 10 to 12 feet high with side slopes ranging from about 1.75H: 1V (Upstream Slope) to about 2.3H: 1V (Downstream Slope). A counterweight berm exists on the downstream slope (Photo No. 20).

Photo No. 20:
South embankment, looking northeast,
photo taken on May 11, 2020.
