FINAL SITE CHARACTERIZATION AND SELF-IMPLEMENTING CLEANUP PLAN PAWTUCKET 1 No. 107 SUBSTATION - CONTROL HOUSE 6 THORNTON STREET PAWTUCKET, RHODE ISLAND

March 30, 2023 Coneco Project No. 5675.F.101

RE: **Final Site Characterization and Self-Implementing Cleanup Plan** Pawtucket 1 No. 107 Substation - Control House 6 Thornton Street Pawtucket, Rhode Island

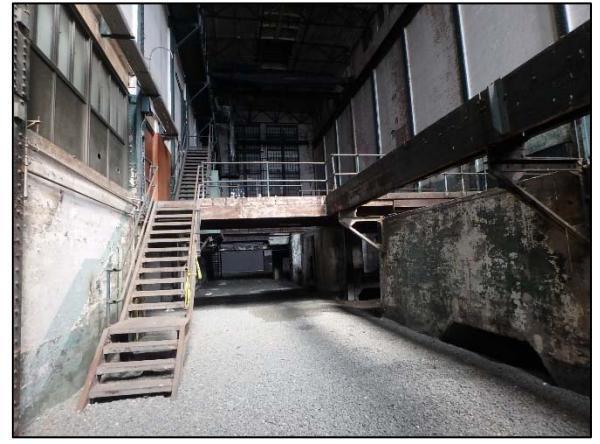
### Photo 4

Overview of the Turbine Room on September 9, 2018, as viewed from the southeast. Note the trap rock covering the floor.

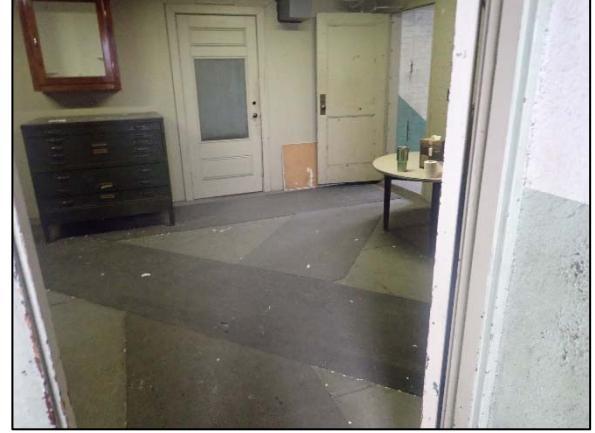
### Photo 8

Overview of the second floor Office 1 room, where PCB Remediation Waste has been identified in the ceiling paint and concrete as well as the rubber floor matting, on April 29, 2021, as viewed from the northwest.

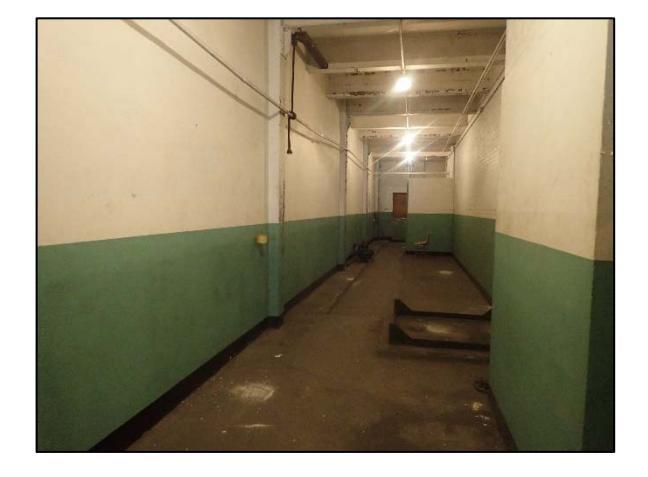
## Photo 11

Overview of the third floor East Hallway, comprising PCB Remediation Waste, on April 29, 2021, as viewed from the north.
