TRANSMITTAL			
iZA Ge	eoEnvironmental, Inc.						
	lley Street, Suite 300						
Providence, Rhode Island 02909 01.421.4140 (fax) 401.751.8613				Date: 1/14/19			
				Attention: Mr. Joseph N	Attention: Mr. Joseph Martella		
То:	Rhode Island Departmer	nt of Environmental M	anagement	Re: Liquefaction Facilit	Re: Liquefaction Facility Project		
Ī	Office of Waste Manage		-		ir Quality Monitoring (AQM)		
	235 Promenade Street			121 Terminal Road	/ 642 Allens Avenue		
	Providence, Rhode Island	d 02908		Providence, Rhode	Island		
				Site Remediation File No. SR-28-1152			
	Shop Drawings		Attached Prints	Change Order Plans	Samples Specifications		
	Under Separate Cov	ver, the following Item	s:	via:			
	ipped:						
Х	Via Email	Co	urier	Regular Mail	Hand Delivered/Picked Up		
	Copies	Date	No.		Description		
	1	1/7/19	-	Air Quality Monitoring (AQN	Air Quality Monitoring (AQM) Results –		
			Week of 1/7/19 (1/7/19, 1/8/19, 1/9/19, 1/10/19 and 1/11/19) AQM Station 1 Graph AQM Station 2 Graph AQM Station 3 Graph

Prepared by National Grid LNG LLC Liquefaction Facility Project -STRAP Perimeter Air Quality Monitoring (AQM) 121 Terminal Road / 642 Allens Avenue, Providence, Rhode Island

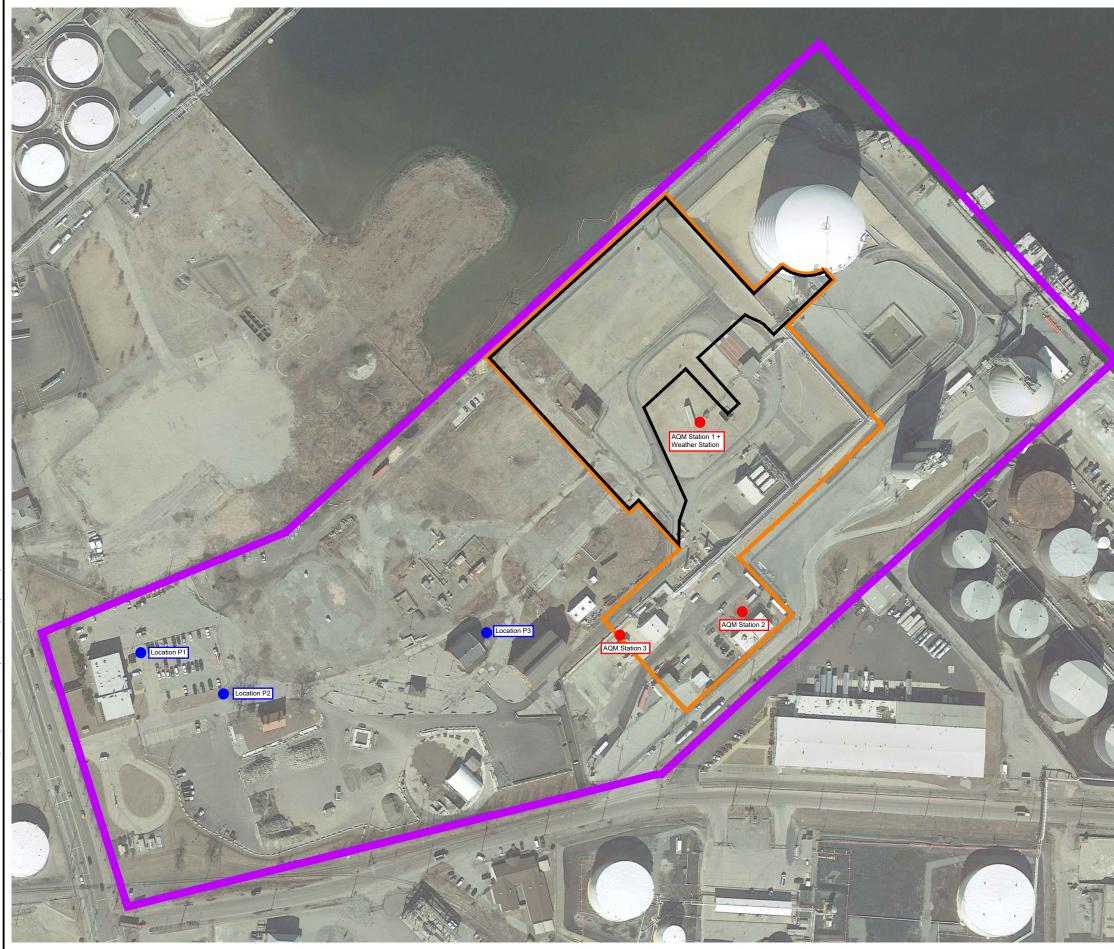
- 1. BASE MAP DEVELOPED FROM A GOOGLE PROFESSIONAL ELECTRONIC IMAGE FILE. DIGITAL AERIAL ORTHOPHOTOGRAPHY WAS PUBLISHED IN FEBRUARY 2018.
- 2. SITE BOUNDARIES ARE APPROXIMATE.
- 3. PERIMETER AIR MONITORING PROGRAM CONDUCTED AS DESCRIBED IN THE MAY 12, 2017 SHORT TERM RESPONSE ACTION PLAN (STRAP) AND OCTOBER 11, 2017 STRAP ADDENDUM, WHICH WERE APPROVED BY RIDEM WITH THE OCTOBER 27, 2017 STRAP APPROVAL.
