TRANSMITTAL

Liquefaction Facility Project -

STRAP Perimeter Air Quality Monitoring (AQM)

121 Terminal Road / 642 Allens Avenue, Providence, Rhode Island

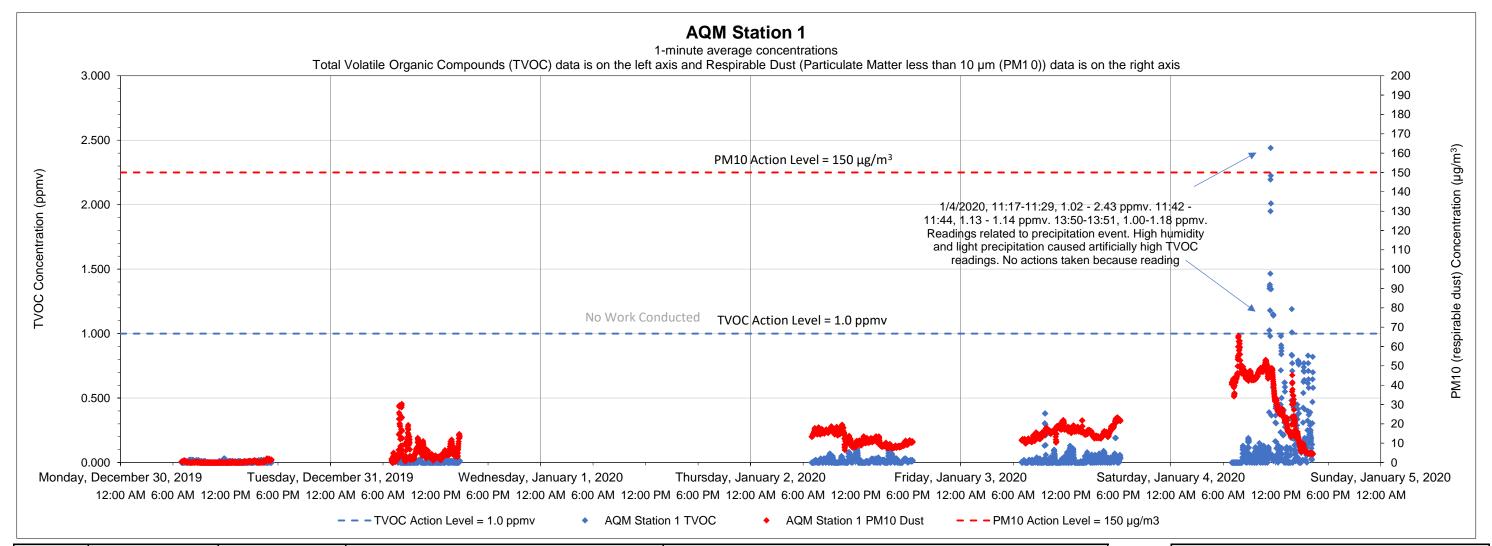
| Date | Time | Constituent | Observed Range of Sustained Readings | Response Actions Performed |
|---|---|---|---|--|
| 1/4/2020 | 11:17 | TVOCs | 1.02-2.44 | No actions taken, readings were not attributed to ongoing site work. |

1/4/2020 - Precipitation events caused sustained action level exceedances. Equipment temporarily removed from service and calibrated. A handheld PID was utilized to confirm that the station's readings were innacurate, and the site was checked for odors. Readings can be attributed to moisture from high humidity and precipitation entering the equipment box. Further troubleshooting planned for Monday 1/6/2020.

| Data Summary St | atistics | |
| TVOCs average concentration | 0.04 | ppm |
| TVOCs maximum concentration | 2.44 | ppm |
| TVOCs action level | 1 | ppm |
| PM10 average concentration | 13.15 | μg/m³ |
| PM10 maximum concentration | 65.55 | μg/m³ |
| PM10 action level | 150 | μg/m³ |

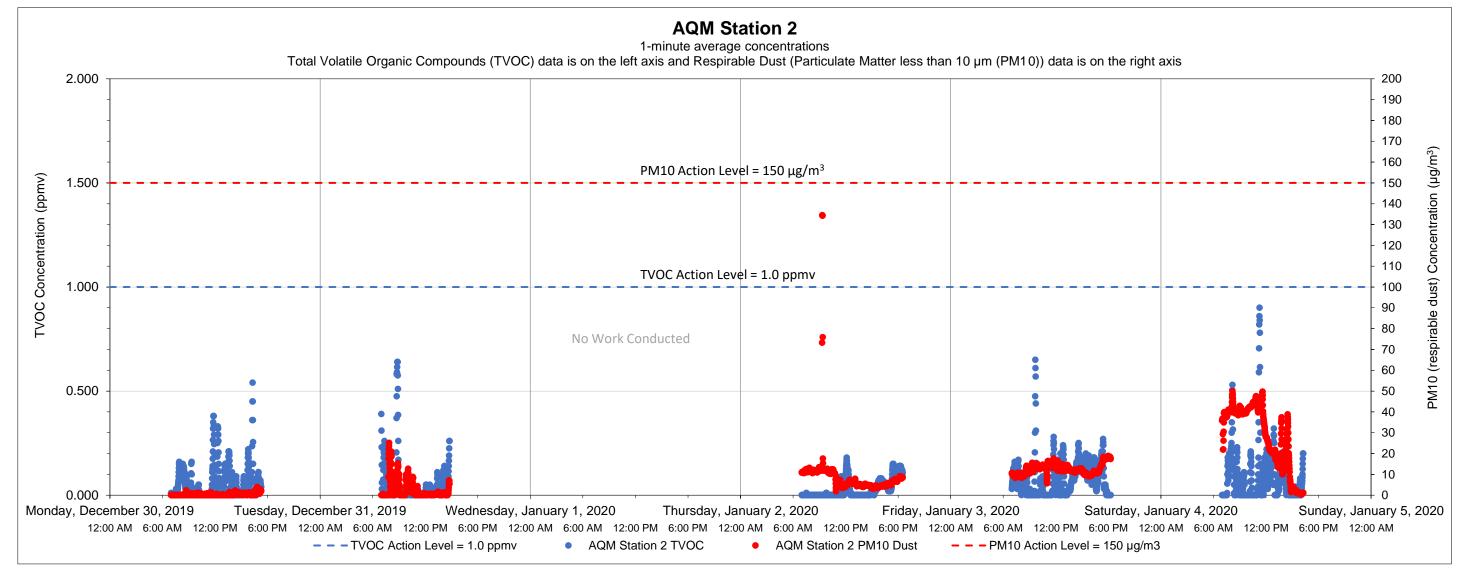
| Data Summary Statistics | | | |
| TVOCs average concentration | 0.06 | ppm | |
| TVOCs maximum concentration | 0.90 | ppm | |
| TVOCs action level | 1 | ppm | |
| PM10 average concentration | 10.34 | μg/m³ | |
| PM10 maximum concentration | 134.43 | μg/m³ | |
| PM10 action level | 150 | μg/m³ | |

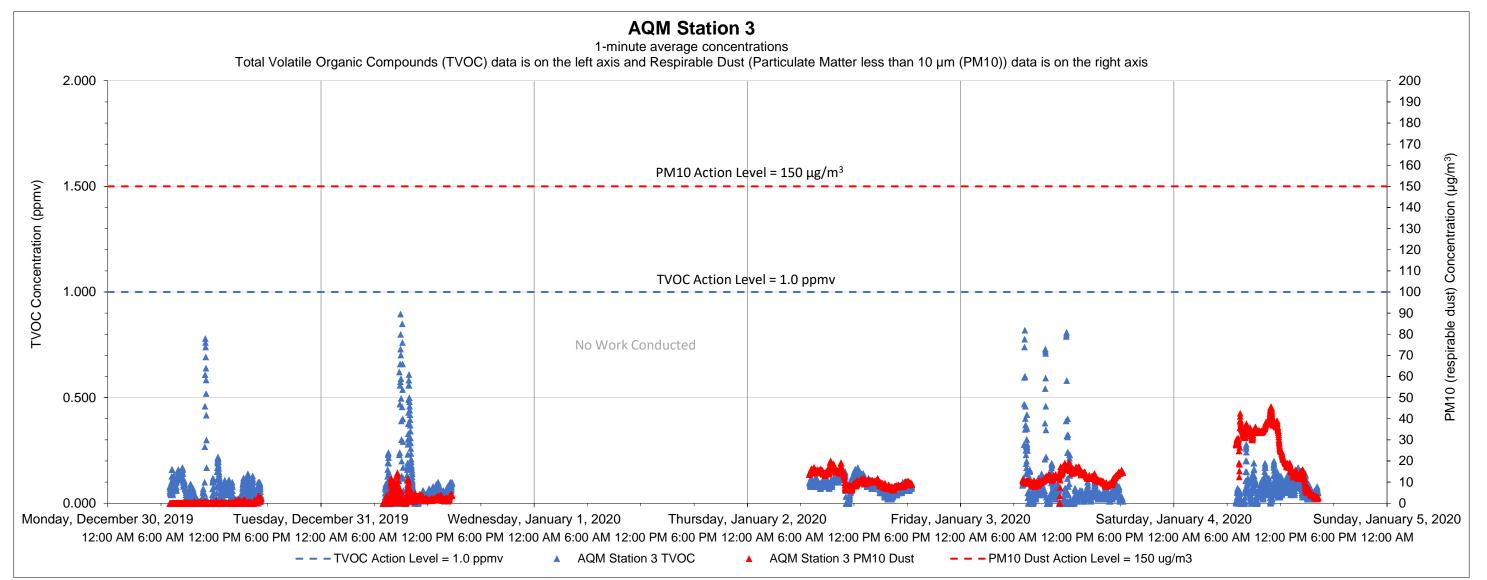
| Data Summary Sta | tistics | |
| TVOCs average concentration | 0.08 | ppm |
| TVOCs maximum concentration | 0.90 | ppm |
| TVOCs action level | 1 | ppm |
| PM10 average concentration | 10.37 | μg/m³ |
| PM10 maximum concentration | 45.72 | μg/m³ |
| PM10 action level | 150 | μg/m³ |

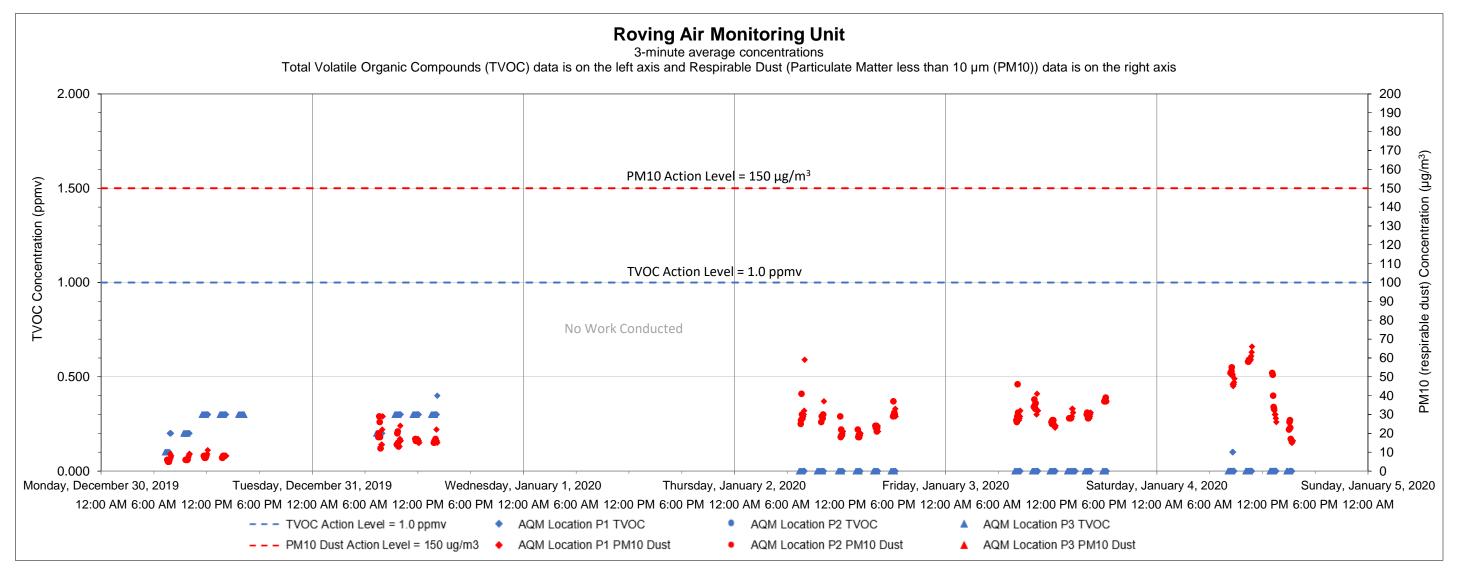
| Data Summary Statistics | | | | | | | | |
| TVOCs average concentration | 0.08 | ppm | | | | | | |
| TVOCs maximum concentration | 0.40 | ppm | | | | | | |
| TVOCs action level | 1 | ppm | | | | | | |
| PM10 average concentration | 24.27 | $\mu g/m^3$ | | | | | | |
| PM10 maximum concentration | 66 | μg/m³ | | | | | | |
| PM10 action level | 150 | μg/m³ | | | | | | |

- 1) Transient readings were conducted over a three minute time period. A reading is sustained if it is held for over a five minute time period.
- 2) The location of each AQM location is presented on the attached summary figure. This graph depicts data collected by the roving unit.
- 3) Air quality monitoring performed in accordance with the May 12, 2017 Short Term Response Action Plan (STRAP), the October 11, 2017 STRAP Addendum (including Attachment N Clarifications to the Proposed Air Monitoring Program for STRAP Activities) and the October 27, 2017 Short Term Response Action Approval Letter issued by RIDEM. Monitoring active STRAP activities.

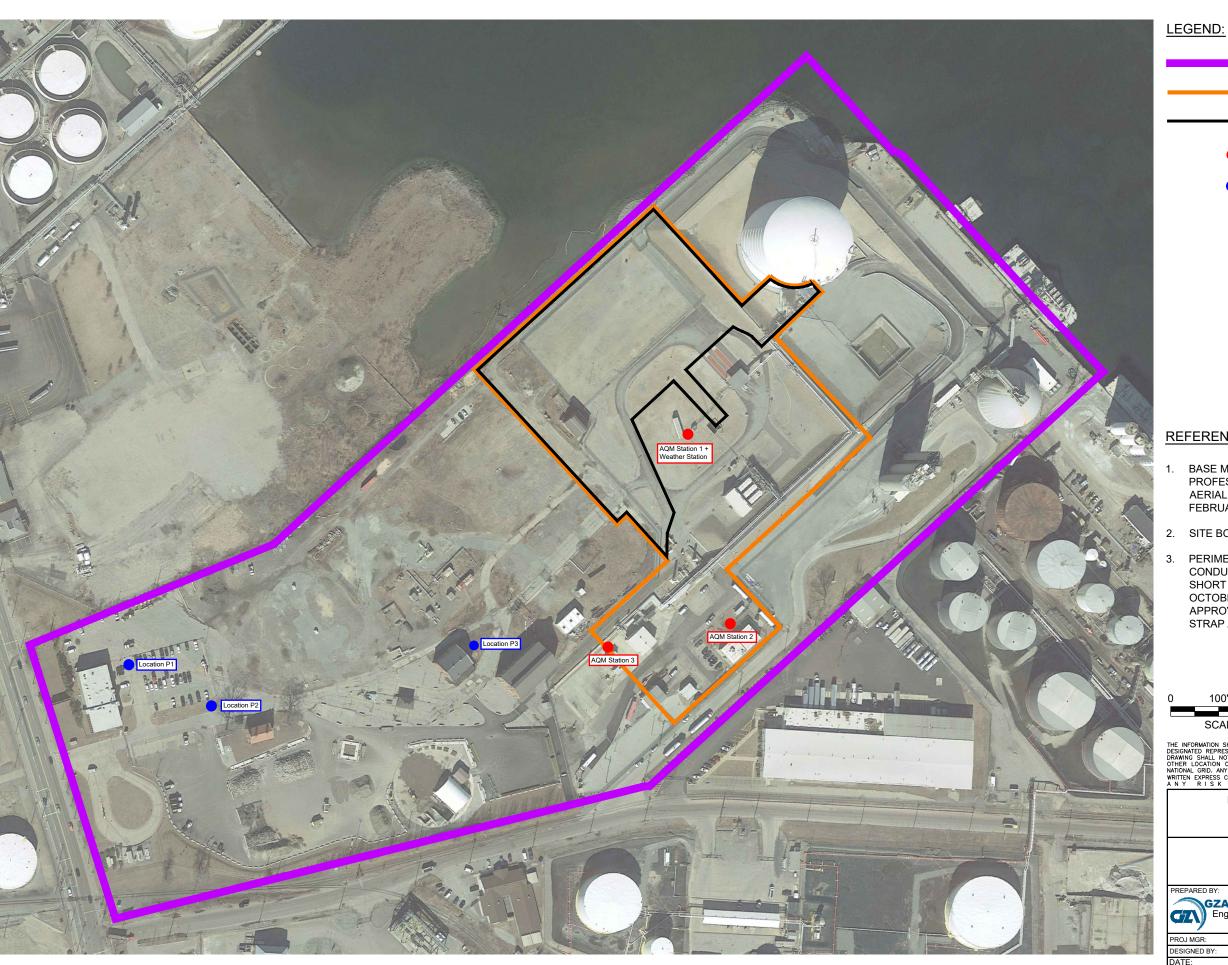
Summary Figure Week of 12-30-2019

AIR QUALITY MONITORING (AQM) STATION

642 ALLENS AVENUE FORMER MGP SITE

HANDHELD MONITORING LOCATIONS
