# Removal and Replacement of Mercury Switch in 1980-1998 GM Rectangular Hood Lighting Assembly

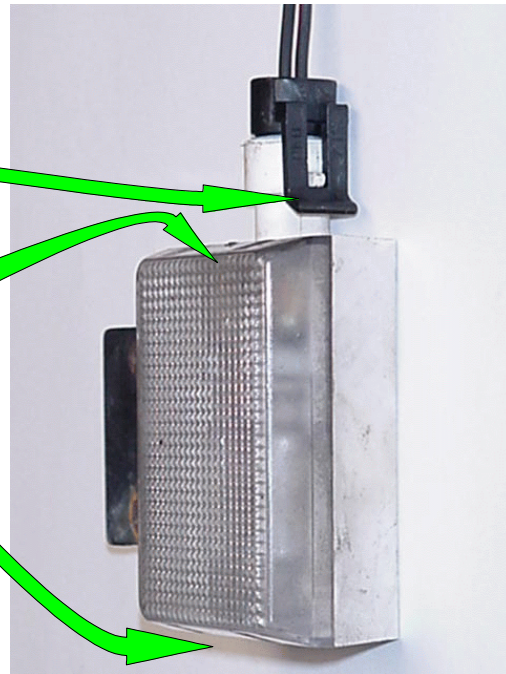
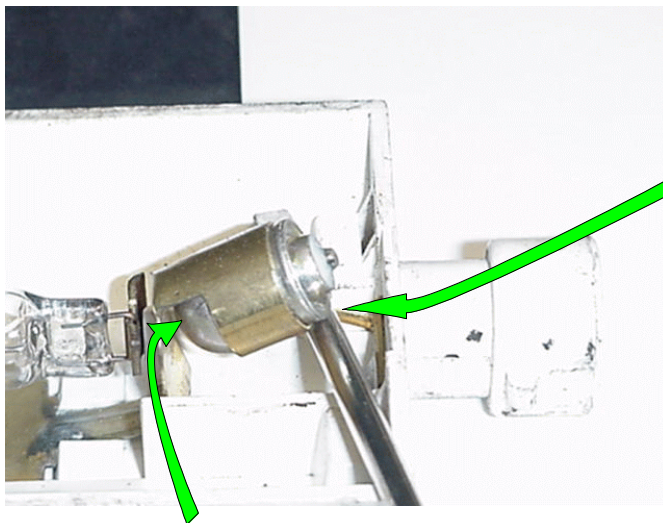
1. Remove the wiring clip by sliding a screwdriver under the clip and sliding the clip back to remove the power source

2. Remove the clear plastic dome by gently squeezing the center of the dome on the short sides with thumb and forefinger

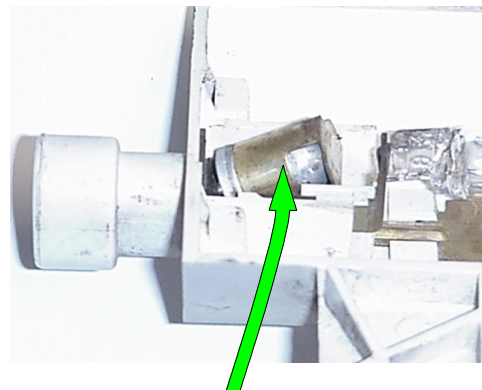
3. Pry up the mercury switch holder with a small screwdriver

4. Push the mercury switch out of the holder using a screwdriver and replace the mercury switch with a ball-bearing switch oriented as shown

5. Push the mercury switch holder back into place with a screwdriver and adjust the position of the switch to have the center conductor touch the copper strip on the assembly wall
