# Removal and Replacement of Mercury Switch in 1998 Ford Trunk Lighting Assembly

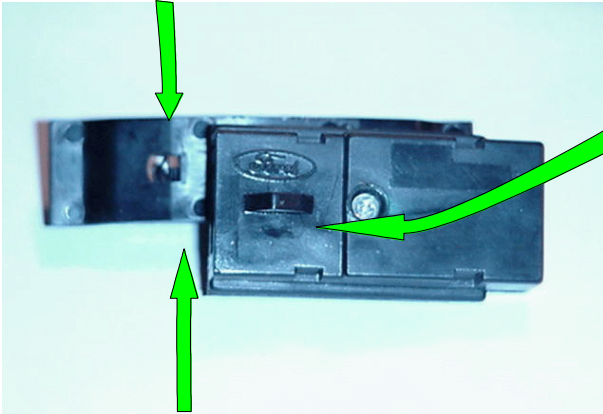
1. Locate the lighting assembly on the drivers side trunk lid arm. Use a screwdriver to pry the assembly fastener off the trunk lid arm.

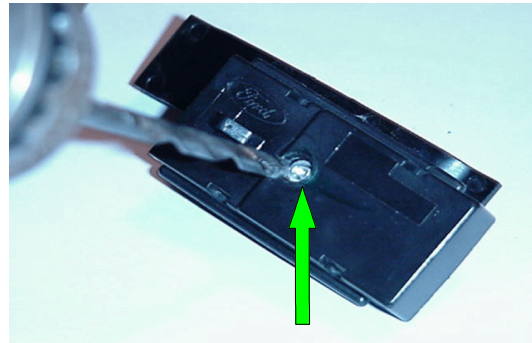
2. Remove the power source by lifting the wiring connector over the tab and pulling the wiring harness off the lighting assembly.

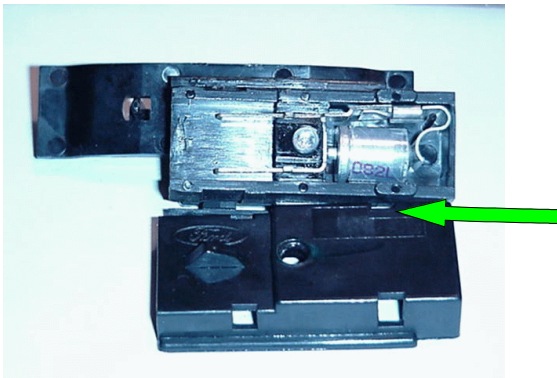
3. Remove the bulb from the assembly by pulling it from socket

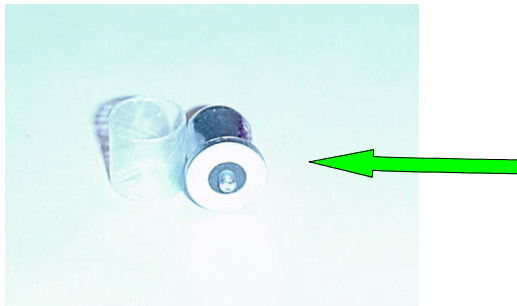
5. Pry the plastic casing apart using a straight blade screwdriver and remove the mercury switch

4. Use a drill with a 3/8" bit to remove the head of the pop-rievet that secures the two halves of the assembly.

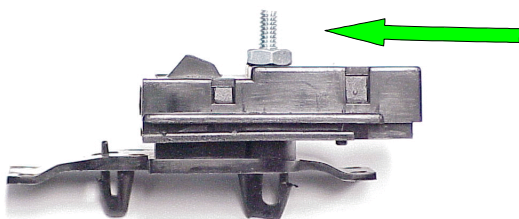
6. Remove the plastic insulator from the mercury switch and place it on the ball-bearing switch. Replace the new switch with the insulator in the assembly using the same orientation as in step 5.

7. Remove the old pop rivet. Snap the casing back together. Then use a 1" #8-32 bolt and #8-32 nut to replace the pop-rievet and tighten to secure the assembly. Snap the assembly back into place, reattach wiring clip, and insert bulb. Verify that the switch is actuating properly.
